Technical Investigation Report on Lift Incident
at 478-480 King's Road, North Point, Hong Kong

Electrical and Mechanical Services Department
July 2013

**Technical Investigation Report on Lift Incident
at 478-480 King's Road, North Point, Hong Kong on 2 March 2013**

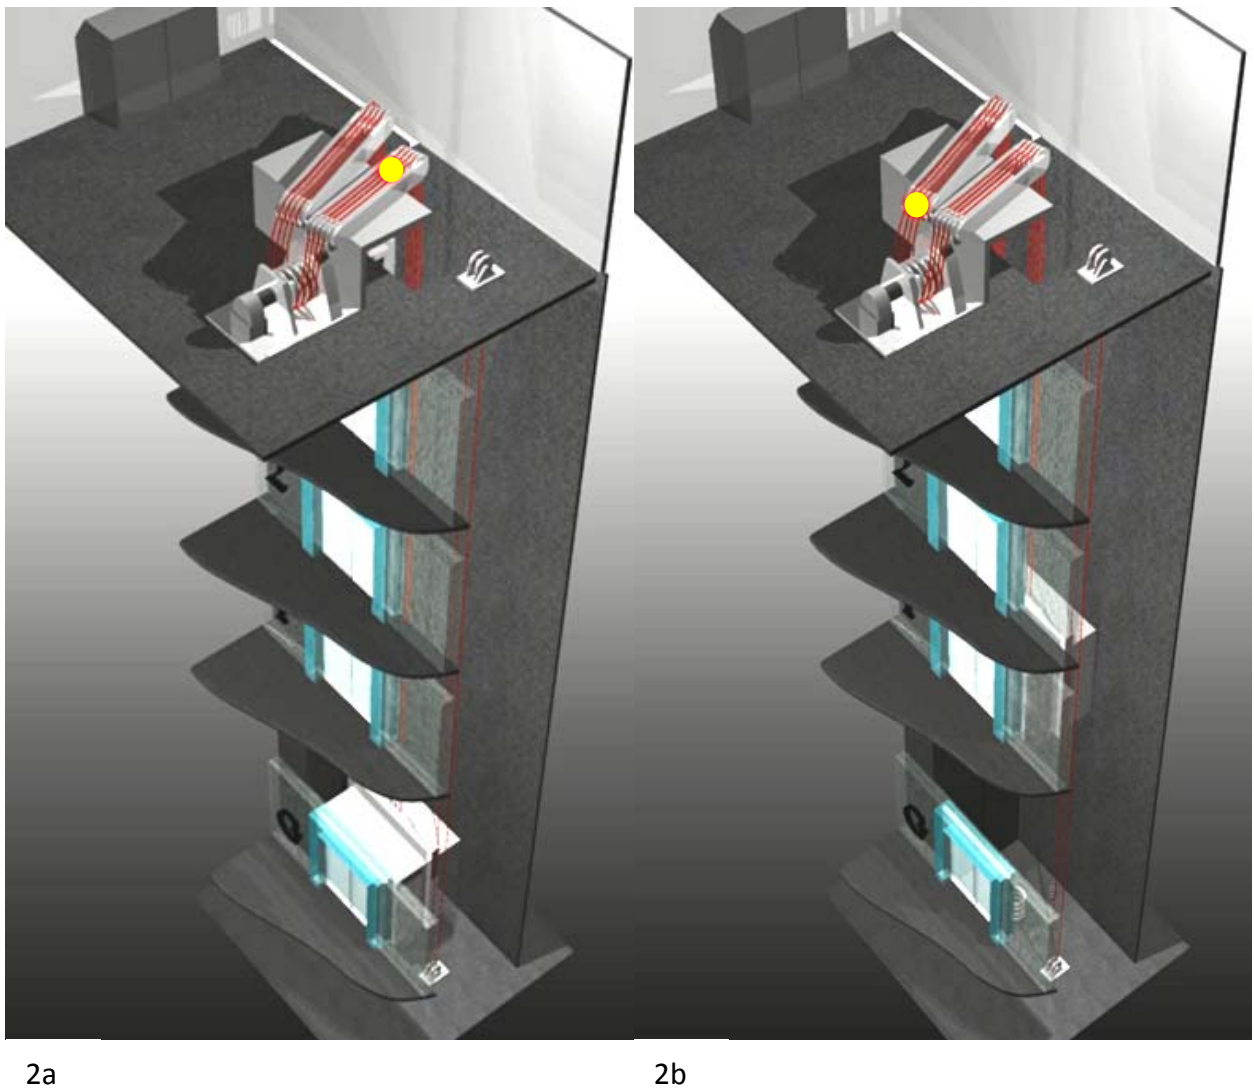
6.4 The four suspension ropes were found broken at positions between 12.5 m and 13.5 m from the fixing points at the lift car, corresponding to the point where the suspension ropes rest on the diverting pulleys when the lift was at G/F (refer to Figure 2). The G/F is the floor with the most frequent stops, thus the above sections of the suspension ropes should experience the largest loading and unloading pressure when the passengers enter and exit the lift car.

Figure 2 : A pictorial view to show the position of breaking points of the suspension ropes (yellow dot) corresponding to different positions of the lift car. The diagram on the left hand side (2a) shows the lift car on G/F. The diagram on the right hand side (2b) shows the lift car on 1/F.

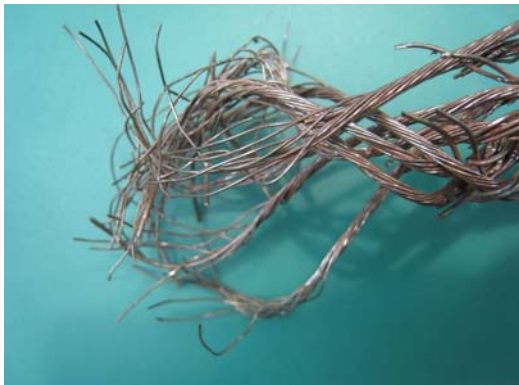
6.10 At the very ends of failed strands in all ropes, only king wires and inner wires were found. The fibre cores and the outer wires were completely missing (refer to Figure 3a). Adjacent to the failed ends, the strands of the ropes opened up after failure. Detailed examination revealed that the fibre cores of the ropes could not be found in the suspension ropes until at some distance from the failed ends. It was suspected that movement of the wires had already cut the fibre cores into small pieces, which had escaped from the ropes when they broke (refer to Figure 3b). Besides, notches formed on the outer wires of the strands were observed and these indicated that abrasion had occurred between strands of the ropes (refer to Figure 3c).

Figure 3a : A closer view of the broken end of a suspension rope. Only inner wires and king wires remained.

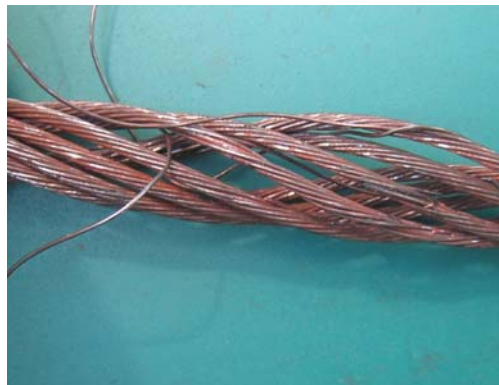
Figure 3b : The fibre cores were missing in a short section next to the failed end of the rope.

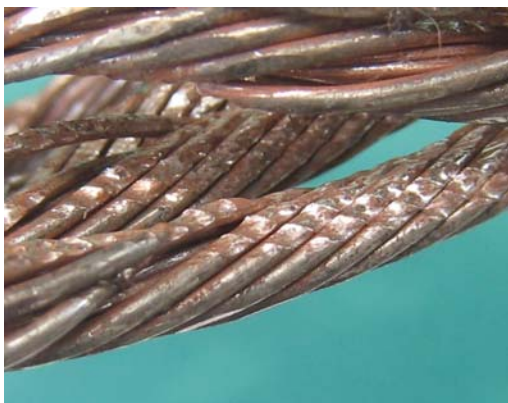
Figure 3c : Notches formed due to abrasion between strands.

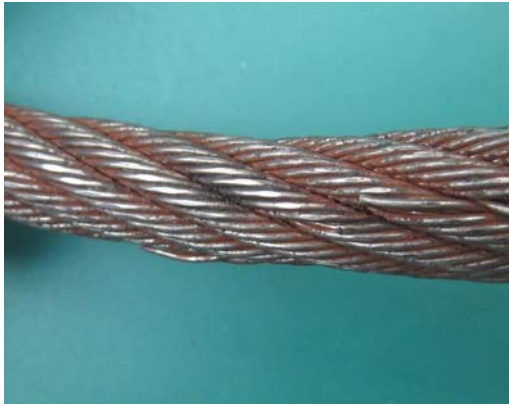
6.11 Away from the failed ends, the suspension ropes were relatively dry and rouge was observed in the valleys between strands along a substantial section of the suspension ropes. Moreover, wear was clearly visible along outer wires for most of the length of all ropes (refer to Figure 4).

Figure 4 : Wear of the rope along outer surface (crown wear) and red iron oxide particles (rouge) in the valleys between strands.

6.17 From the results of the tensile tests and examination of the suspension ropes, it is obvious that the failure of the ropes was due to excessive wear and tear of the ropes. Due to insufficient lubrication for a prolonged period of time since their replacement in September 2010, the fibre core of the rope section had dried up and could not provide the strands with the necessary lubrication and radial support. The strands came in contact with each other causing abrasive wear between and within strands. These had resulted in significant reduction in the strength of the suspension ropes. Immediately before the failure, the four suspension ropes had deteriorated severely to a similar extent. The remaining strength of the ropes could no longer support the weight of the lift car with passengers inside combined with the dynamic loads when the lift stopped on 1/F. The ropes failed at almost the same time.

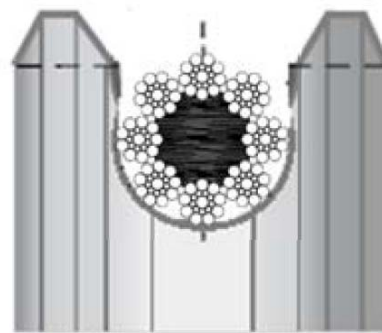
6.13 The examination revealed that the four grooves in contact with the ropes were found to have worn down to the bottom of the undercut (see Figure 6). A traction sheave with this substantial groove wear would result in rope slip and hence extra abrasion of the rope as shown in Figure 4.

Figure 6 : Groove worn down to the bottom of the undercut

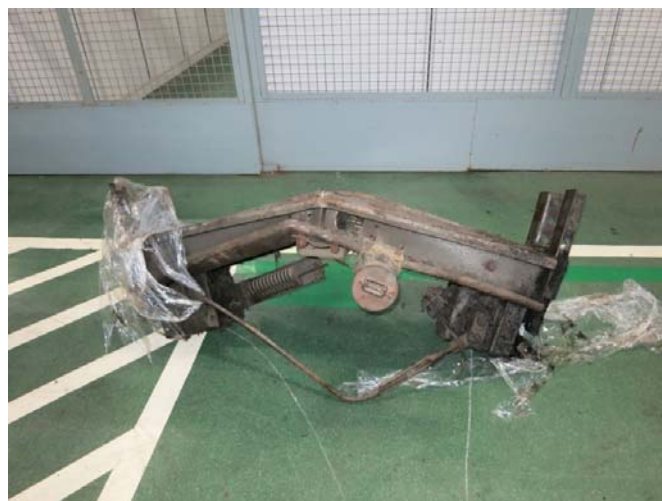
6.20 The breakage of the suspension ropes and non-operation of the safety gears led to the plunging of the lift car into the lift pit. Figure 7 shows the deformation of the bottom part of the lift car supporting frame (“bottom frame”). The deformation of the bottom frame was caused by the impact of the lift car to the spring buffer in the lift pit.

Figure 7 : Outlook of the deformed lift car bottom frame.

6.21 The impact speed of the falling lift car was analysed. The impact speed of the lift car loaded with seven passengers should be above 2.7 m/s. This speed was well above the activation speed (1.4 m/s) of the overspeed governor of the lift. The analysis shows that overspeed governor should have been activated before the lift car reached the buffer.

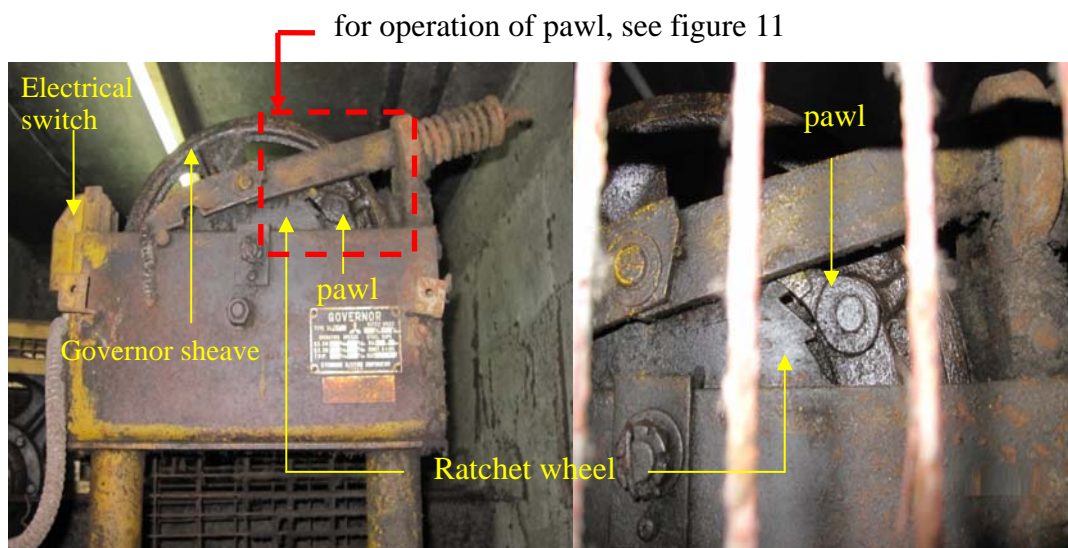
6.22 During the on-site inspection immediately after the incident on 2 March 2013, the electrical switch of the overspeed governor was found activated. Besides, the pawl of the overspeed governor was released and had come close to the valley between two teeth of the ratchet wheel. However, it was not fully engaged with the ratchet wheel. These indicated that the overspeed governor had already reached its activation speed.

Figure 8 : Overspeed governor of the lift. The Figure on the left shows that the pawl of the overspeed governor had been released and came close to the valley between two teeth of the ratchet wheel.

6.25 It was mentioned in section 6.22 that, after the incident, the pawl of the overspeed governor was released and had come close to the valley between two teeth of the ratchet wheel but was not in the fully engaged position. Due to the failure of engagement of the pawl with the ratchet wheel, the subsequent mechanism to activate the safety gears could not be operated to prevent the lift car from falling down.

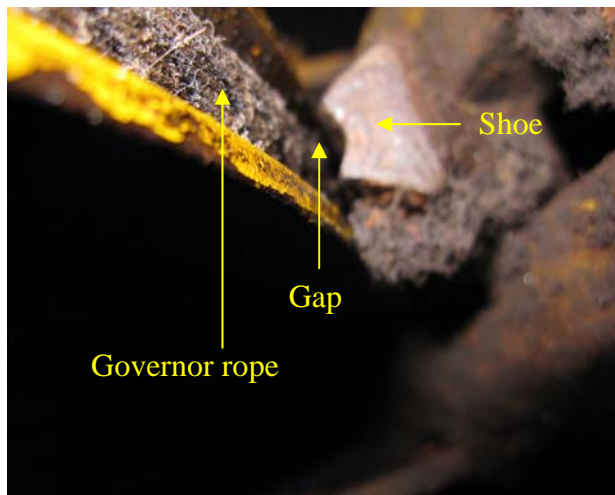
6.24 Although the activation speed of the overspeed governor was correctly set, it was noticed that a gap was found between the governor rope and the shoe of the governor, signifying that the governor rope was not gripped by the shoe in the incident. (refer to Figure 10)

Figure 10 : Gap between the shoe of the governor and the governor rope, indicating no gripping of the governor rope by the shoe in the incident.

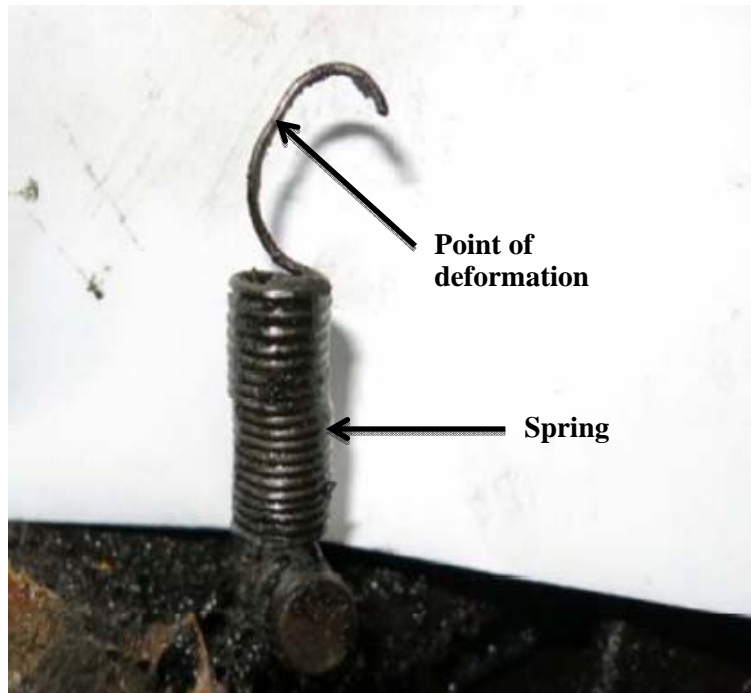
6.26 The pawl of the overspeed governor was spring-loaded to ensure its engagement with the ratchet wheel when the latch was released. The operation of the pawl and ratchet wheel is shown in Figure 11. It was found that the tension spring of the pawl was not properly connected to the pawl and the connection end of the spring was deformed (see Figure 12).

Figure 12 : Photo shows deformation of the spring end.

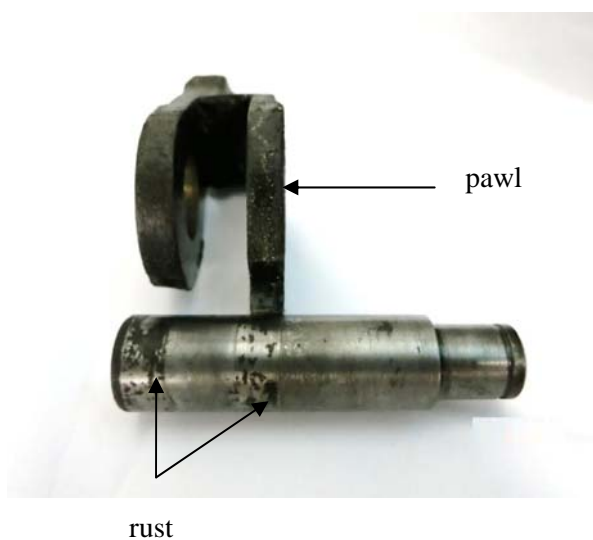
6.27 The pin (pivot joint) of the pawl was dismantled and examined. Rust was found on the surface of the pin. (see Figure 13). The rust would increase the friction of the pin and impair the swift response of the pawl of the overspeed governor.

Figure 13 : Pin of the pawl of the overspeed governor.

7.3 The overspeed governor failed to activate the operation of the safety gears to stop the lift car. Despite that the activation speed was reached, the pawl of the overspeed governor failed to engage with the ratchet wheel during the incident, rendering it unable to activate the safety gears of the lift. The improper connection of the tension spring of the pawl and the rusty pin of the pawl were attributable to such unsuccessful engagement.
