EM/LE/55 Pt. II

17 May 1994

Circular No. 8/94
Manually Operated Collapsible Car Gate

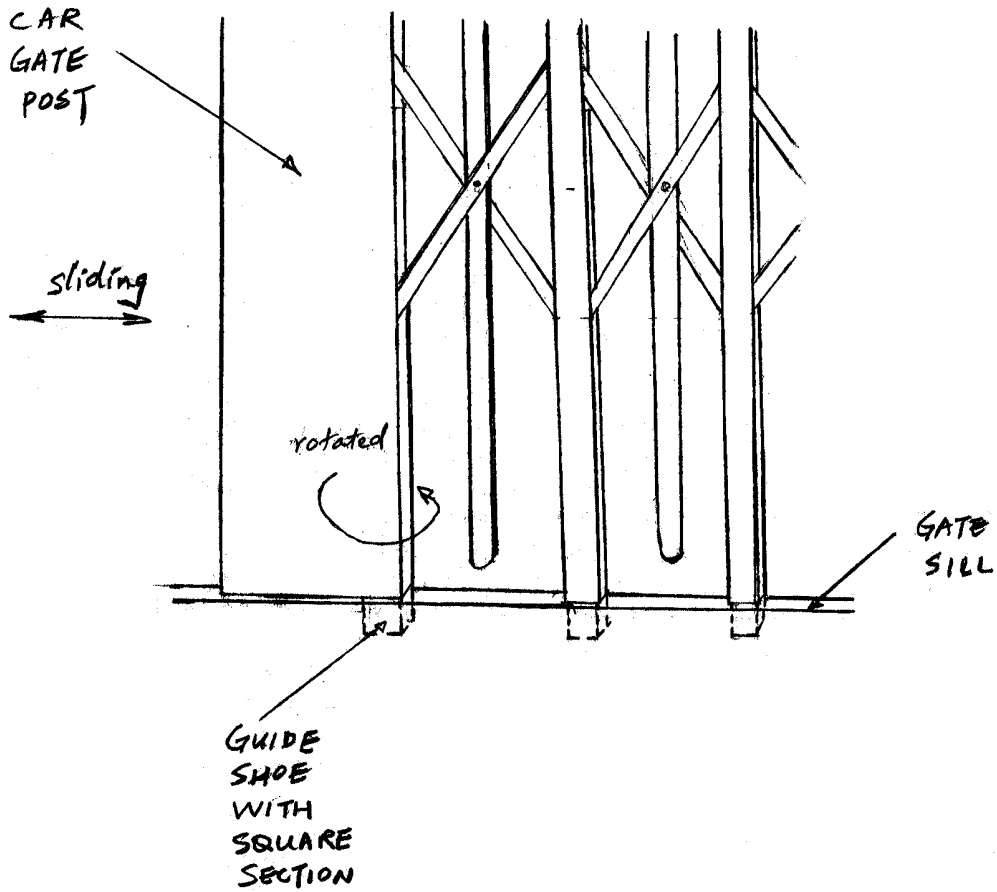
MANUALLY OPERATED COLLAPSIBLE
CAR GATE

In a recent accident, the car gate post of a lift struck on the landing sill while the lift car was travelling downwards, resulting in bad damages to the car gate and car roof. The subject lift was a general freight lift with manually operated collapsible car gate installed some years ago. The guide shoe at the car gate was of a square section. Whilst the design (see attached sketch) was adequate to guide and restrain the gate in normal operation, the square section allowed rotational movement of the gate post pivoted on the guide shoe such that the unrestrained side of the gate post protruded beyond the car cage and hit the landing sill when an external force of sufficient magnitude was acted to turn the gate post.

In view of the occurrence, I should be grateful if you could carry out inspections to all lifts with similar manually operated collapsible car gate under your maintenance and modify the installation whenever the above mentioned shortfall was discovered.
