2007 年 6 月 11 日

昂坪纜車
車廂墜下事故

專家委員會報告

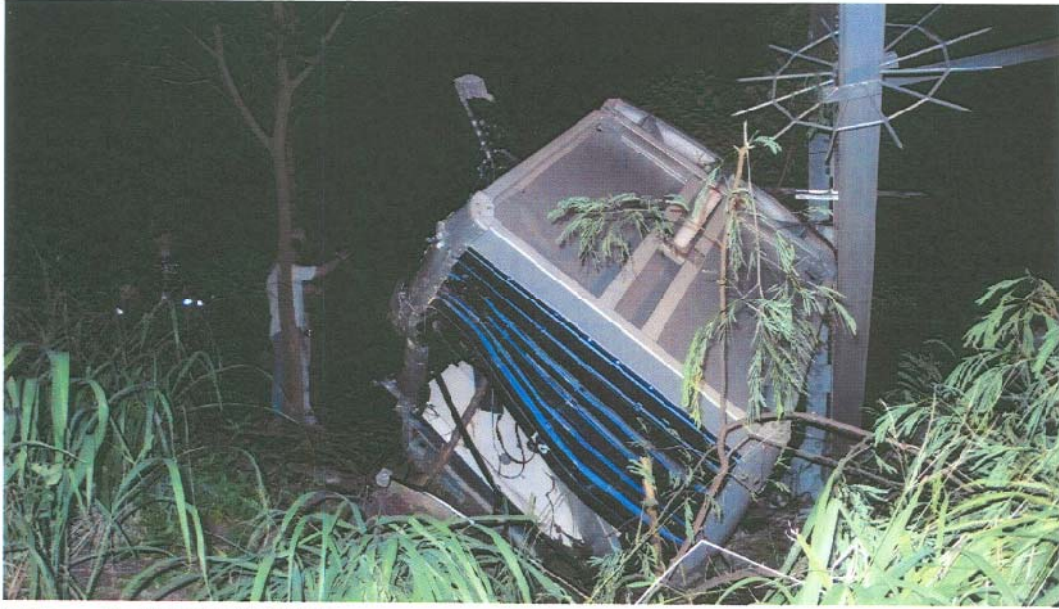
2007 年 6 月 11 日晚上 8 時許，昂坪纜車的 21 號車廂被發現倒在 2B 號塔旁的地上。車廂損毀嚴重，其後證實車廂是從離地約 50 米的高處墜下。圖 1 為 21 號車廂的殘骸照片。

圖 1－ 21 號車廂的殘骸

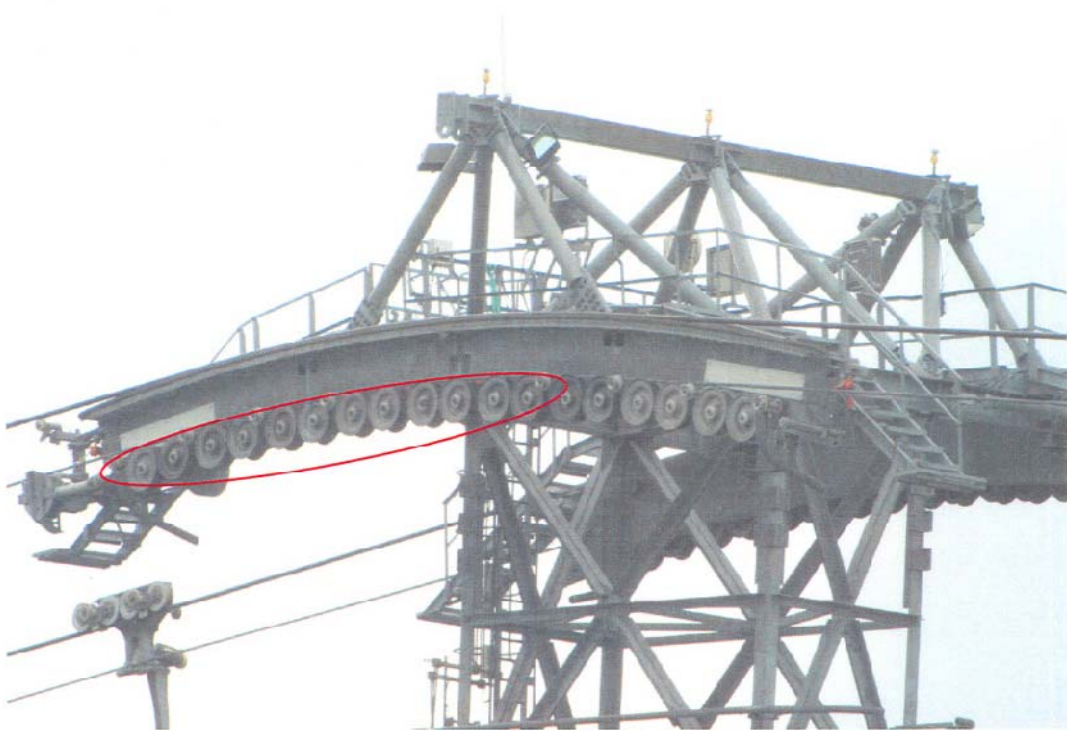
- 12.1 除 21 號車廂嚴重損毀外，2B 號塔上共有 13 個滑輪損壞（圖 6），而 2B 號塔若干結構部分亦有刮痕。
- 12.2 導軌纜狀況良好，惟發現有一條長 173 米的淺刮痕（圖 7）。
- 12.3 牽引纜表面有數處出現輕微損壞，位置在出軌車廂的夾扣位及其周圍（圖 8）。

圖 6— 2B 號塔上共有 13 個滑輪損壞

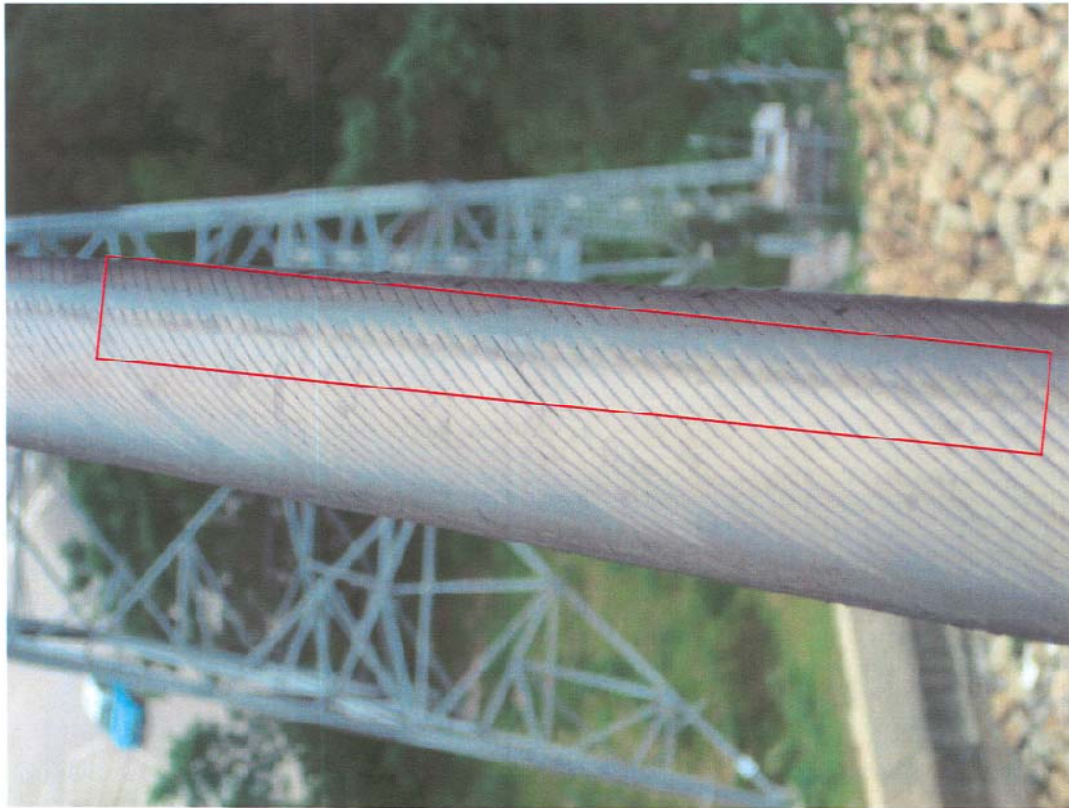
圖 7— 導軌纜有 173 米長的刮痕，此為其中一段

- 17.1 導軌纜上由脫軌處起至 2B 號塔，出現長 173 米的淺刮痕；
- 17.2 車站導向滑輪鎖定螺母下方發現磨損痕跡（圖 11），及
- 17.3 車站導向滑輪內側發現油脂層，證實與導軌纜所用的潤滑劑相同（圖 12）。有關科學鑑證由政府化驗所進行，參見附件一。

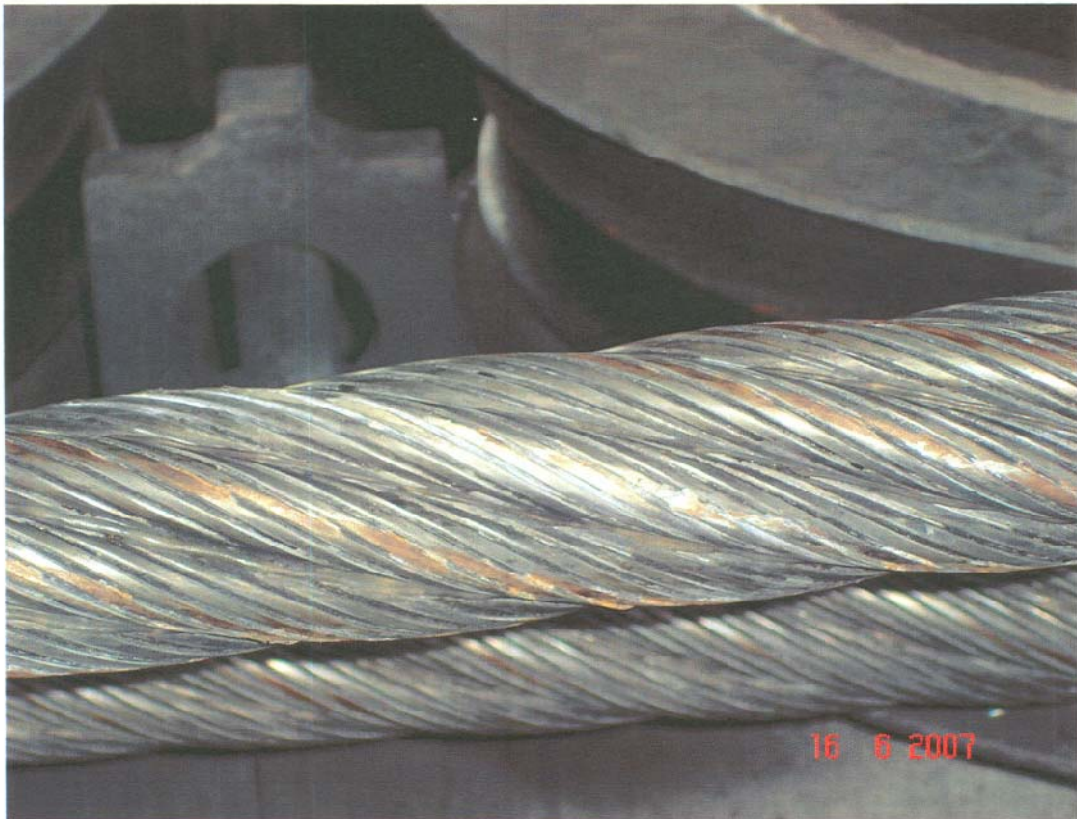
圖 8— 牽引纜表面有輕微損壞

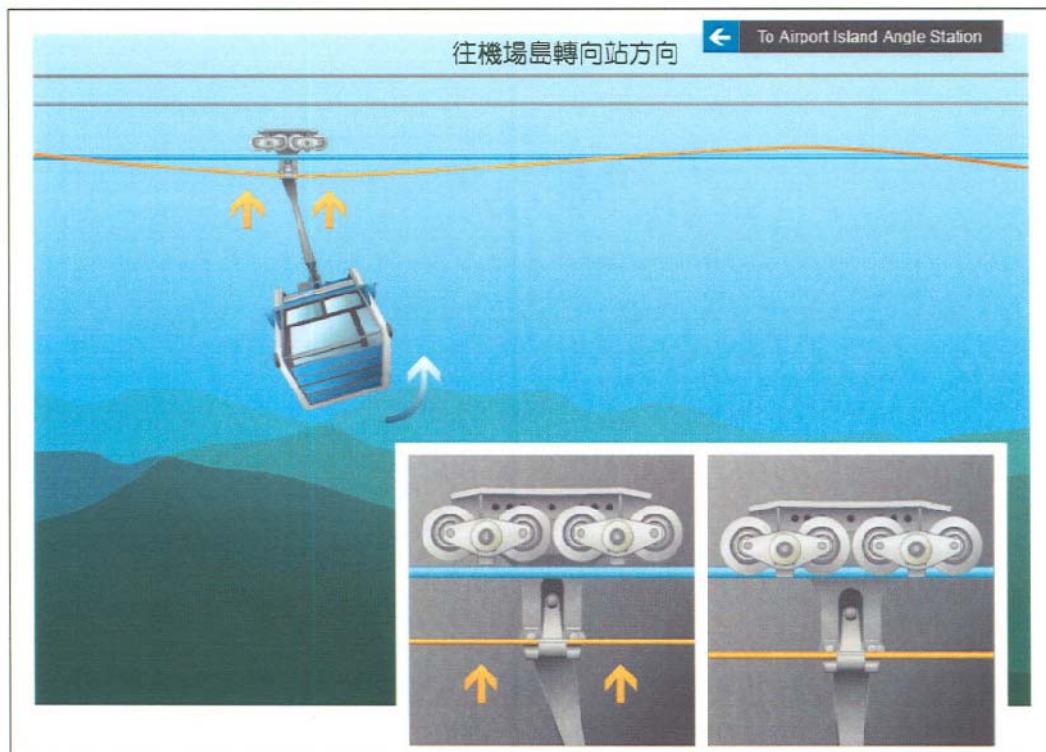
圖 9—21 號車廂因擺動及牽引纜過度擺動而被向上拋起（右邊小圖顯示吊架的正常位置）。

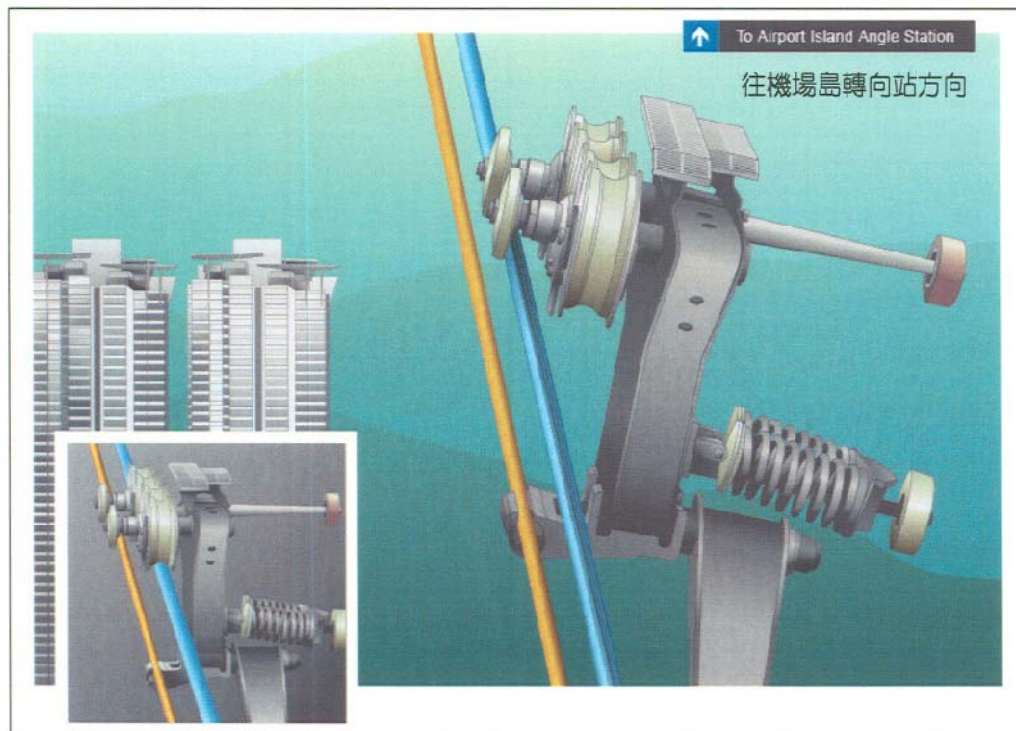
17. 在 19 時 39 分發生脫軌情況後，車廂只倚靠車站導向滑輪的連接軸繼續掛靠在導軌纜上，情形如圖 10 所示。脫軌情況無人發現，當纜車重新啟動時，已脫軌的 21 號車廂的吊架被牽引纜拉向 2B 號塔。該吊架在導軌纜上向前滑動，引致導軌纜上出現刮痕，鎖定螺絲母磨損，導軌纜的潤滑劑沾到滑輪上。過程由以下檢查結果證實：

圖 10— 21 號車廂脫軌，並以吊架上的車站導向滑輪連接軸掛靠在導軌纜上

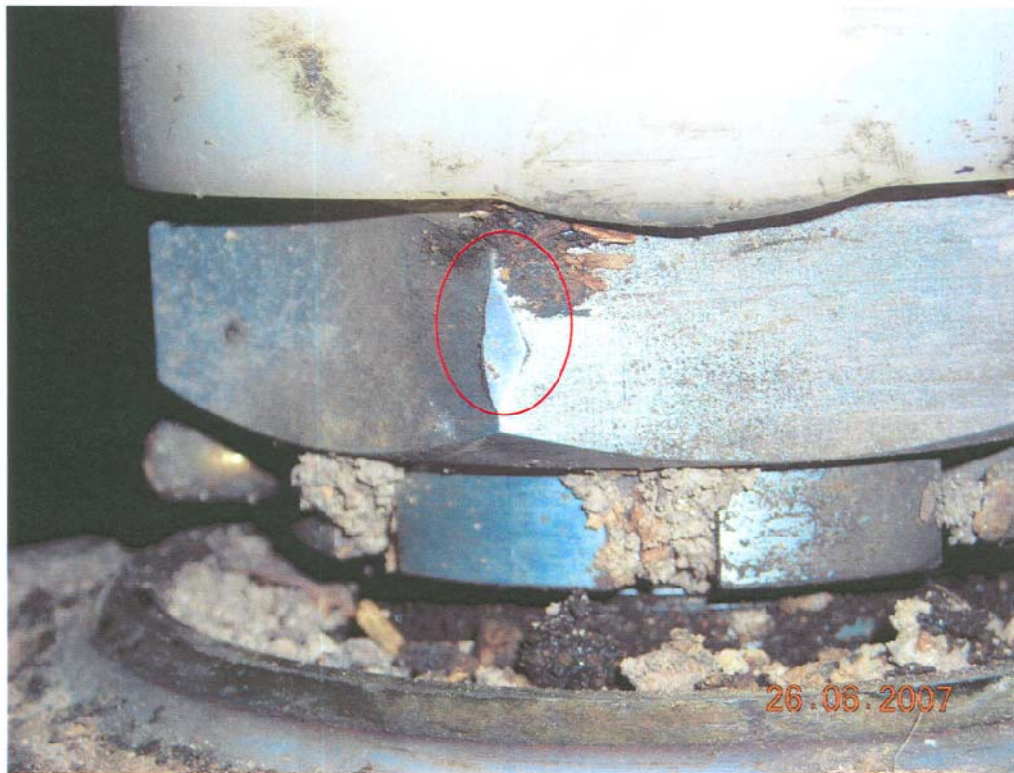
圖 11— 車站導向滑輪的鎖定螺母下方發現磨損痕跡

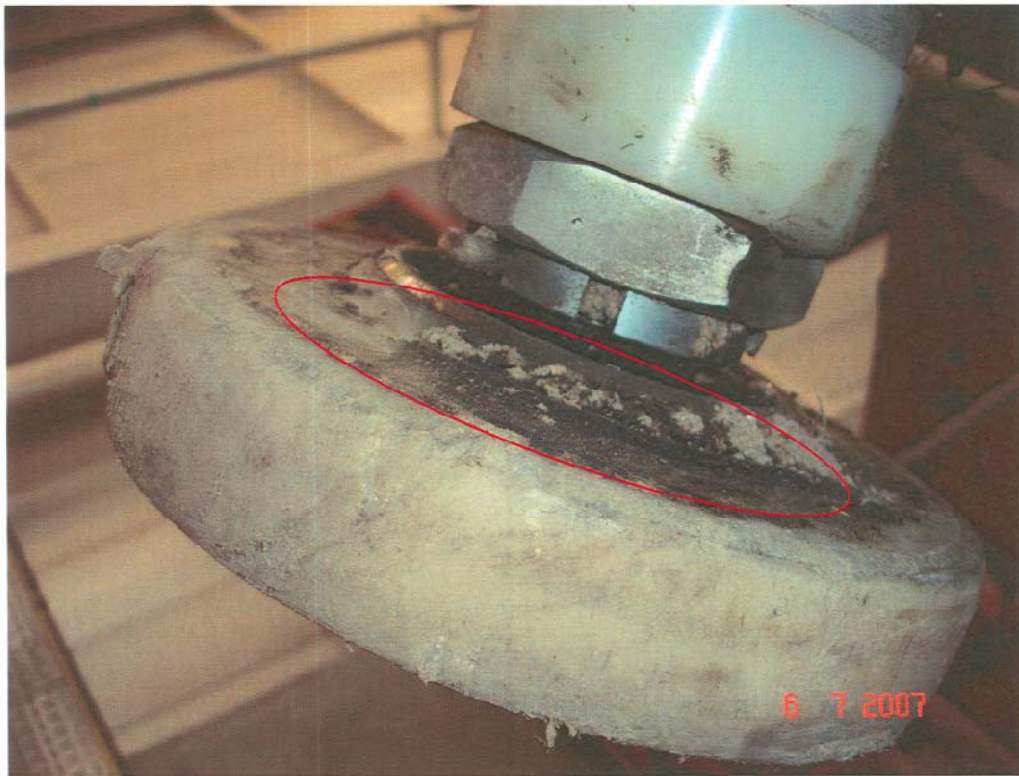
圖 12－ 車站導向滑輪內側發現沾上油脂層

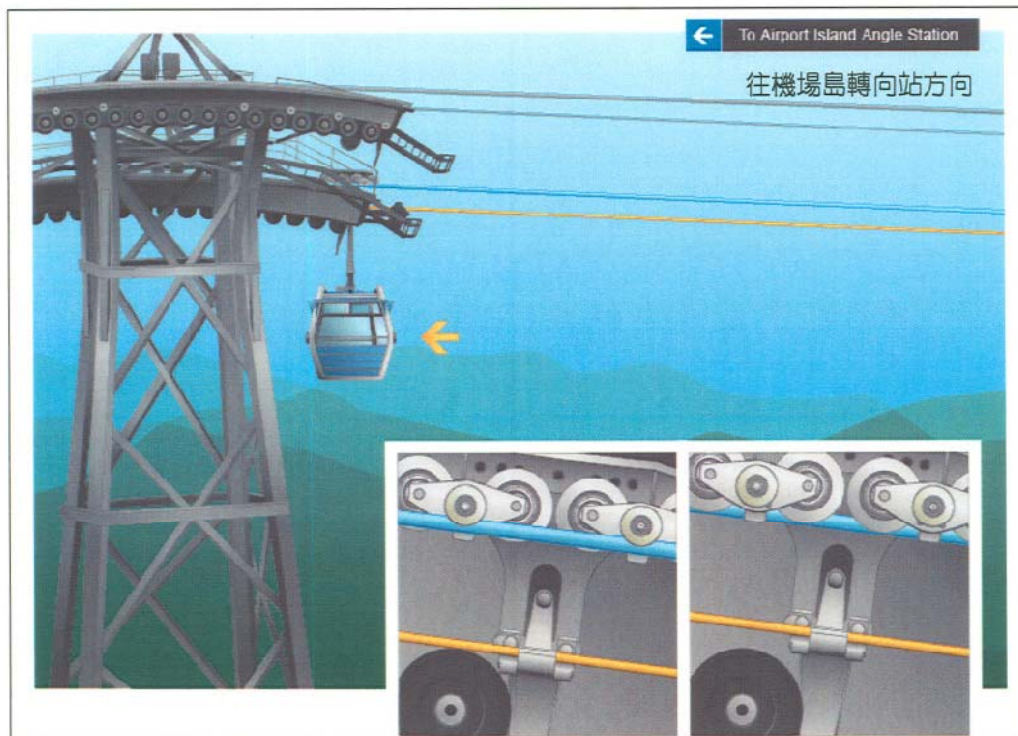
18. 由於脫軌的 21 號車廂移離正確位置 (圖 13)，吊架到達 2B 號塔時，可拆除式夾扣與一組裝置於塔頂的滑輪組趾撞 (圖 14 及 15)，導致滑輪和牽引纜夾扣損毀。圖 16 顯示撞擊後受損的滑輪。大約在第 11 個滑輪的位置，撞擊力令脫軌車廂完全脫離牽引纜。車廂繼而從約 50 米墮下，並倒在 2B 號塔旁的地上。

圖 13— 脫軌的 21 號車廂移位後到達 2B 號塔（左邊小圖詳細顯示吊架移位情況，右邊小圖顯示其正常位置）

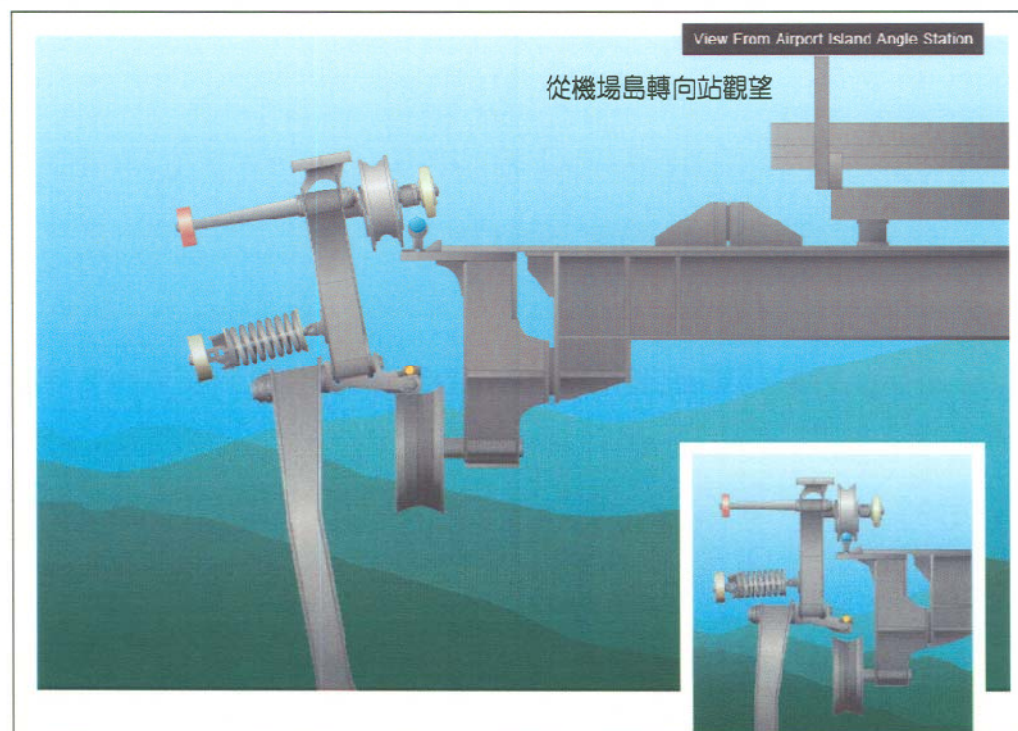
圖 14— 可拆除式夾扣與一組滑輪碰撞後，車廂即將墜下的一刻（小圖顯示吊架的正常位置）

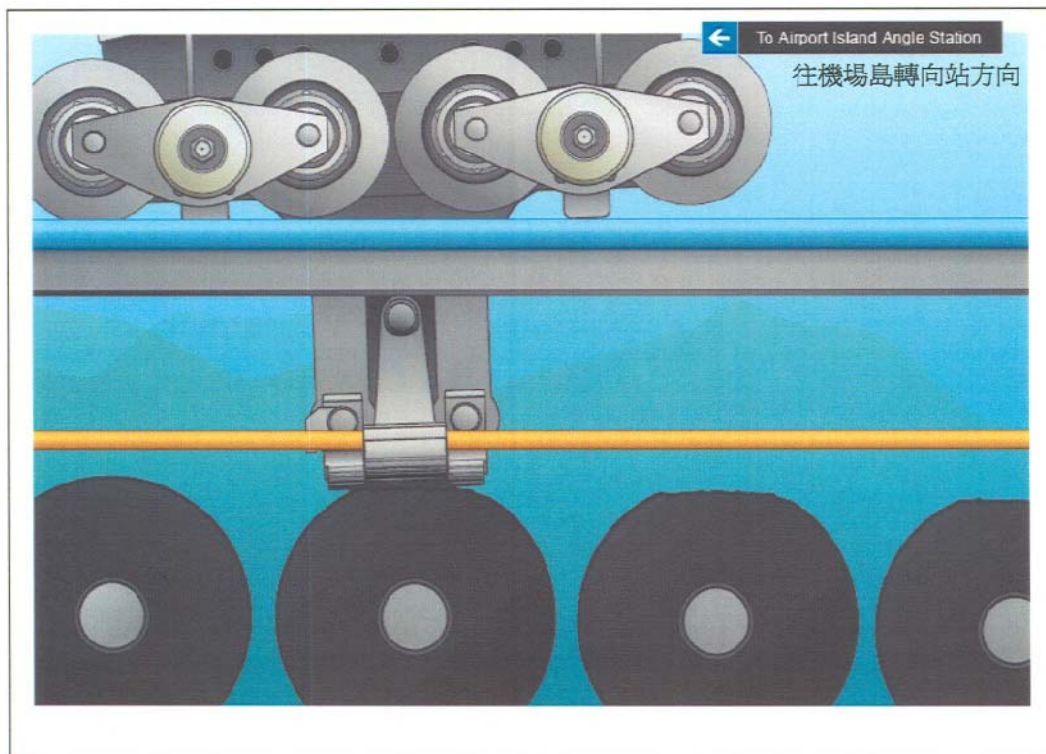
圖 15 — 可拆除式夾扣與 2B 號塔的滑輪碰撞，造成損毀

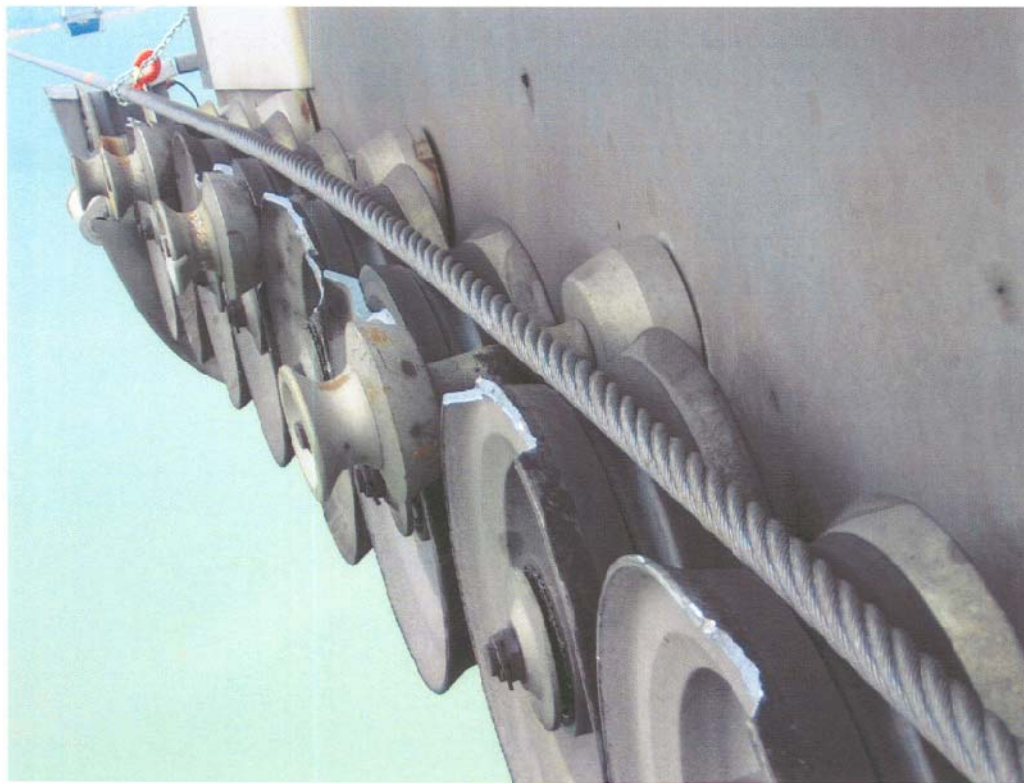
圖 16 — 碰撞後，2B 號塔的滑輪組受損，牽引纜已從捕纜裝置處放回原位

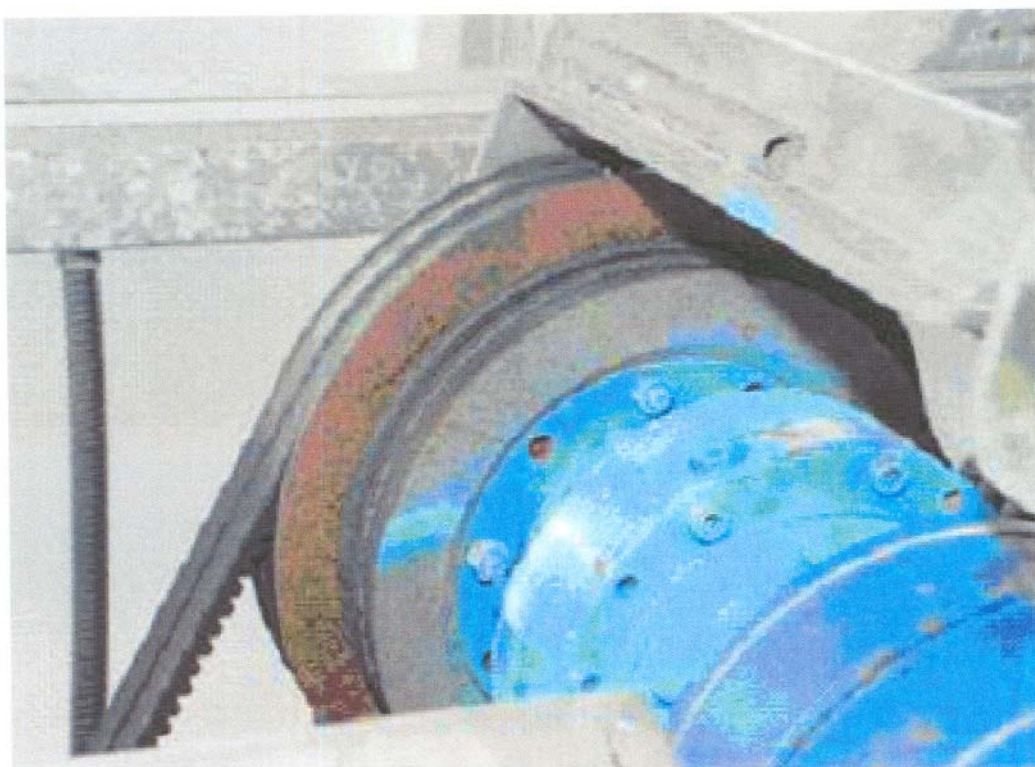
32. 另外，專家委員會注意到纜車系統的若干組件，包括車站內的 V 形皮帶滑輪、導軌纜、吊架與車廂之間的連接栓，均出現銹蝕，而啟用只一年的系統有此情況乃意料之外（見圖 17、18 及 19）。置於車廂儲存庫內的零件亦有銹蝕現象。該等組件應進行防銹處理，或改用質量較佳的物料，以適應香港的潮濕氣候，尤其是北大嶼山區域的潮濕環境。

圖 17— 銹蝕的 V 形皮帶滑輪

鑑於系統多個部分，如制動碟、導軌纜、車站滑輪、車廂吊架等，均出現不同程度的銹蝕現象，應加強有計劃的預防式保養。此外，亦應增加例行檢查及系統組件保養的頻密度，防止因組件故障而令服務長時間中斷。

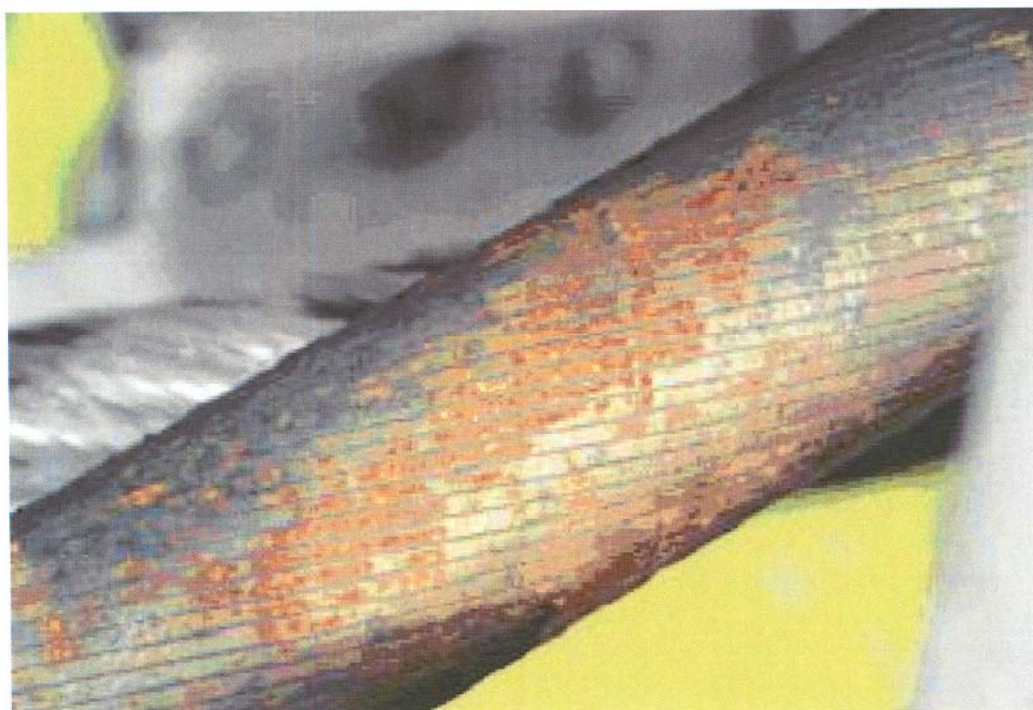
圖 18— 銹蝕的導軌纜

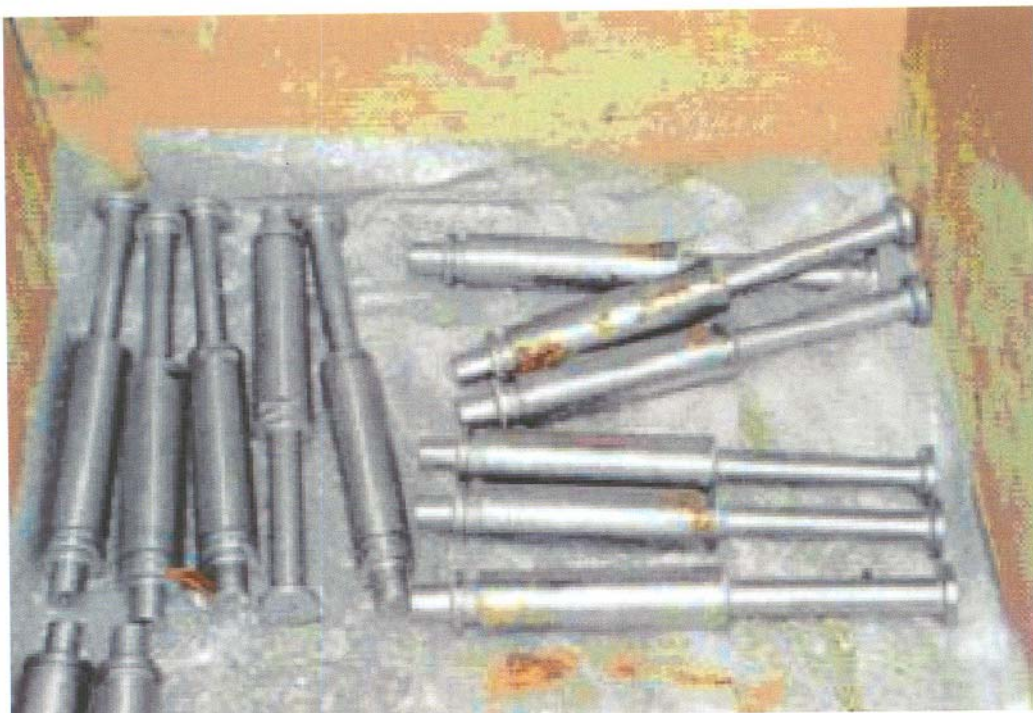
圖 19－ 置於車廂儲存庫內出現銹蝕的零件

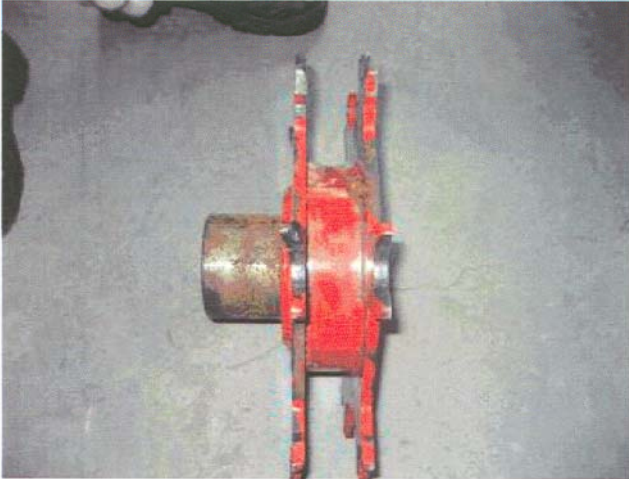
<p data-bbox="667 1904 1308 1937">圖 21—驅動鏈輪的其中一個輪齒受損</p>

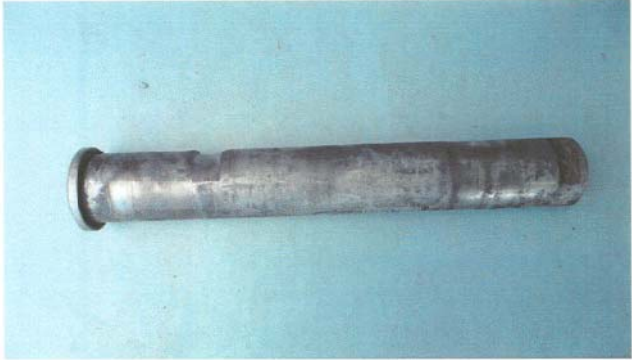
OM10	2007 年 5 月 11 日 服務中斷 2 小時	<p>一枚彈簧加壓減震滑輪於操作中損壞，導致系統失誤。減震滑輪軸表面呈現嚴重磨損，顯示定期檢查及保養不足。</p>

<p>圖 23－呈現嚴重磨損的減震滑輪軸</p>
OM11	2007 年 6 月 11 日 服務由 19 時 52 分起 中斷至今	<p>第 21 號車廂在 2B 號塔位置墜下撞毀。事故因進行年檢時制動器操作失當造成。</p>

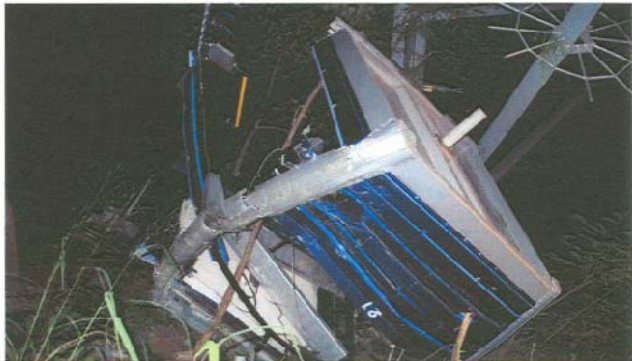
<p>圖 24－事故發生後的第 21 號車廂殘骸</p>

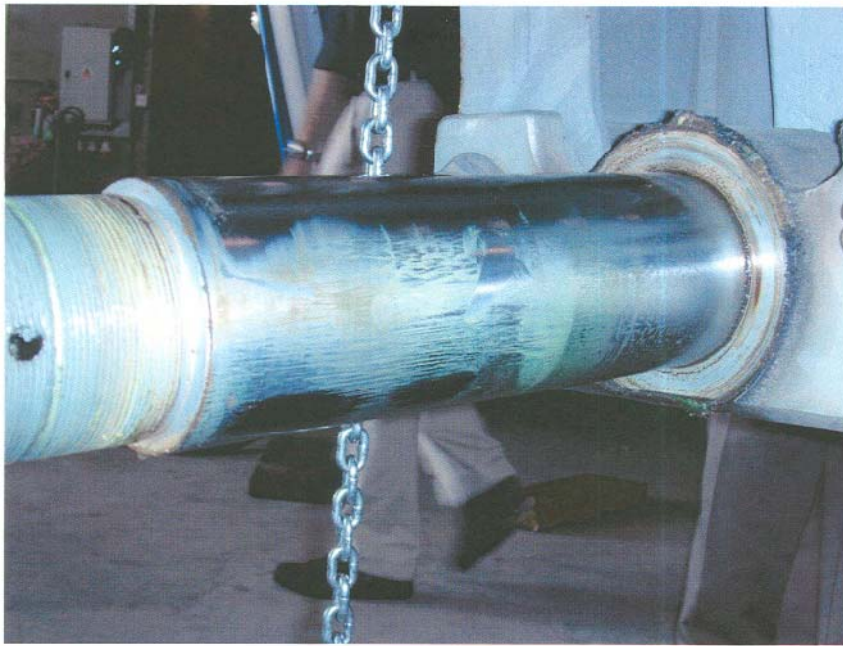
- 3.4.5 A third possible effect can take place when on sharp braking the increased friction (or blocking) in the bearing between carriage and suspension may lift the front and rear of the carriage of the swinging cabin alternately and so displace it from the carrying rope. This effect did not play any role here. The bearing of vehicle 21 under the load of the empty cabin showed on examination an insignificant bearing friction (the lower edge of the cabin stops at $\pm 20 \text{ mm}$ of deviation in case of the cabin moved forward and backwards with very slow back motion). On disassembling the bearing as shown in Fig. 4, it did not show any sign of rust; lubricant was present plentifully and in perfect condition.

Fig. 4: The suspension shaft was in perfect condition, more than sufficient lubricant was present.

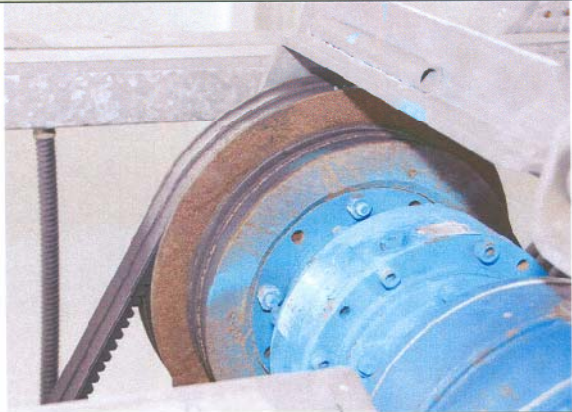
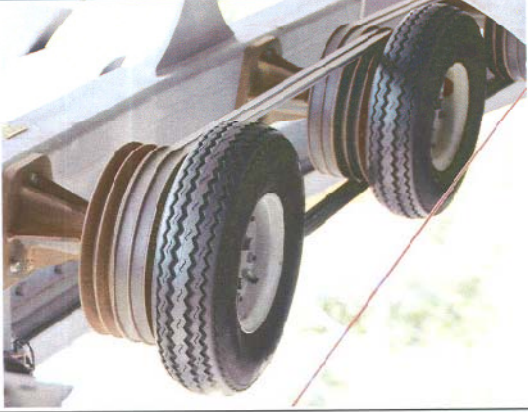
2.1 In the course of the survey it turned out that many construction units show indications of rust, which one does not expect with a so recent installation. Figures 1 to 11 show such construction units.

Fig. 1: Rusty V-belt pulleys at the driving motor of the conveyor systems	Fig. 2: Rusty V-belt pulleys at the conveyor systems

3.1 Rust protection should be generally improved.

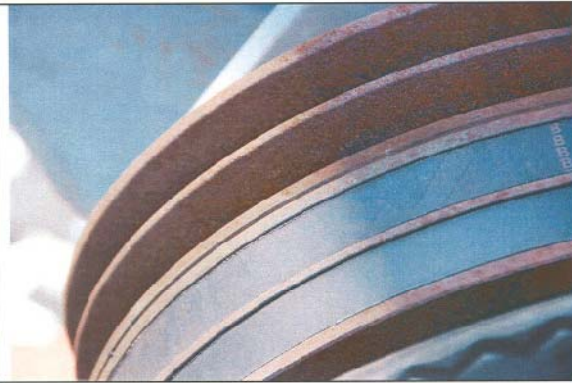
Fig. 3: Rusty V-belt pulleys at the conveyor systems (detail)

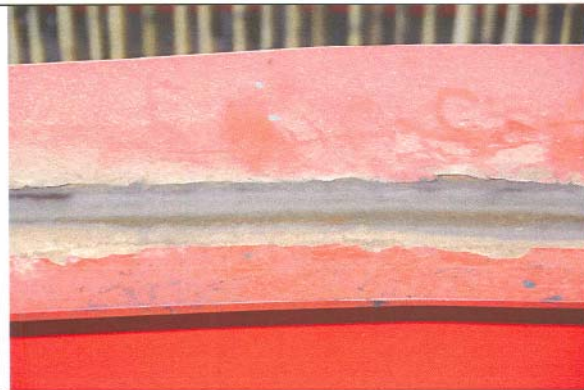
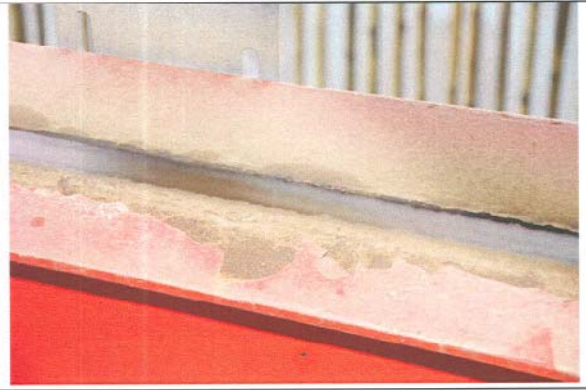
Fig. 4: Rust and peeling coat of paint at the coupling rails

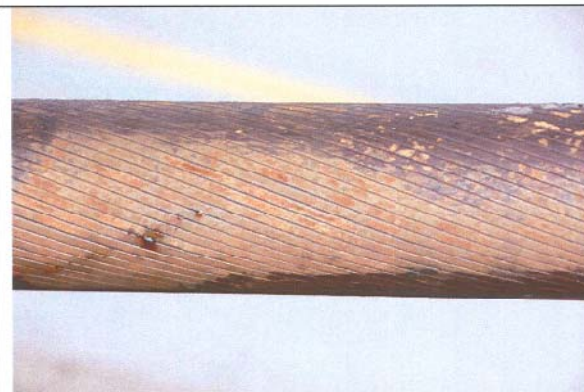
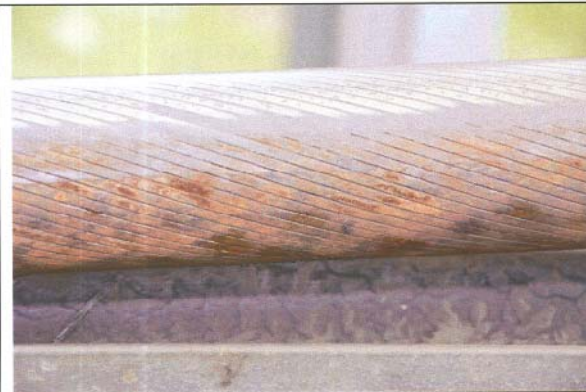
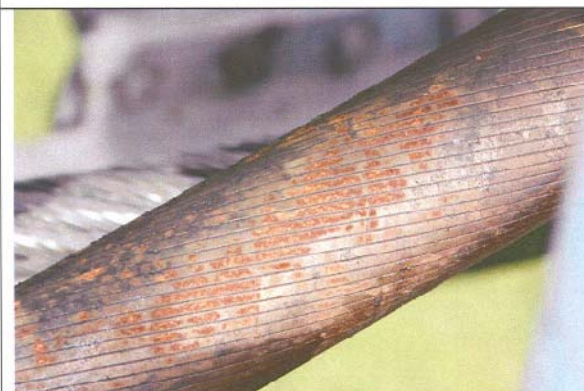
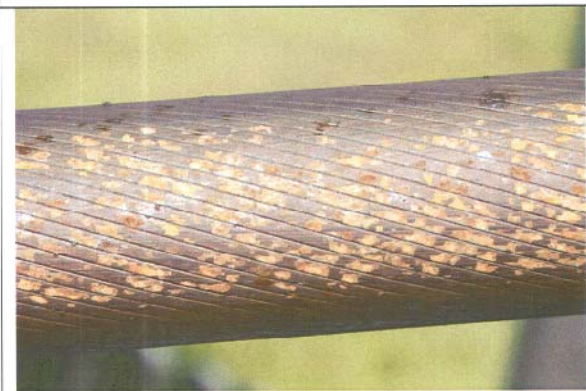
Fig. 6: Rust at the carrying rope within the range of Nei Lak Shan Angle Station

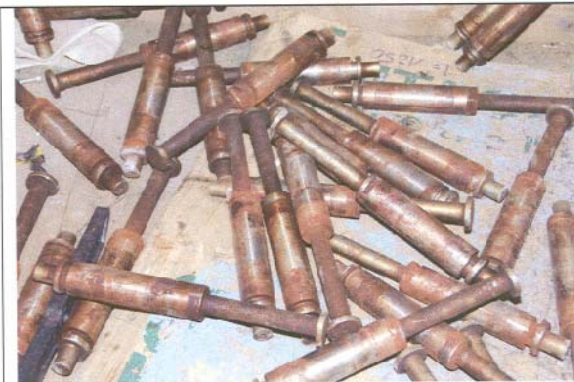
Fig. 10: Rusty axles of the connection of suspension and cabin

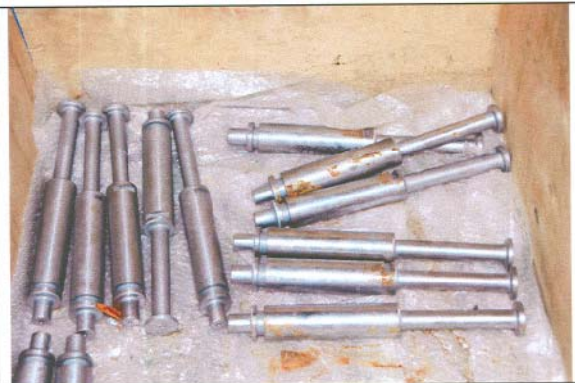
Fig. 11: Even the new axles of the connection of suspension and cabin show traces of rust.

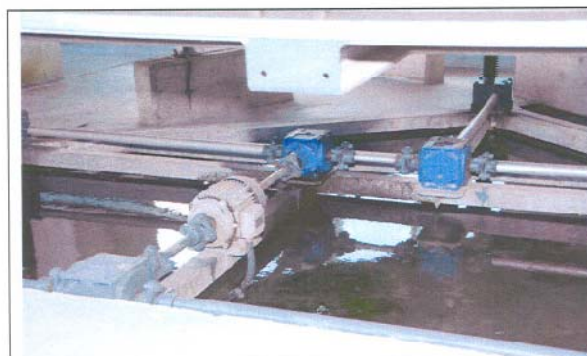
2.2 Within the range underneath the mobile platform in Tung Chung Terminal and Ngong Ping Terminal water was found, which can damage the drive of the mobile platform (electrical and mechanical parts under water). Figures 12 and 13 show that range underneath the platforms.

Fig. 12: Water within the range underneath the movable platform in Tung Chung Terminal

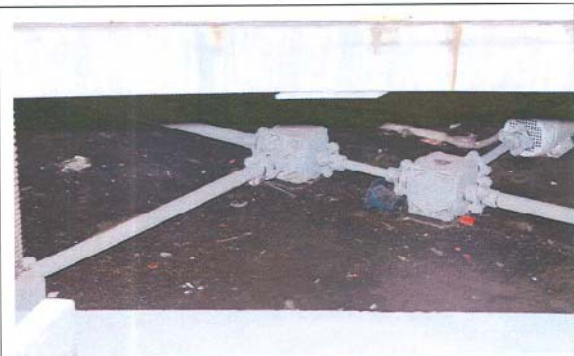
Fig. 13: Water within the range underneath the movable platform in Ngong Ping Terminal

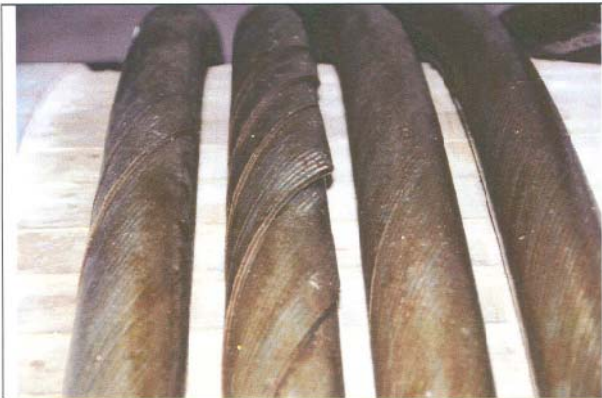
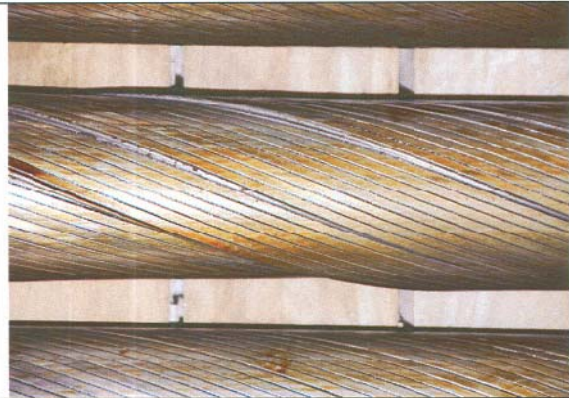
2.3 On some anchor drums the outer layer of z-wires of the carrying rope show structural problems (e. g. Fig. 14 and 15). As Prof. Oplatka has told me Fatzer (manufacturer of the ropes) already took care of the problem.

Fig. 14: Structural problems of the carrying ropes in the outer layer of z-wires

3.3 It should be clarified whether the structural problems of the carrying ropes on some of the anchor drums may cause problems in the future (e. g. at the time of relocation of the carrying ropes).
