Competent Person Written Report (Both passive and active detection are completed) CP Signature : Name: John Chan Approval No. : CP00000 Date : 20/9/2017 Directly Employed by: A Consultant Limited

CP Written Report Work Procedure

Record No.:	266366EMSD	Page:	3	
Working Place :	Opposite to Tai Wai Street Carpark, Tai Po, N.T.			
Nature of Work :	Trench work

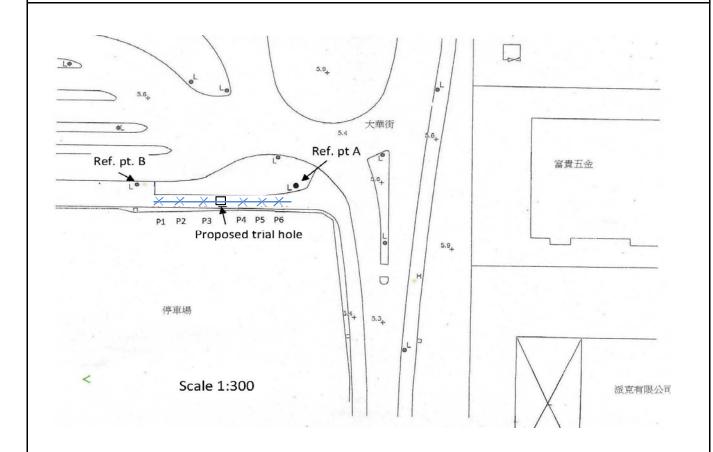
CP Written Report Underground Cable Layout Plan

Frequen	cy: <u>8kHz</u> ,	11kHz & 33kHz
Part C - Matters requiring particular attention Having found that the quantity of exposed cable was not matched with the cable shown in the underground cable plan, we discussed this issue with the electricity supplier on 19.9.2017 and the result was as follow: The electricity supplier confirmed that the location of the part of the cable shown in the cable plan had been altered.					
The above mentioned she was directly super	-			ssistance o <u>f</u>	Peter MA_ and he/
CP s	ignature:	1 Chully		Date:	20/9/2017
CP assistant s	ignature:	May		Date:	20/9/2017
Name	e: (Peter MA)

Cable detection point	Distance from reference point (A)*		Distance from reference point (B)*		Depth from ground level*		Remarks
	Actual (m)	Ratio 1:	Actual (m)	Ratio 1:	Passive detection^ (mm)	Active detection (mm)	(Cable information)
P1	10.8	36.0	1.8	6.0	800	800	1 no. of 11kV underground cable
P2	9.0	30.0	3.6	12.0	750	790	1 no. of 11kV underground cable
P3	7.2	24.0	5.4	18.0	800	810	1 no. of 11kV underground cable
P4	4.2	14.0	8.4	28.0	750	800	1 no. of 11kV underground cable
P5	2.7	9.0	10.2	34.0	750	800	1 no. of 11kV underground cable
P6	1.5	5.0	11.4	38.0	750	800	1 no. of 11kV underground cable

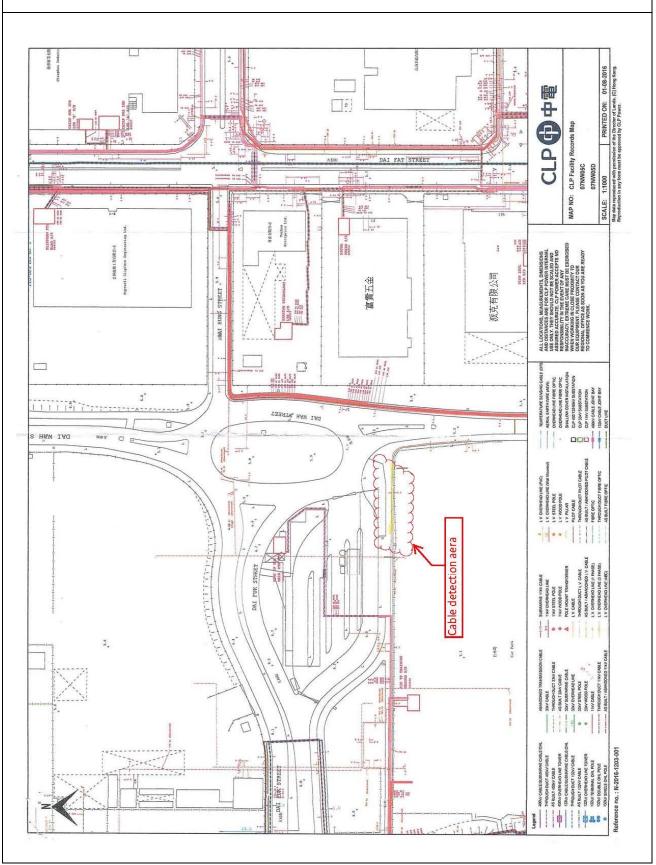
CP Written Report Cable Layout plan of Electricity Supplier

CP Written Report				
Record No.: 266366EMSD	Page:			
Electricity supplier's advice, such as advice sought from the deviations of cable alignment on site from electricity supplies				
The working party has requested cable plans from the electricity supplier on				
Having found that the quantity of exposed cable was not matche plan, we discussed this issue with the electricity supplier on 19.9 The electricity supplier confirmed that the location of the part of taltered.	.2017 and the result was as follow:
