Investigation Report on

Incident of the New Signalling System Testing on

MTR Tsuen Wan Line

Date of Incident: 18 March 2019

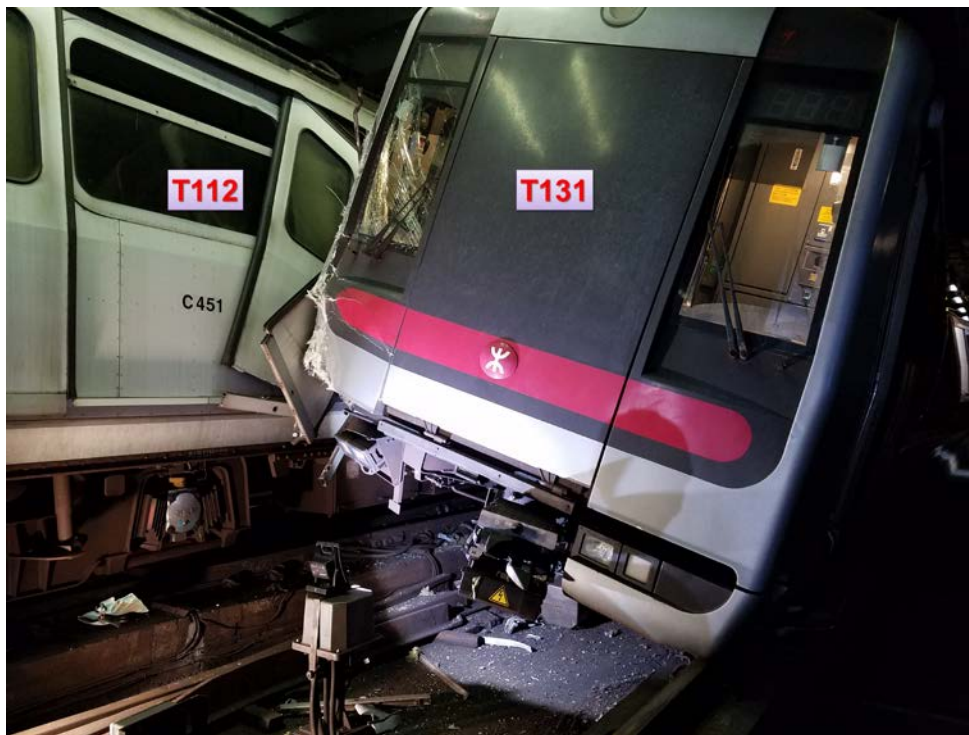
2.3 According to the train logs, train T131, which was travelling from Admiralty Station to platform no. 1 of Central Station, collided with train T112 at a speed of 19 kph at the Central Station crossover track (Figure 1) at the time of the incident. At that moment, train T112 was travelling from Central Station to Admiralty Station at a speed of 31 kph when passing through the crossover track. The collision resulted in damages to the second to fourth cars of train T112 (Figure 2) and derailment of two bogies of the first car of train T131. The two train captains were taken to hospital for medical check and discharged on the same day.

Figure 1: Condition of the trains after collision

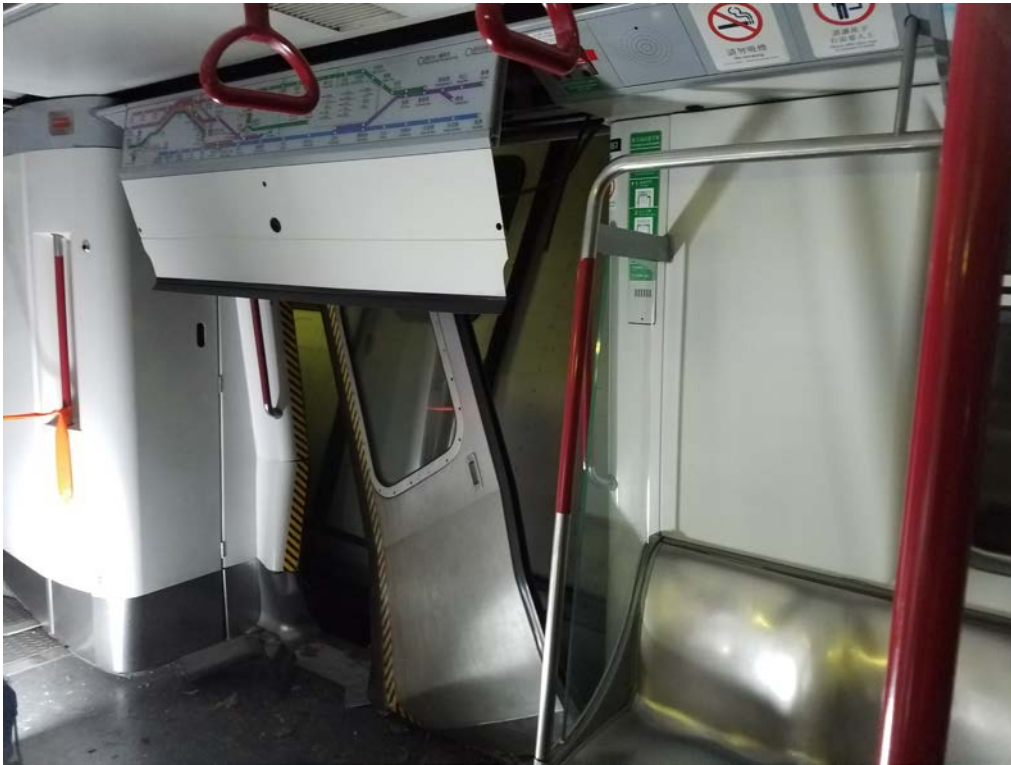
Figure 2: Damage to the saloon of train T112

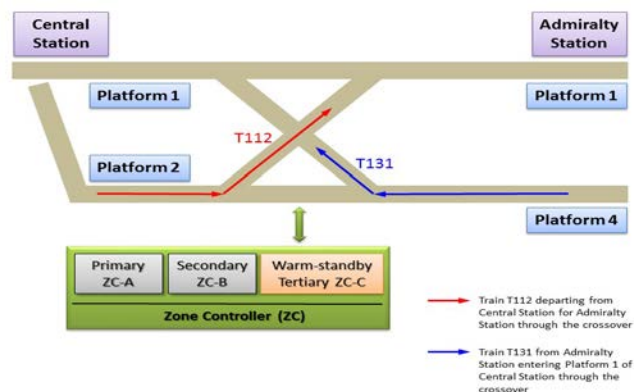
2.4 According to the train logs and the train captains' interview records, the train captain of train T131 had pressed the emergency brake button before the collision to try to stop the train, but train T131 could not be stopped timely and collided with train T112. Moreover, according to the train logs, the ATP system could not function at that moment to restrict these two trains from entering into the crossover track at the same time. Figure 3 illustrates the train movements during the incident.

Figure 3: Train movements during the incident

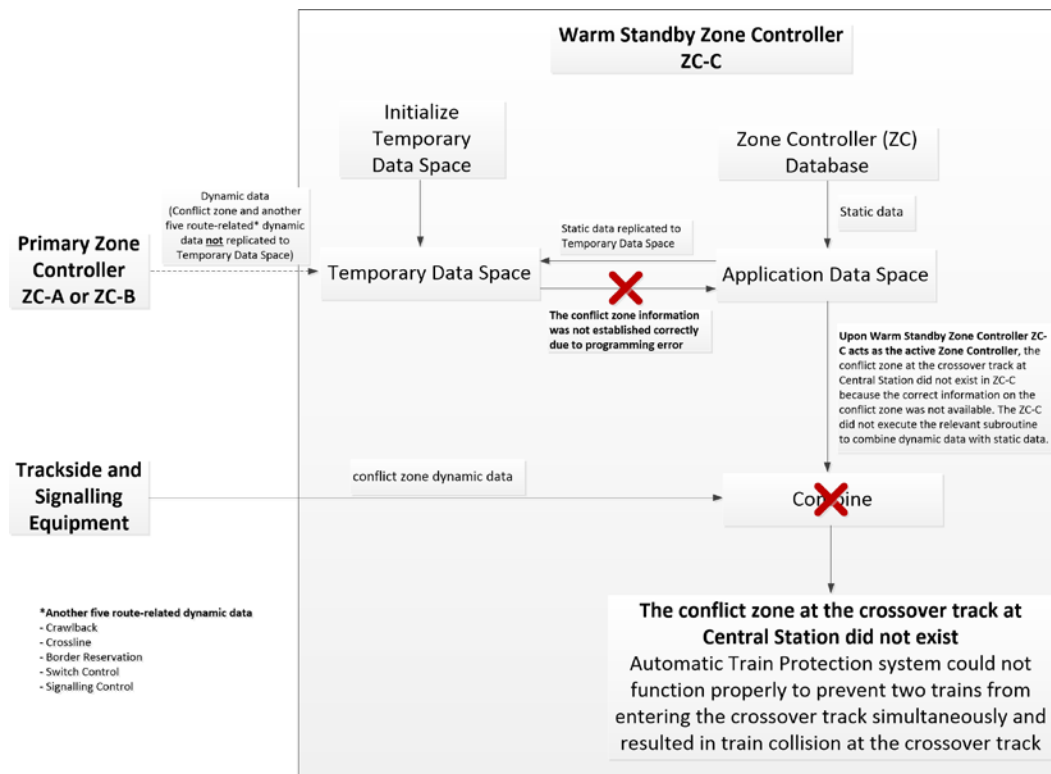
The investigation revealed, when ZC-C took up the active ZC role, the computer programme for handling conflict zone data did not execute the relevant subroutine to combine the dynamic data with the static data and did not re-create the conflict zone information correctly (Figure 6). Because the correct information on the conflict zone was not available, the conflict zone at the crossover track at Central Station did not exist in ZC-C. In the end, the ATP system could not function properly to prevent two trains from entering the crossover track simultaneously and resulted in the train collision.

Figure 6: The tertiary ZC did not execute the relevant subroutine to combine the dynamic data with static data

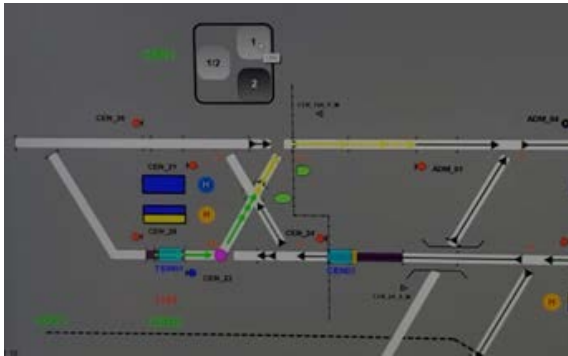
Figure 7: Simulator in ATDJV Hong Kong Office showed the route setting for trains T112 and T131 entering the conflict zone at Central Station at the same time.

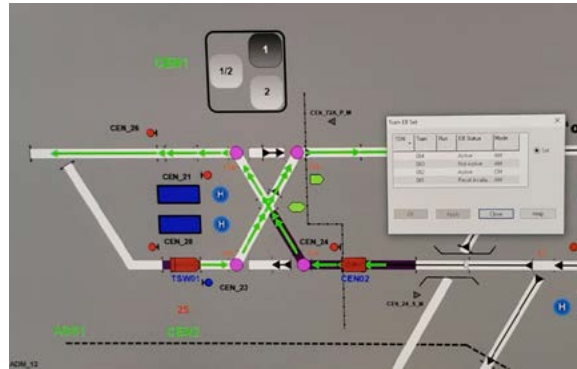
Figure 8: Simulator in ATDJV Hong Kong Office showed the trains entering the conflict zone at Central Station, as the route setting had allowed them to do so.

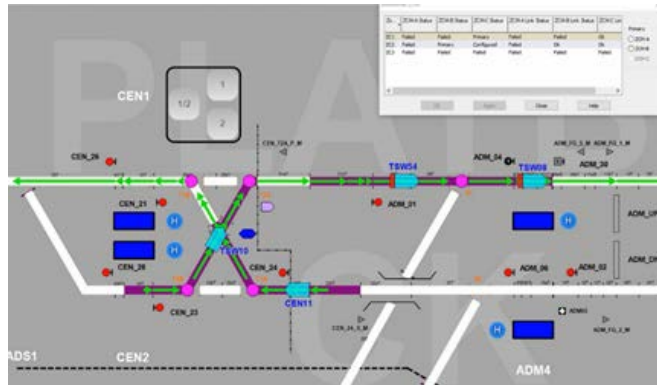
Simulation tests (Figures 9 and 10) were conducted at Ho Man Tin Station by using the ZCs and VOBCs of the incident trains with the same location and conditions of the incident, with a view to ascertaining whether the incident was caused by the incident ZCs and VOBCs. According to the results of the simulations, the same incident would happen by using the incident ZCs and VOBCs in the simulator.

Figure 10: Simulation results showed the ZCs and VOBCs of the incident trains allowing the trains to enter the conflict zone at Central Station at the same time
