紅磡站列車出軌事故

技術調查報告

**Technical Investigation Report on
Train Derailment Incident at
Hung Hom Station on MTR East Rail Line**

事故日期：2019 年 9 月 17 日

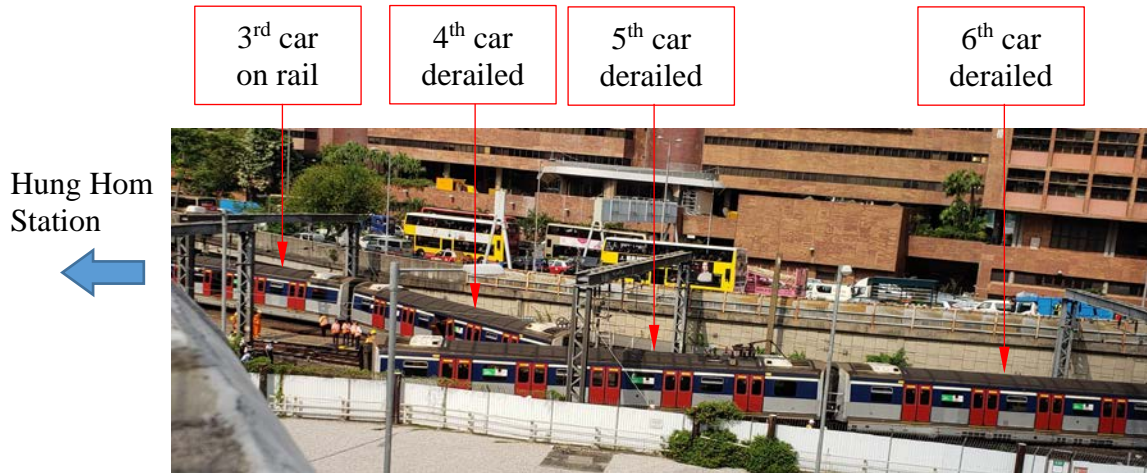
- 2.2 At the time of the incident, the train was entering Platform 1 of Hung Hom Station. The 4th to 6th cars derailed, and the coupler connecting the 4th and 5th cars was disconnected. Eight passengers were injured. **Figure 1** shows the status of the train immediately after derailment.

Figure 1 : Status of the incident train immediately after derailment

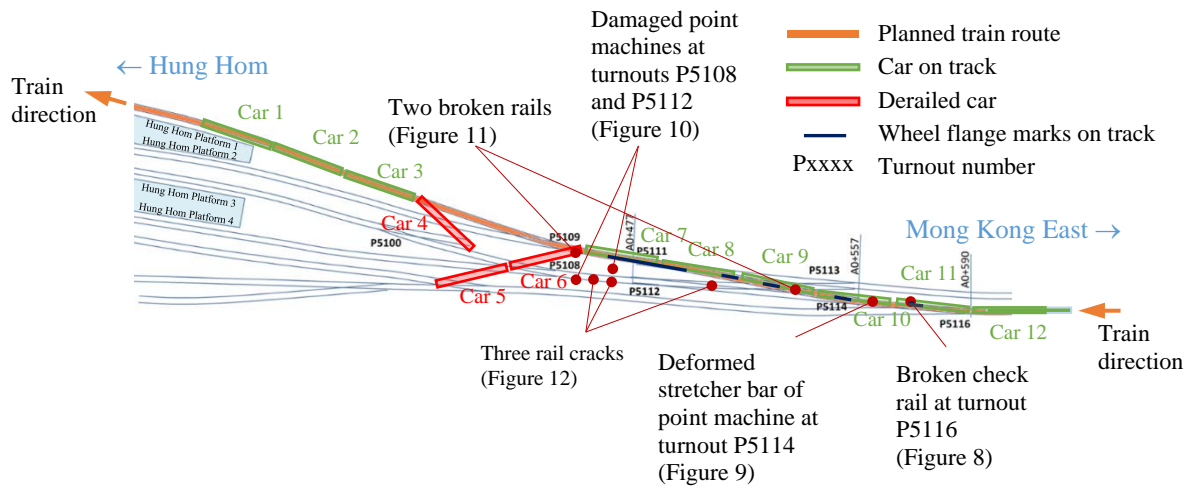
- (a) The incident train was scheduled to enter Platform 1 of Hung Hom Station. During the incident, the 4th to 6th cars derailed, and the coupler connecting the 4th and 5th cars was disconnected. The first three cars and the last six cars remained on the track rail. There were eight turnouts at the incident location to control train movement to and from different platforms at Hung Hom Station. The status of the incident train after derailment and the damage to the nearby railway facilities are shown in **Figure 7**. Photos of wheel flange marks, broken rails, rail cracks, and damaged point machines are shown at **Appendix I**.

Figure 7 : Status of incident train after derailment and damage to nearby railway facilities

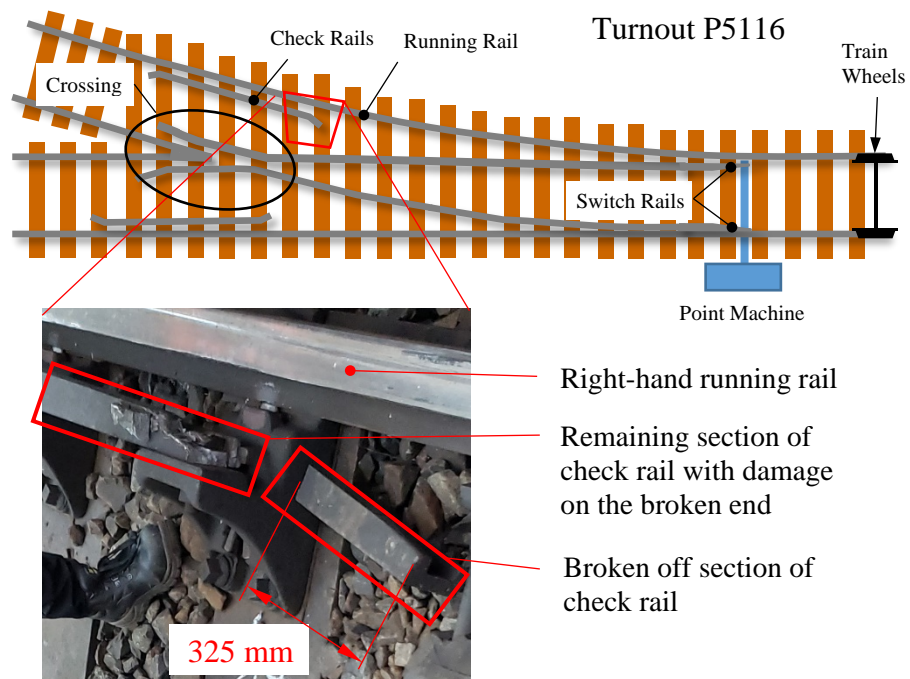
- (b) The check rail at turnout P5116 towards Hung Hom Station was found broken (see **Figure 8**). The length of the broken section was measured to be 325 mm.

Figure 8 : Broken check rail at turnout P5116

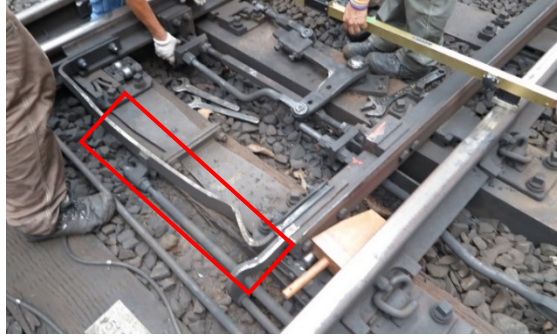
- (c) At turnout P5114, the components of the point machine¹⁹ were deformed and damaged as shown in **Figure 9**. The motor drive of point machines of turnouts P5108 and P5112 were also damaged as shown in **Figure 10**.

Figure 9 : Deformed stretcher bar of point machine at turnout P5114

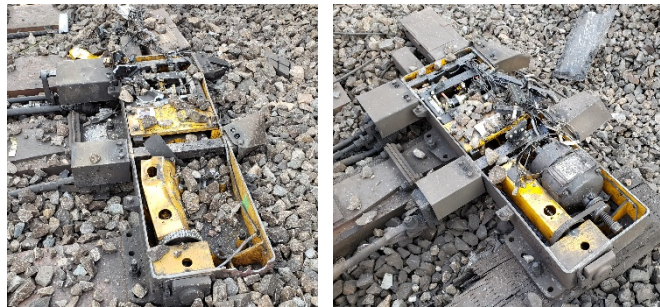
Figure 10 : Damaged motor drives of point machine at turnouts P5108 (left) and P5112 (right)

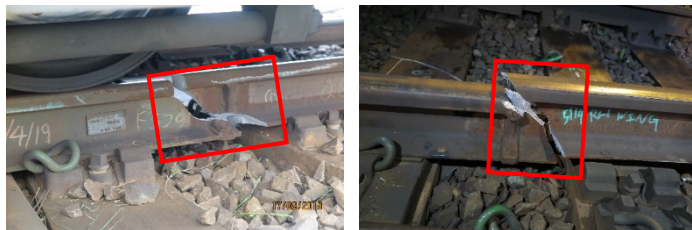
- (d) Two broken rails (see **Figure 11**) and three rail cracks (see **Figure 12**) were found at the incident location.

Figure 11 : Two broken rails

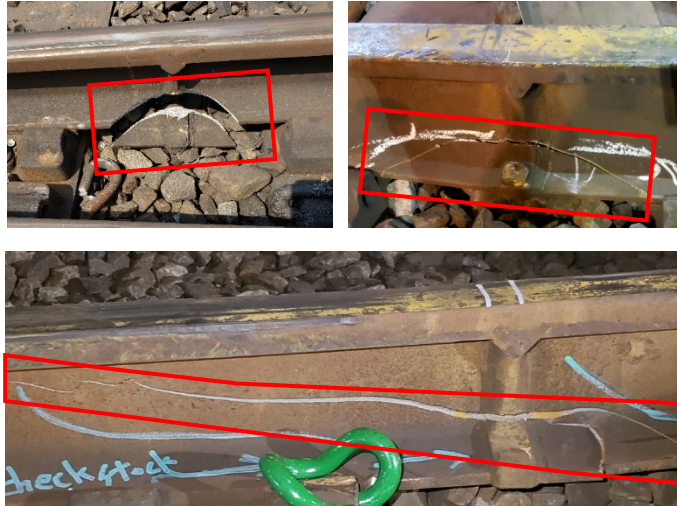
Figure 12 : Three rail cracks at the incident location

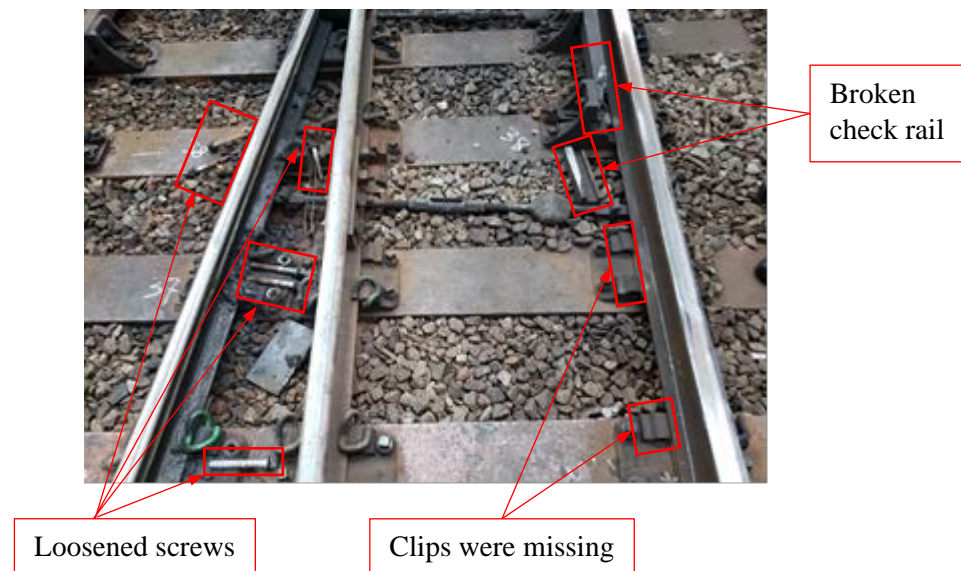
- (e) During investigation at turnout P5116, some fastening screws for fixing the baseplates to the sleepers were found to have been taken out and put aside. MTRCL confirmed that these fastening screws were found loosened and removed by their staff without the use of any tools after the incident (see **Figure 13**). Some clips for retaining the rail on the baseplates at the inside of the right-hand rail near the broken check rail were missing.

Figure 13 : Loosened fastening screws, missing clips, and broken check rail at turnout P5116

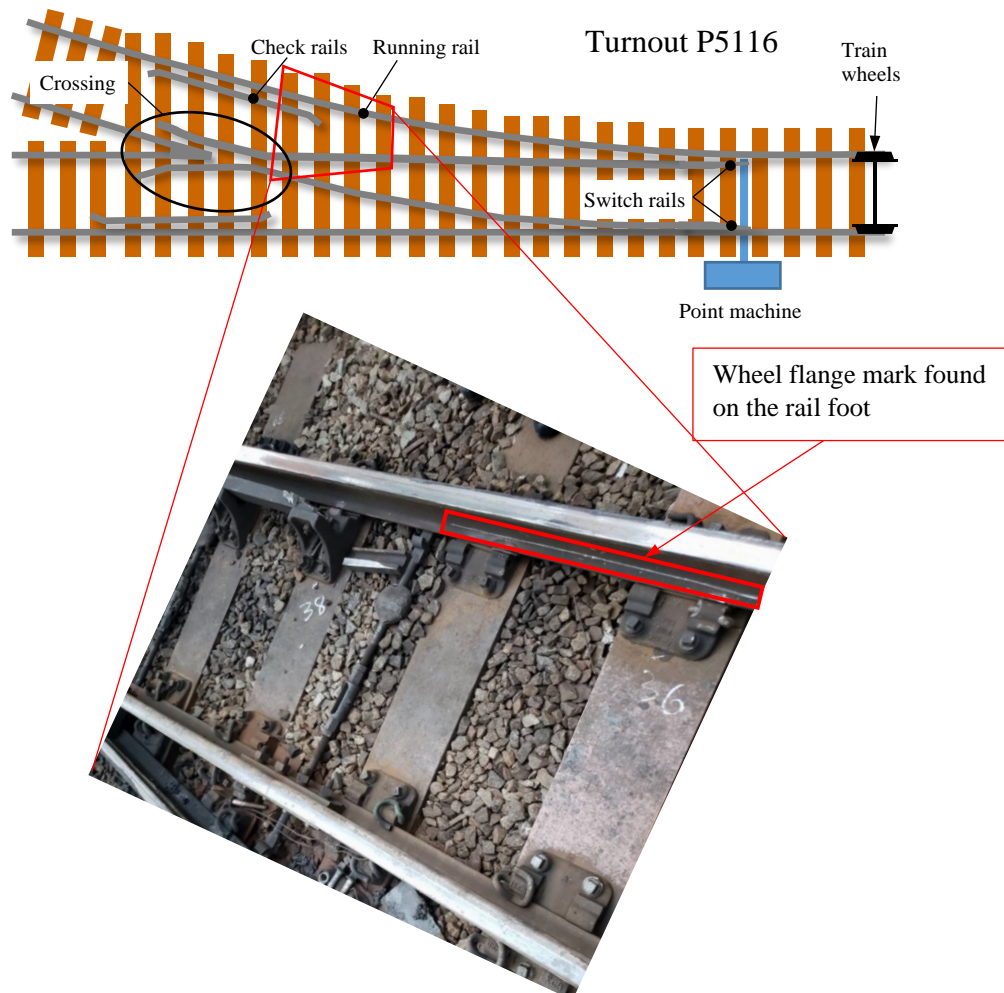
- (f) Wheel flange marks, as caused by the wheel flanges²⁰, were observed on rail foot and sleepers along the tracks at the incident location. An example of wheel flange mark found on the running rail near 36th sleeper of turnout P5116 is shown in **Figure 14**.
- (g) The track gauge of the running rails at turnout P5116 was measured after the incident and found exceeding the Safety Intervention Limit of 1,455 mm.
- (h) The train operation log showed the train speed was 39 km/h at the time of derailment.
- (i) No external object that was not part of the railway system was found at the incident location and nearby areas during site investigation with the Hong Kong Police Force.

Figure 14 : Wheel flange marks on the rail foot

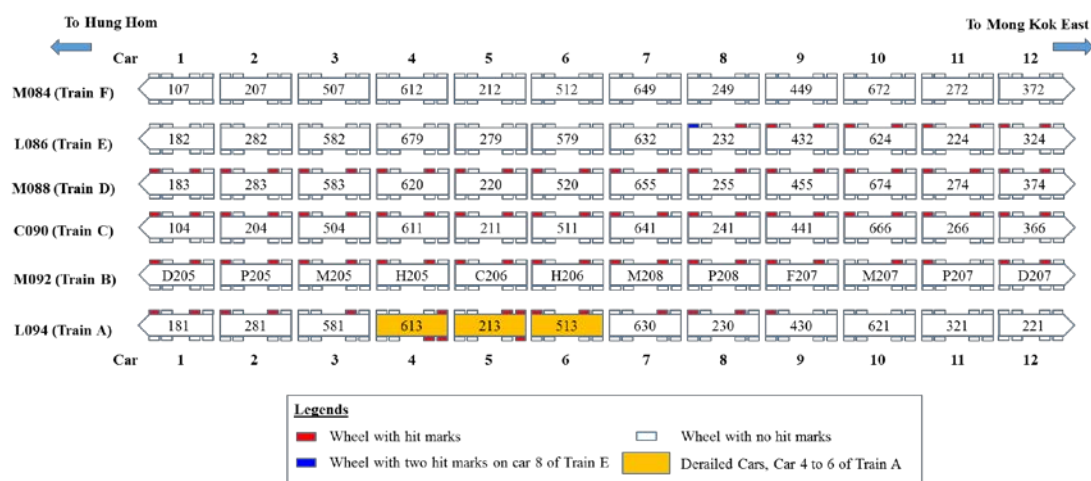
4.3.1 EMSD examined the incident train (train ID L094, referred to as “Train A” in this report) and the five trains that arrived at Hung Hom Station immediately before the incident train (train ID M092, C090, M088, L086 and M084, referred to as “Train B” to “Train F” in this report) at MTRCL Ho Tung Lau Depot on 20 and 22 September 2019. **Table 2** shows Train A to Train E with hit marks found on the right-hand wheels and their respective arrival schedule at Hung Hom Station. No hit mark was observed on the wheels of Train F. **Figure 15** shows the record of hit marks on wheels.

Figure 15 : Record of hit marks found on wheels of Train A to Train F

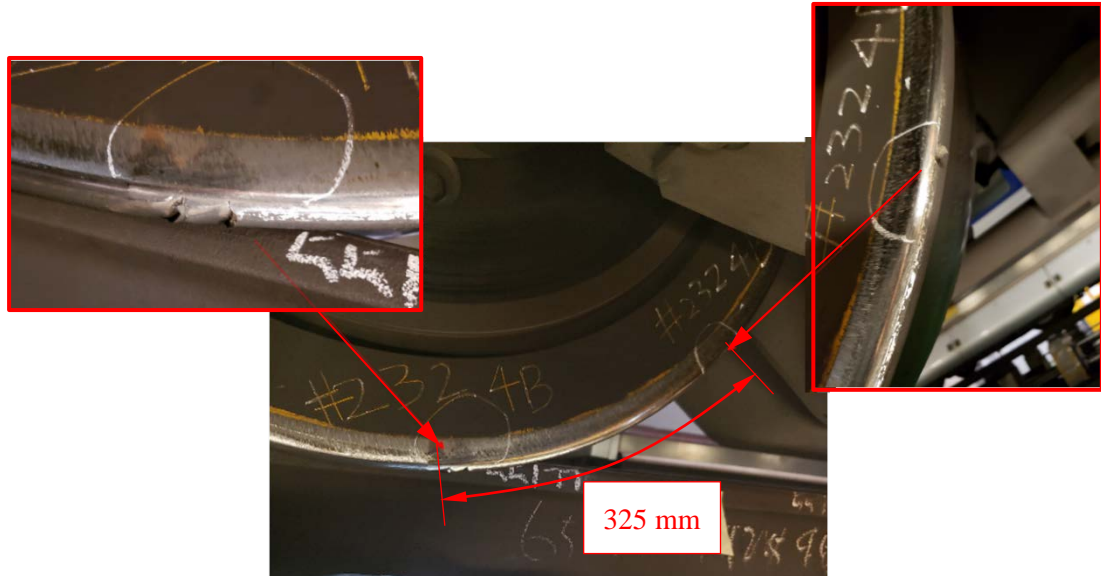
4.3.2 EMSD examined and found two hit marks with a separation of 325 mm (see **Figure 16**) on the first right-hand wheel on the first bogie of the 8th car of Train E. The separation distance of these two hit marks matched with the

length of the broken check rail at turnout P5116. As no hit mark was found on the wheels of the 1st to 7th cars of Train E, it was evident that the 8th car was the first to have hit and broken the front end of the check rail of turnout P5116.

Figure 16 : Two hit marks separated by 325 mm on the first right-hand wheel of the 8th car of Train E

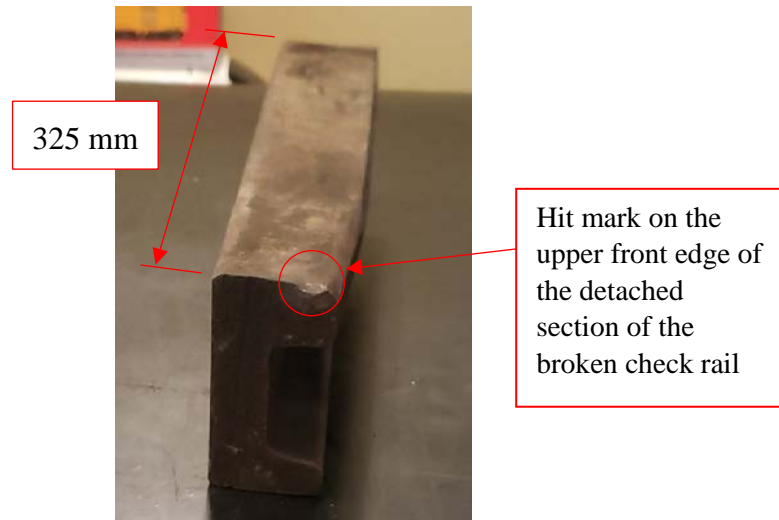
The check rail of turnout P5116 towards Hung Hom Station was found broken. The purpose of the check rail was to restrict lateral movement of wheels to ensure that trains take the correct route through the crossing. The detached

section of the broken check rail was of length 325 mm (see **Figure 17**). From the hit mark at the upper front edge of the check rail and the hit marks on the wheels of the 8th car of Train E, it was evident that the breakage was due to fracture failure from collision with the wheel of the 8th car of Train E, instead of material fatigue.

Figure 17 : Front view of detached section of broken check rail

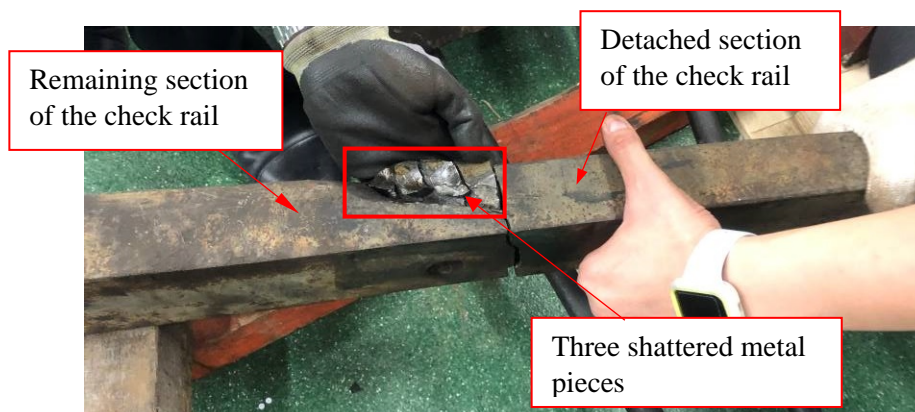
Three smaller pieces of broken metal were found near the broken check rail on the track. The shape of the metal pieces, when putting together, matched with that of the fractured surface of the remaining section of the broken check rail (see **Figure 18**). It was evident that these metal pieces were shattered off from the fractured surface as a result of being hit by wheels of subsequent Train E to Train A.

Figure 18 : Broken check rail and shattered metal pieces

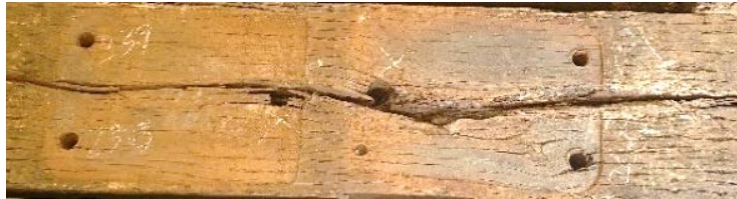
Both timber and synthetic sleepers were used at the incident location. Some of the timber sleepers were found to have rotted (see **Figure 19**). EMSD seized some sleepers from the derailment location.

Figure 19 : Rotten timber sleeper

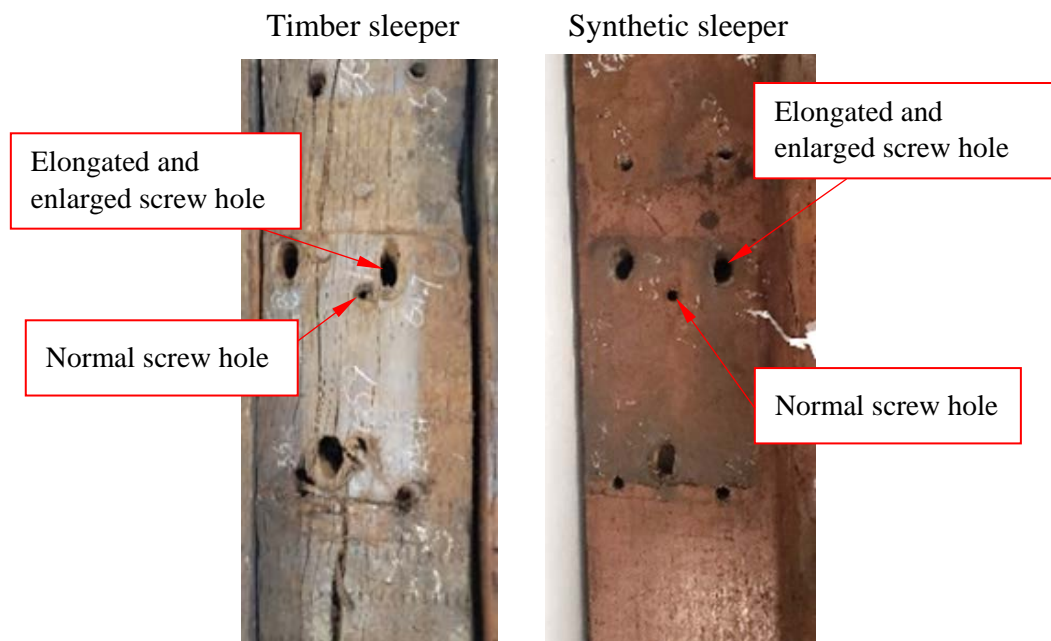
Elongated and enlarged screw holes were found on all the seized sleepers (**Figure 20**). These screw holes would not have been able to secure the positions of baseplates on the sleepers, thus failing to maintain the standard track gauge.

Figure 20 : Sleepers with elongated and enlarged screw holes

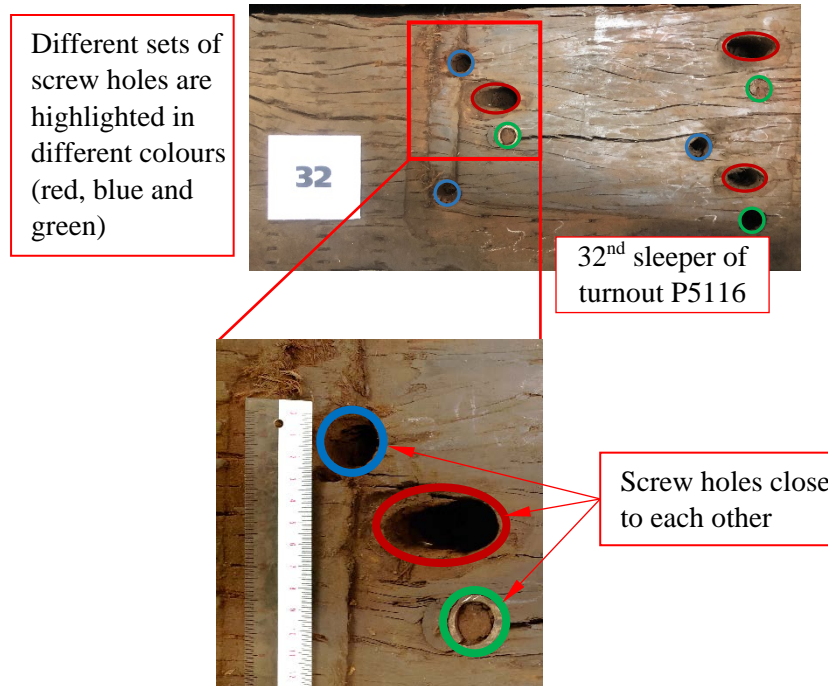
More than one set of screw holes underneath the baseplate were observed on some seized sleepers. During track maintenance, a loosened baseplate may be fixed by shifting and re-orientating the baseplate and mounting it with a new set of screw holes on the existing sleeper. The new screw hole should be separated from existing screw holes with

sufficient distance to ensure the integrity of the new screw hole. Three sets of screw holes were found underneath the baseplate of left hand rail of the incident route on the 32nd sleepers of turnout P5116 (see **Figure 21 and Figure 22**). Some screw holes were very close to each other, which would weaken the timber and its restraint of the baseplate.

Figure 21 : Screw holes underneath the baseplate of left hand rail of the incident route on the 32nd sleeper of turnout P5116

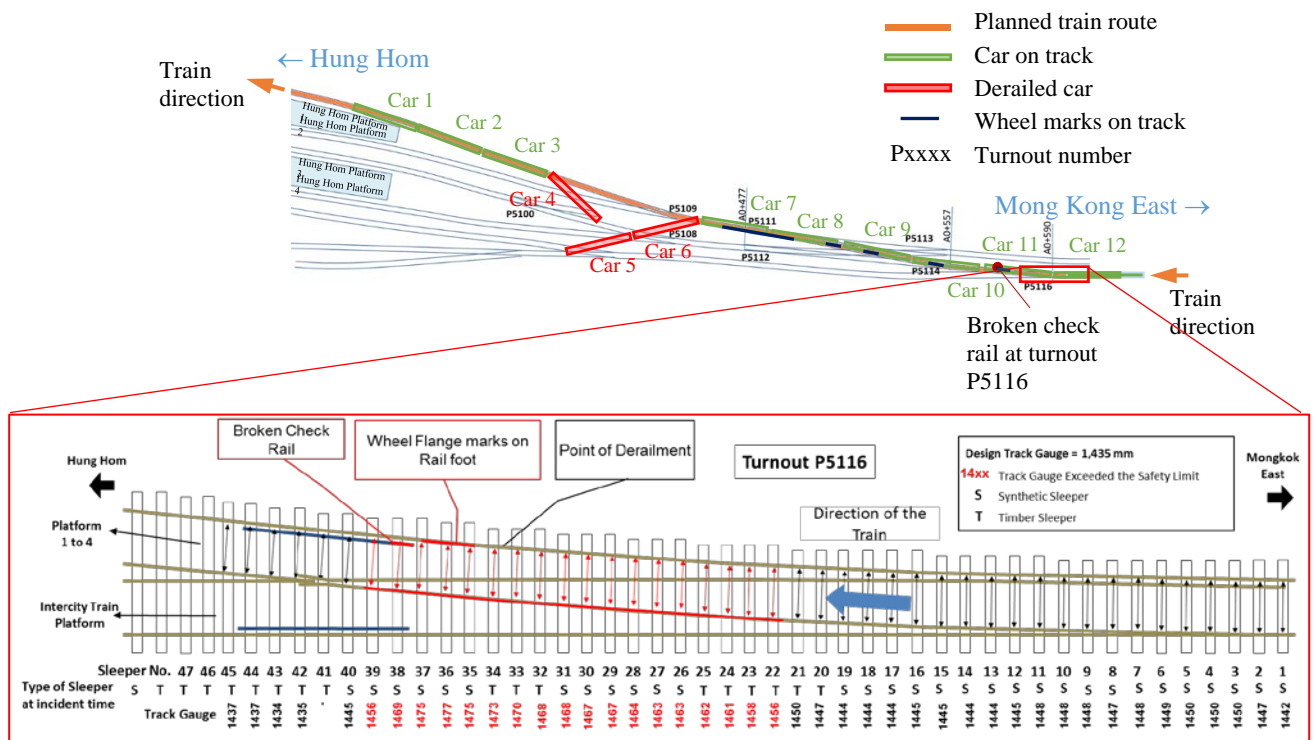
EMSD's investigation team, including the appointed experts, conducted detailed inspections at the incident location to determine the point of derailment. Given the travelling direction of trains, the investigation team found that the wheel flange mark first appeared on the rail foot between the 35th and 36th sleepers of turnout P5116. Considering the train speed and the time taken for the wheel to fall and touch the rail foot, it was evident that the point of derailment was between the 33rd and 34th sleepers of turnout P5116. **Figure 22** shows the location of the point of derailment at turnout P5116.

Figure 22 : Point of derailment and track gauge at turnout P5116

According to the static gauge measurement immediately after the incident, the gauge of the track section between the 22nd and 39th sleepers of turnout P5116 were all measured to have exceeded the Safety Intervention Limit of 1,455 mm as marked in red at **Figure 22**. The track gauge at the point of

derailment at the 34th sleeper at turnout P5116 was 1,473 mm, which was 38 mm wider than the standard gauge of 1,435 mm. In view of the rotted condition of sleepers, the track gauge under dynamic loading of trains would be even wider, and this excessive gauge widening had caused the train to derail at the time of incident. The investigation team concluded that the cause of the derailment was excessive gauge widening.

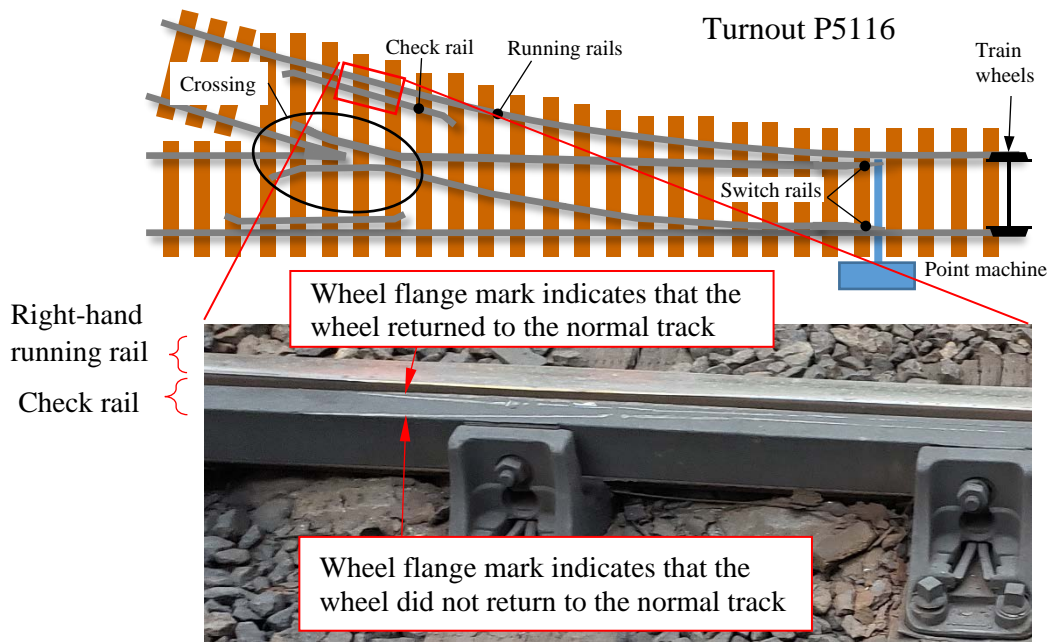
Wheel flange marks were found on the top of the check rail at turnout P5116 (**Figure 23**). It was evident that some wheels of Train A to Train E had hit the check rail and climbed onto the top of the check rail.

Figure 23 : Wheel flange marks on top of the check rail

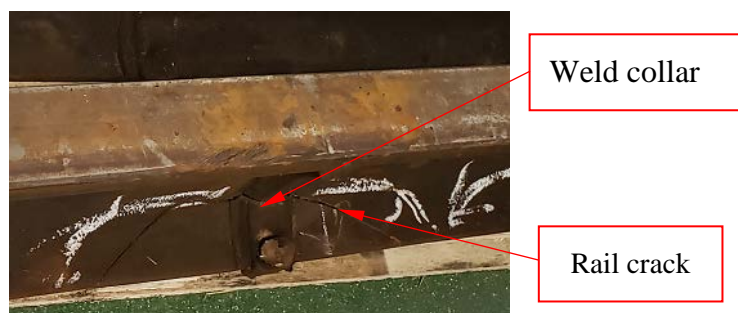
Two broken rails and three rail cracks were found at five different locations around the incident location. All points of fracture were located at welded joints. All broken points and cracks were recent fracture, instead of fatigue failure. It was evident that these fractures and cracks were caused by the derailed wheel flange striking the protruding part of the weld collar (see **Figure 24**), which were not uncommon in train derailment incidents.

Figure 24 : Wheel flange mark on the weld collar of a cracked rail

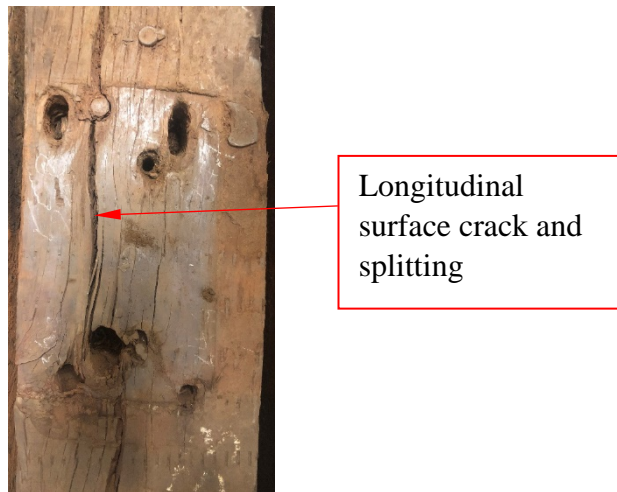
The investigation team examined the sleepers that were seized from site at or near the point of derailment. Many of the timber sleepers were found to have rotted internally. Longitudinal surface cracks and splitting were noted on some timber sleepers. The type of surface cracks present was evidence of internal rotting of timber. Deterioration of the integrity of the timber due to rotting reduces the ability of the screws to hold the baseplate firmly in place on the sleeper, resulting in gauge widening. **Figure 25** shows the condition of a rotten timber sleeper with longitudinal surface crack and splitting.

Figure 25 : Rotten timber sleeper

- 7.1 MTRCL have reviewed the timber sleeper condition across the entire EAL route and replaced the sleepers of dissatisfactory condition. MTRCL were requested to enhance the maintenance regime to closely monitor the track conditions with reference to relevant trade practices to ensure railway safety.
- 7.2 MTRCL were also requested to install on-board real-time monitoring devices on passenger train to give greater and more timely visibility of track deficiencies and make good use of this monitoring and reporting system to improve track maintenance.
