Ngong Ping 360 Ropeway
Incident occurred on 25 January 2012
Report of Investigation

Electrical and Mechanical Services Department
3 April 2012

Ngong Ping 360 Ropeway
Incident occurred on 25 January 2012
Executive Summary of the Report of Investigation

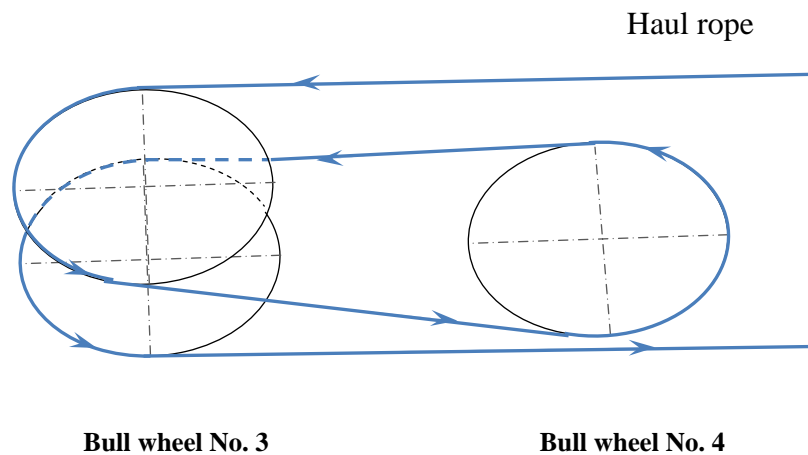
5.6 According to the statements provided by the Competent Person, vigorous vibration of the haul rope between bull wheels No. 3 and No. 4 (see configuration of the haul rope at Figure 3) was observed along with the abnormal noise before triggering of the position sensor of bull wheel No. 4. The triggering of the position sensor was attributed to the vigorous vibration of the bull wheel No. 4.

Figure 3 : Haul rope winding between the bull wheel No. 3 and bull wheel No. 4

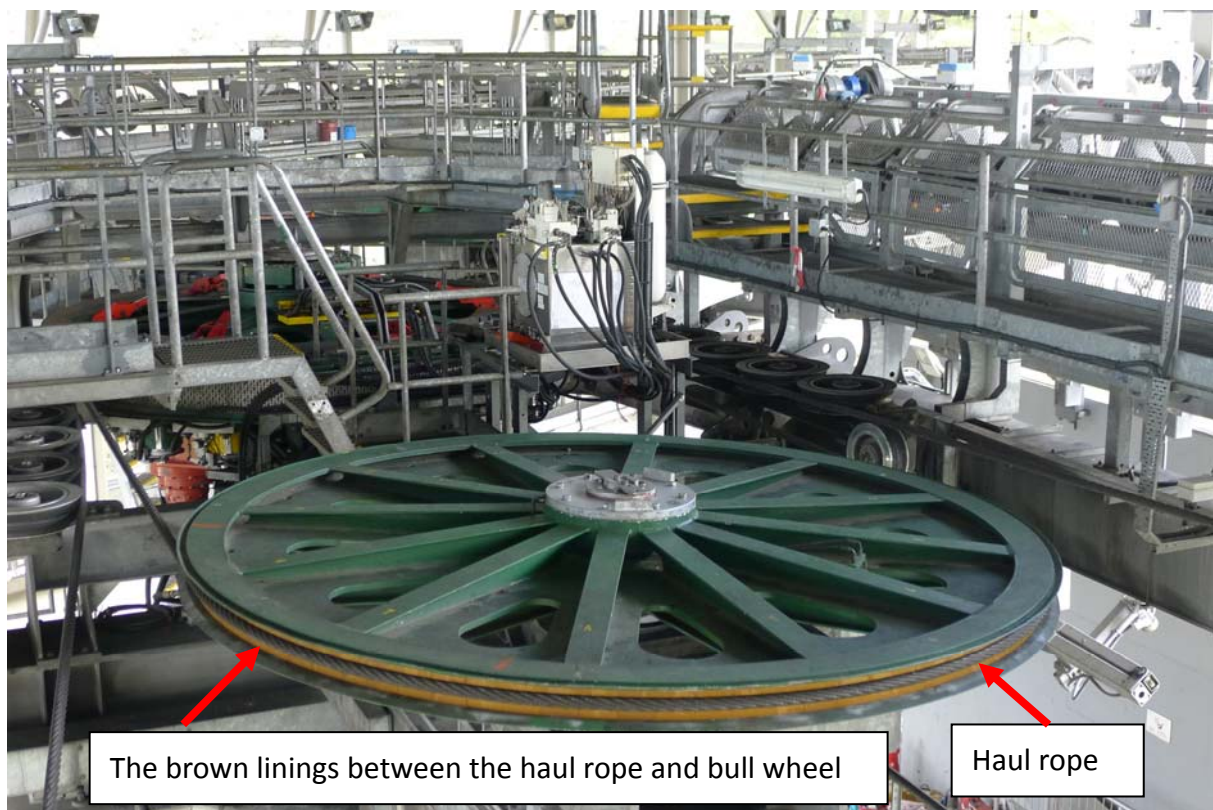
Figure 4 : Haul rope winding around the linings of the bull wheel No. 4

5.9 The on-site measurement of the lining (plastic) of the bull wheel No. 4 after the incident showed that about 45% of the lining (39 out of 87 lining units) already exceeded the wear limit. Uneven worn out of the lining was found.

and resulted in the unsmooth rotation of the bull wheel. This unsmooth rotation would lead to intermittent stretching and releasing of the haul rope which caused the uneven worn out of the lining and out-of-roundness of the bull wheel. Subsequently, vibration was induced to the haul rope and thus the bull wheel.

- (v) All bearings of the Ropeway shall be completely checked and regreased before resumption of service, noting that the same grease was used.
- (vi) The procedures and equipment for the measurement of all bull wheel linings, including the extent of wear and ovality (roundness) along the lining surface, shall be reinforced and clearly specified, so as to ensure more timely identification of worn-out lining and early remedial actions for replacement of the worn-out lining and/or refining the curvature of lining profile.

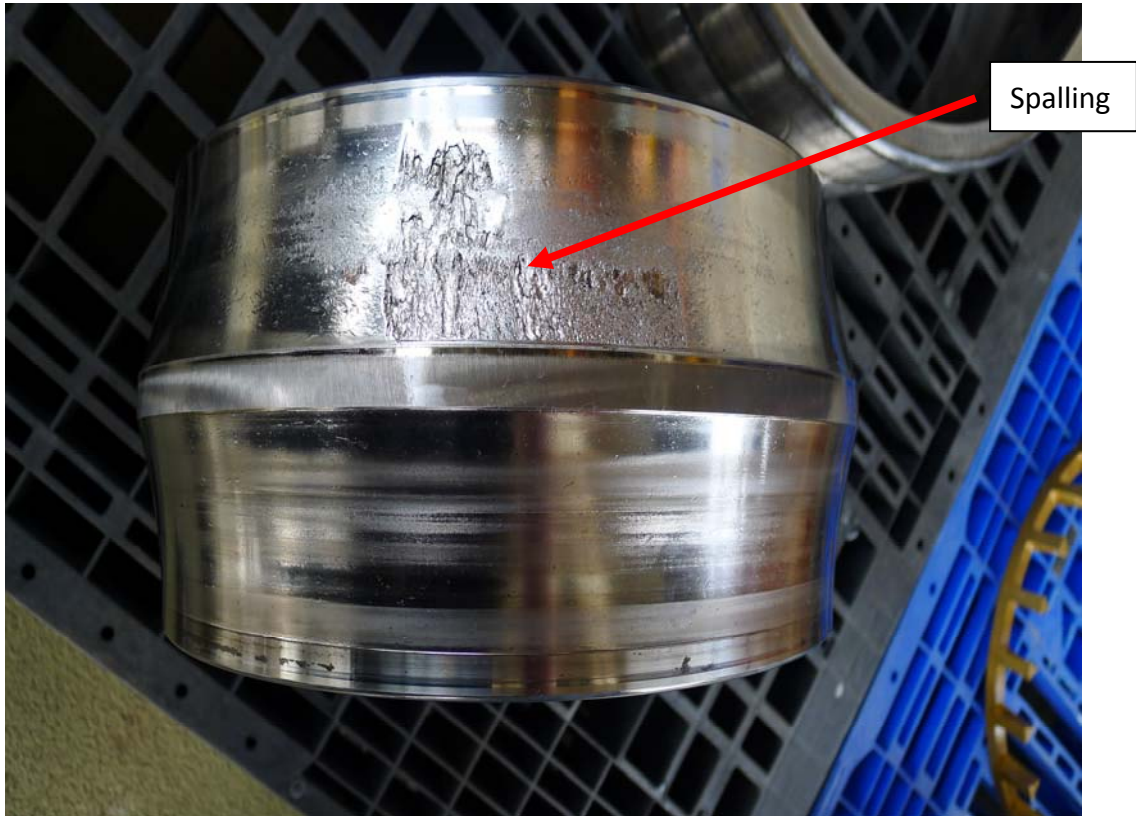
- (i) The spalling only occurred in the upper bearing ;
- (ii) For the inner ring of the upper bearing, brown staining from corrosion was found at the bottom raceway at the low loaded side (see Figure 6) while heavy spalling was found at the top raceway at the high loaded side (see Figure 5) ;
- (iii) In addition to spalling, heavy denting was found on the upper rollers of the upper bearing, as might be expected with the spalled metal fragments and the denting on the upper race (see Figure 7) ; and
- (iv) Corrosion/rust was also observed on the outer ring between the upper and lower rollers (see Figure 8).

Figure 5: Spalling in the top raceway of the inner ring of the upper bearing

5.16 As reflected from the result of the laboratory tests, it is considered that the spalling of the bearing was mainly caused by ineffective lubrication, arising from high moisture content in the grease leading to degraded lubricating effectiveness. The iron oxide particles in the grease might further degrade the lubricating effect of the grease and accelerate the spalling of the bearing.

- (i) All the bull wheel bearings should be replaced because they all may be subject to the same unsatisfactory greasing condition, which may lead to potential bearing spalling at a later stage.
- (ii) Vibration monitoring system of all the bull wheel bearings should be upgraded to capture the vibration data in an on-going basis, while the collected data should be analysed in a more frequent interval (every 2 weeks) against the pre-warning level.
- (iii) Grease analysis should be performed monthly to closely monitor the moisture and metal content of the grease, so as to step up the regreasing interval/frequency according to the analysis result.
- (iv) Arrangement shall be made to properly store and handle the grease to be

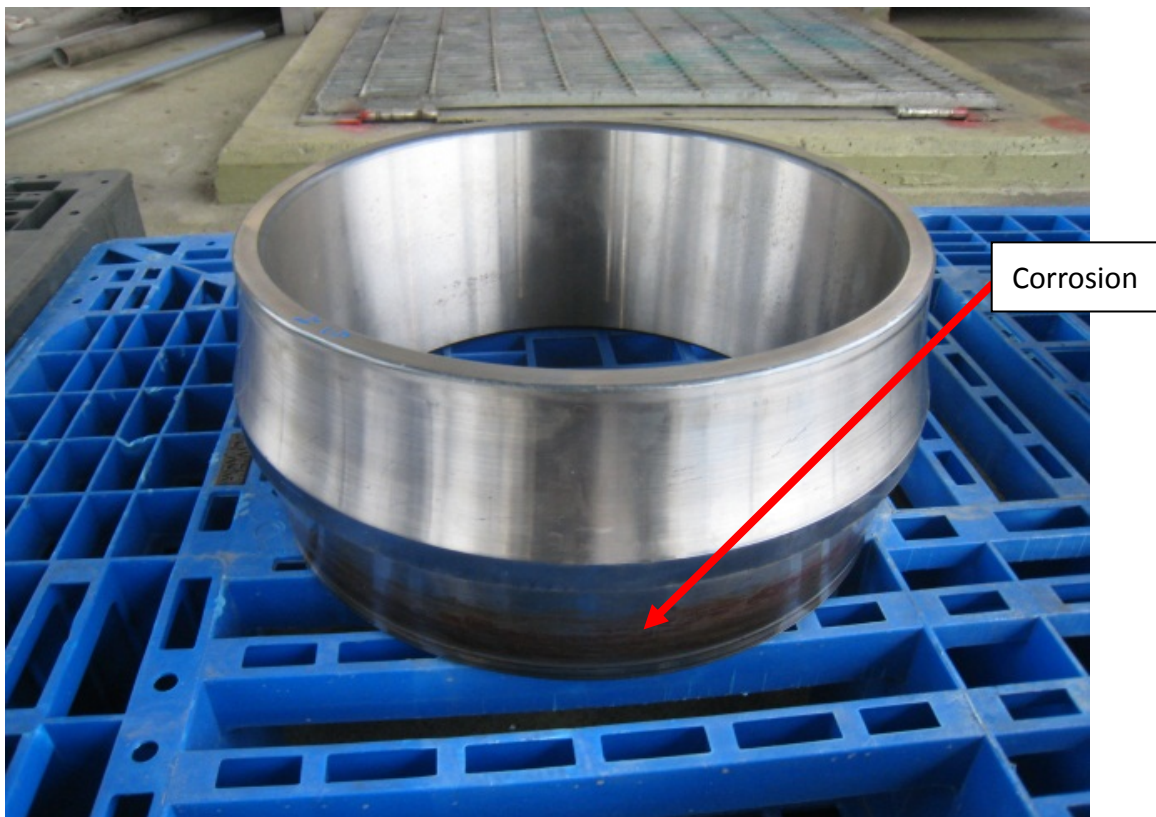
Figure 6: Corrosion in the bottom raceway of the inner ring of the upper bearing

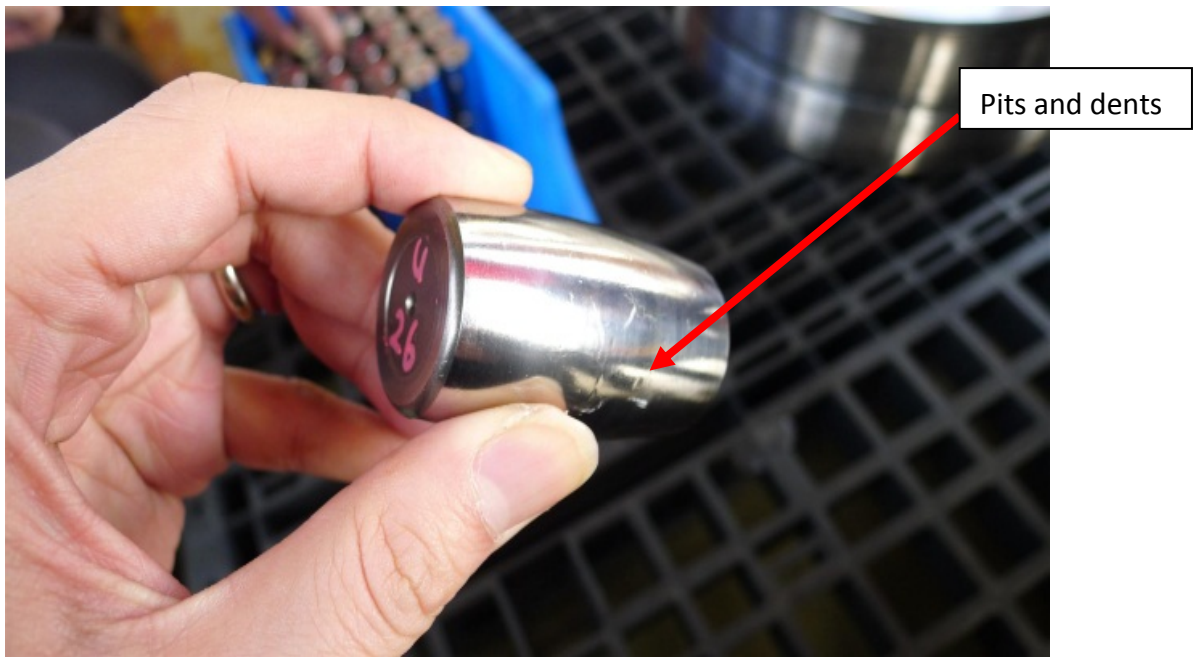
Figure 7: Pits and dents on rolling element from the top row of the upper bearing

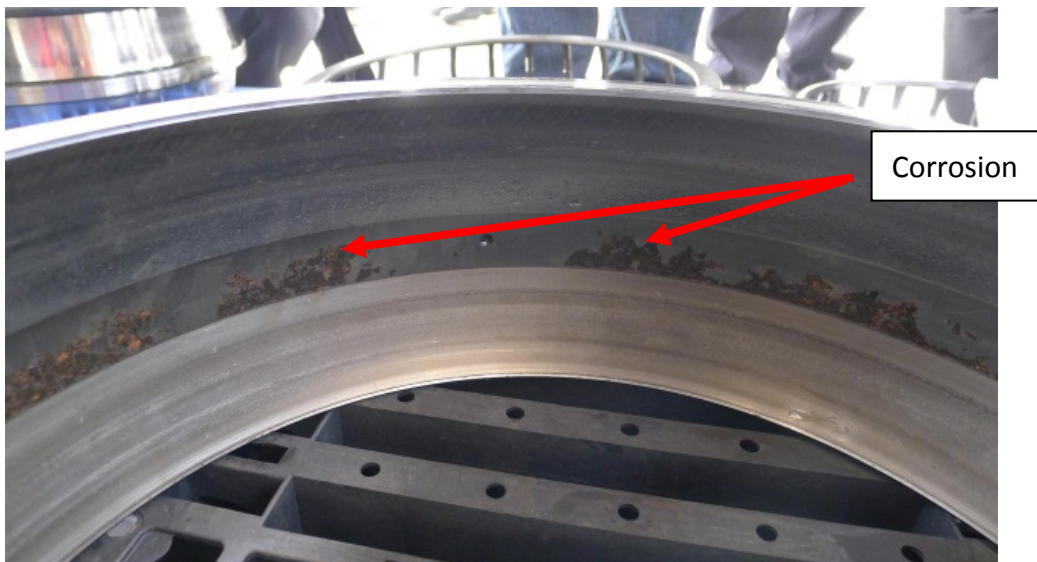
Figure 8: Corrosion in the outer ring of the upper bearing
