**Report of Incident Investigation on
Helium Balloon Ride at Ocean Park**

Electrical and Mechanical Services Department

30 August 2012

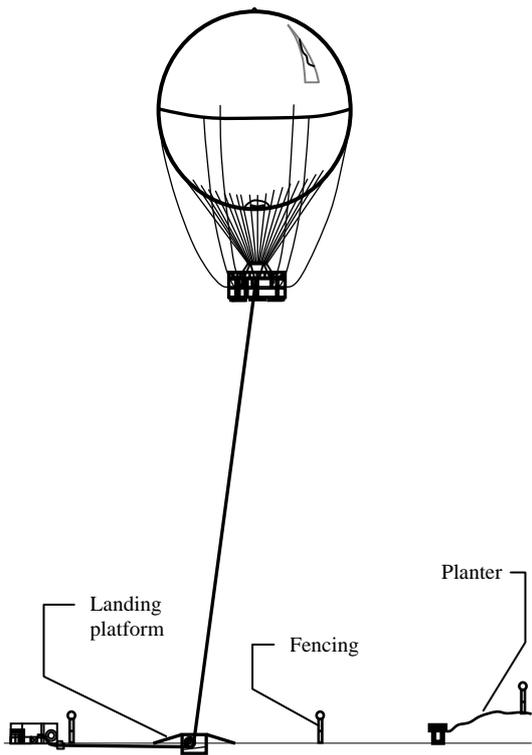
2. On 28 June 2012, the Helium Balloon Ride at the Ocean Park, carrying seven passengers and one on board operator (pilot), was descending (retrieving by the winch) from about 60 m above the ground at around 3:48 pm (please refer to Figure 1a and Figure 1b).

Figure 1a – Helium Balloon at 60 m

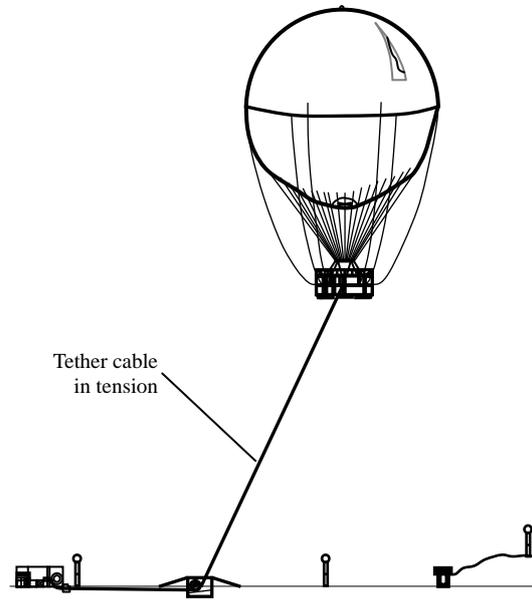
Figure 1b – Balloon descending at 0.6 m/s

12. Within the next 20 seconds, the balloon began to descend at normal speed of around 0.6 m/s.

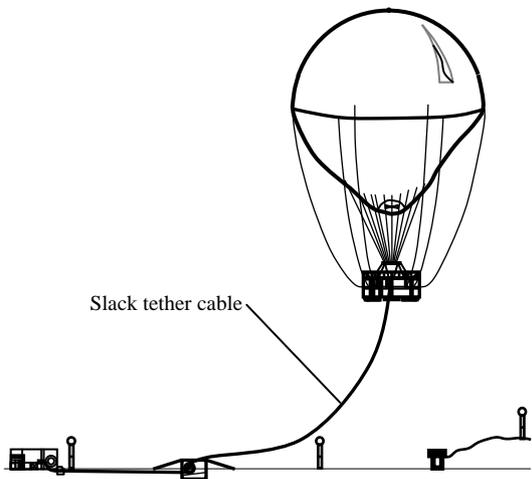
3. At around 20 m above the ground, the balloon was descending faster than the retrieving speed of 0.65 m/s (please refer to Figure 1c) and gradually landed to the planter around 29 m away from the normal landing platform (please refer to Figure 1d) with the remaining buoyancy provided by the residual helium.

Figure 1c – Balloon descending at higher speed at around 20 m above ground

13. At a height of around 20 m above ground, the descending speed increased to around 1.2 m/s which indicated that the buoyancy force given by the remaining helium in the envelope was less than the overall weight of the balloon, and the tether cable became slack.

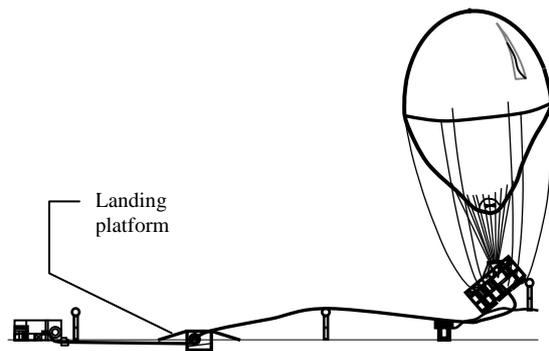
Figure 1d – Gondola landed on planter

14. Due to the wind effect, the balloon was dragged off from the landing platform and landed to the planter at around 29 m away from the landing platform.

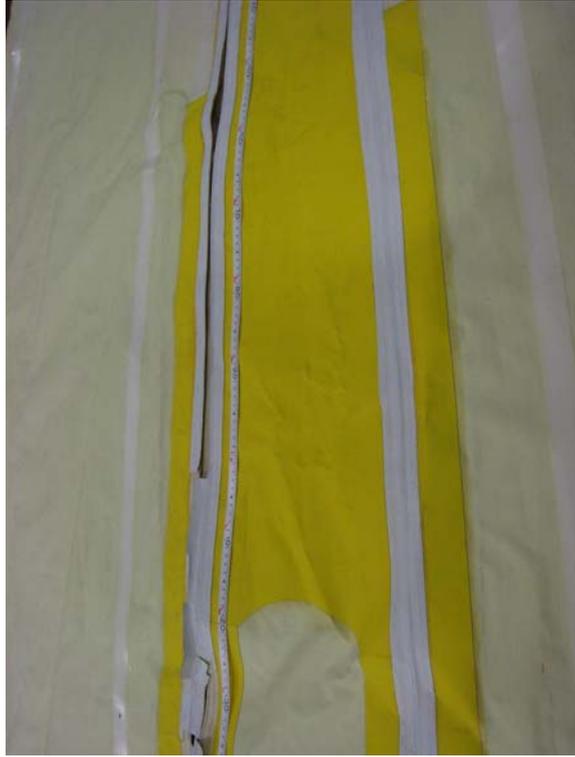
20. It was however found that the right-hand edge of the rip panel tongue was detached from the right covering strip and split from the right-hand rip panel joint (please refer to Figure 4) and the air tightness of the balloon could not be maintained. It is believed that the helium escaped from this opening leading to a loss of buoyancy.

*Figure 4 – Failure in right-hand rip panel joint
(the orientation is reversed as
viewed from inside of envelope)*

34. Taking into account of the above findings, it is recommended that the Ocean Park and the balloon manufacturer to work out a comprehensive method to inspect the rip panel joint.

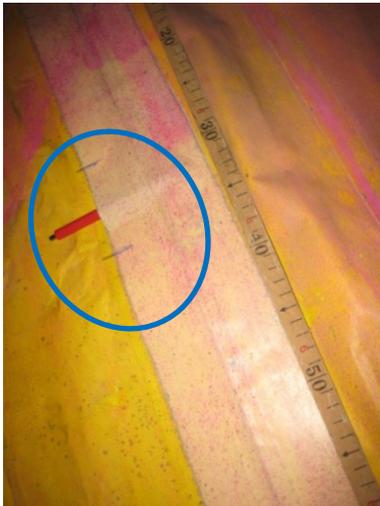
*Figure 5a – Detachment in left
covering strip at the
edge (circled in blue)*

27. These local detachments were found at the centre as well as the edge of the left covering strip (please refer to Figure 5a and Figure 5b). It was suspected that such local detachments might also be present at the right covering strip before the incident.

28. The rip panel joint was subject to expansion and contraction as well as thermal effect during operation¹ and the adhesion between the covering strip and the rip panel joint could be degraded by these cyclic effects, hence these local detachments were formed.

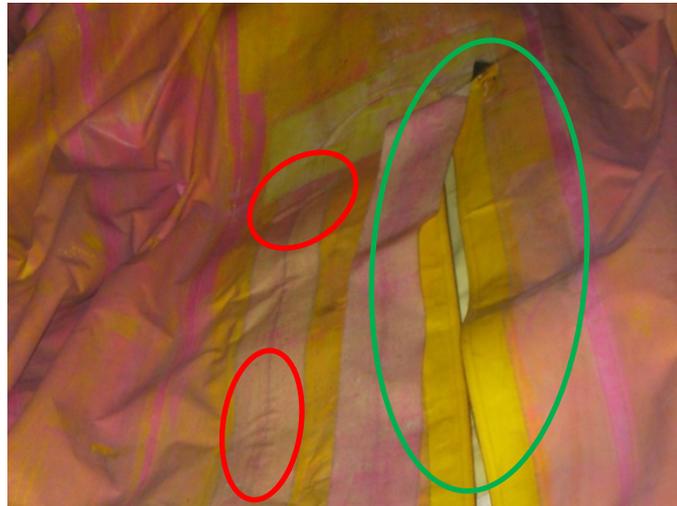
25. Upon inspection of the opening of the rip panel, it was found that the right-hand edge of the rip panel tongue completely detached from the rip panel joint (please refer to Figure 5b) while the left-hand side remained intact. This indicated that the split on the right-hand side was not caused by the pulling action of the red command rope as such action would have torn both sides of the rip panel joint at the same time. The finding was consistent with the statement taken from the pilot on board that no one had touched the command ropes during the course of the flight cycle. Therefore, the manual operation of the rip panel is excluded from the cause.

*Figure 5b – Some detachments in left covering strip at the
centre (circled in red)*

*Right covering strip detached from the rip
panel tongue (circled in green)*

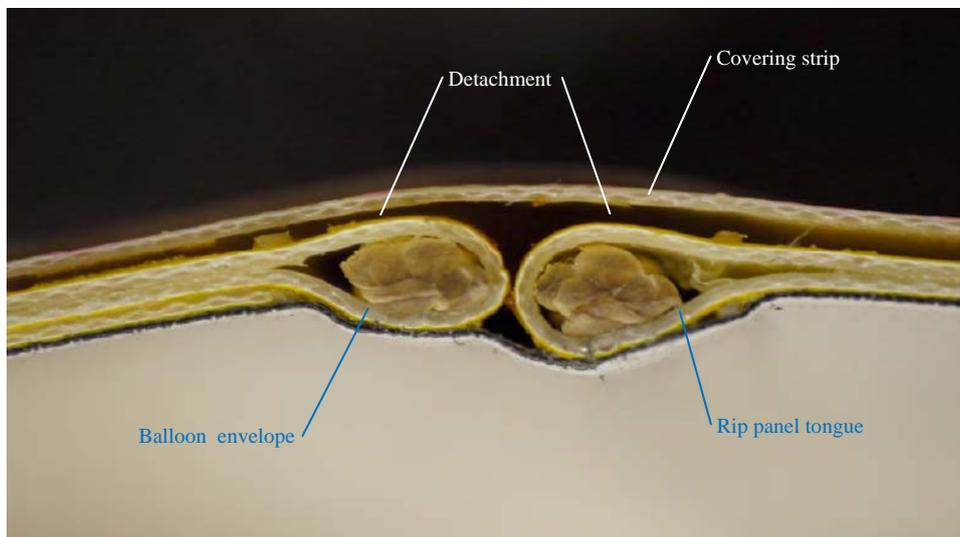
29. Subject to the thermal and mechanical cyclic effects throughout the repeated flight cycles, it is likely that the size of these local detachments grew progressively (please refer to Figure 6).

Figure 6 – Cross section of the rip panel joint with detachment of covering strip

33. Subject to the thermal and mechanical cyclic effects throughout the repeated flight cycles, the size of these local detachments progressively grew. The rip panel joint strength was therefore further weakened and resulted in splitting at the joint.
