Technical Report on the Lift Incident

on 25 October 2008

at Shin Nga House, Fu Shin Estate, Tai Po

Electrical and Mechanical Services Department

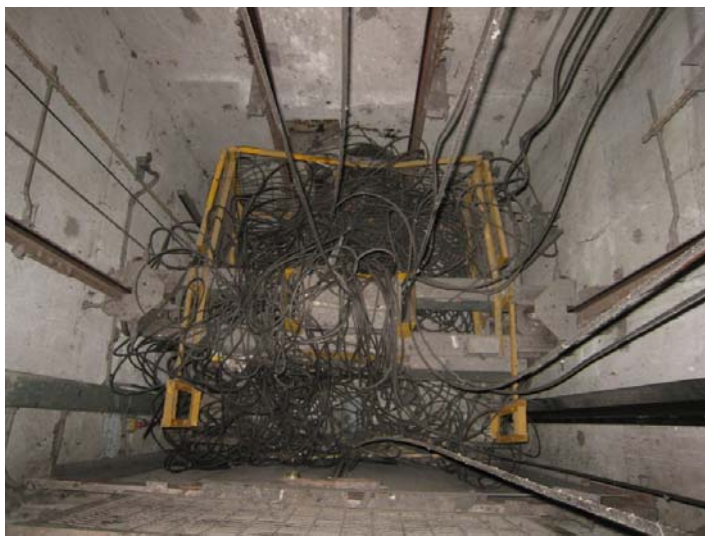
In the evening of 25 October 2008, at around 7:21pm, a lift without passenger of number L32 at Shin Nga House, Fu Shin Estate, Tai Po fell to the ground floor level. Damages were found at the lift car. In addition, 7 out of the 8 suspension ropes were broken and found lying on top of the lift car as shown in Figure 1.

Figure 1 – Lift No.L32 car top and suspension ropes.

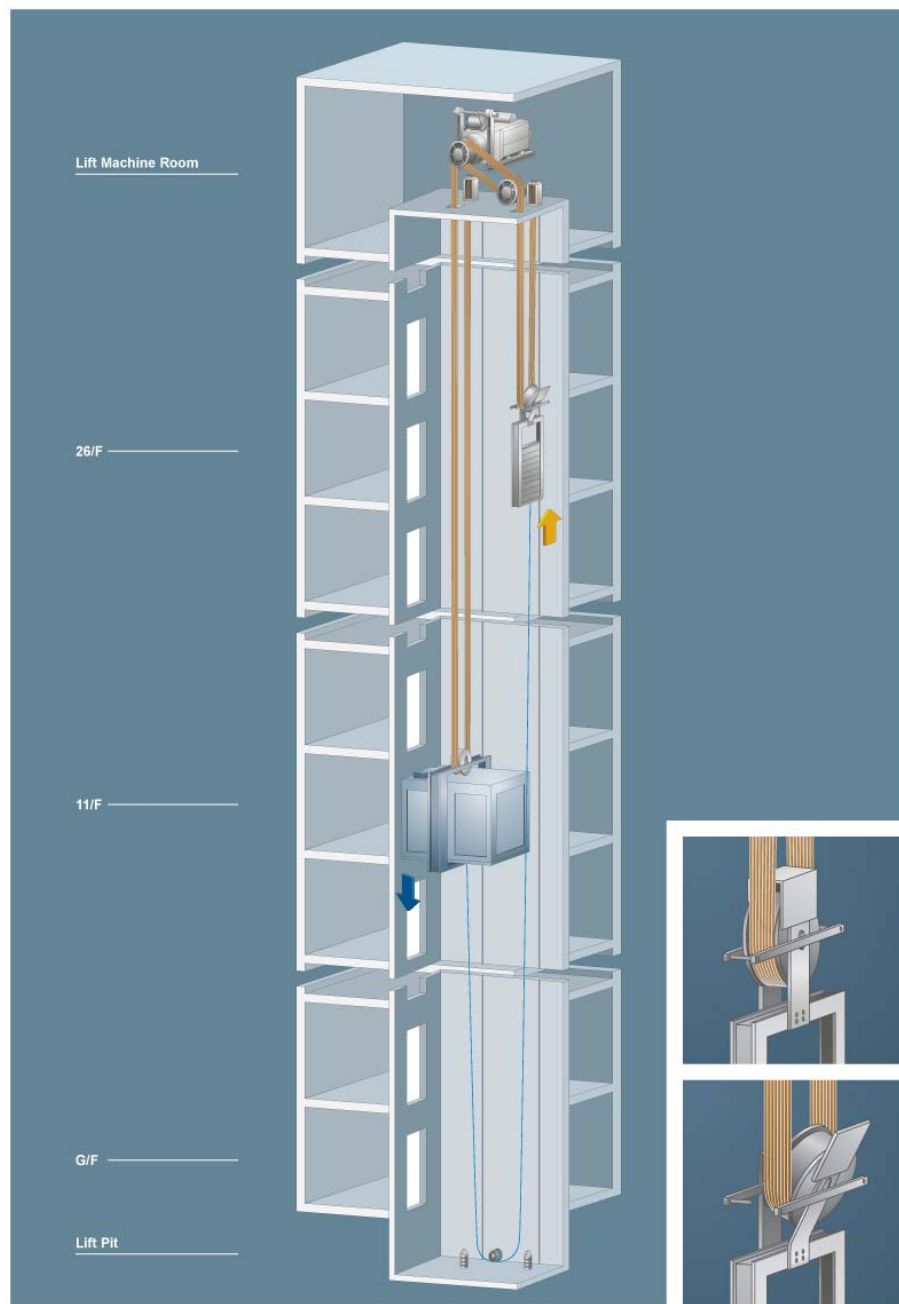
12.1 When the lift descended from the 14th floor to ground floor at around 7:21pm, the lift counterweight ascended upward to the 21st floor. The corroded inner race of the counterweight pulley bearing fractured, causing the bearing balls coming loose from the bearing track. As a result, as shown in Sketch 1, one side of the pulley shaft lost support and consequently, the pulley tilted upward by the pull of the suspension ropes. The tilting also caused the pulley to come into contact with the counterweight bracket and exert pressure on it, causing one of the "arms" deformed. When one end of the shaft could no longer be retained by the bracket, the suspension ropes completely dislodged from the pulley.

Sketch 1 – Dislodgement of the suspension ropes from counterweight pulley.

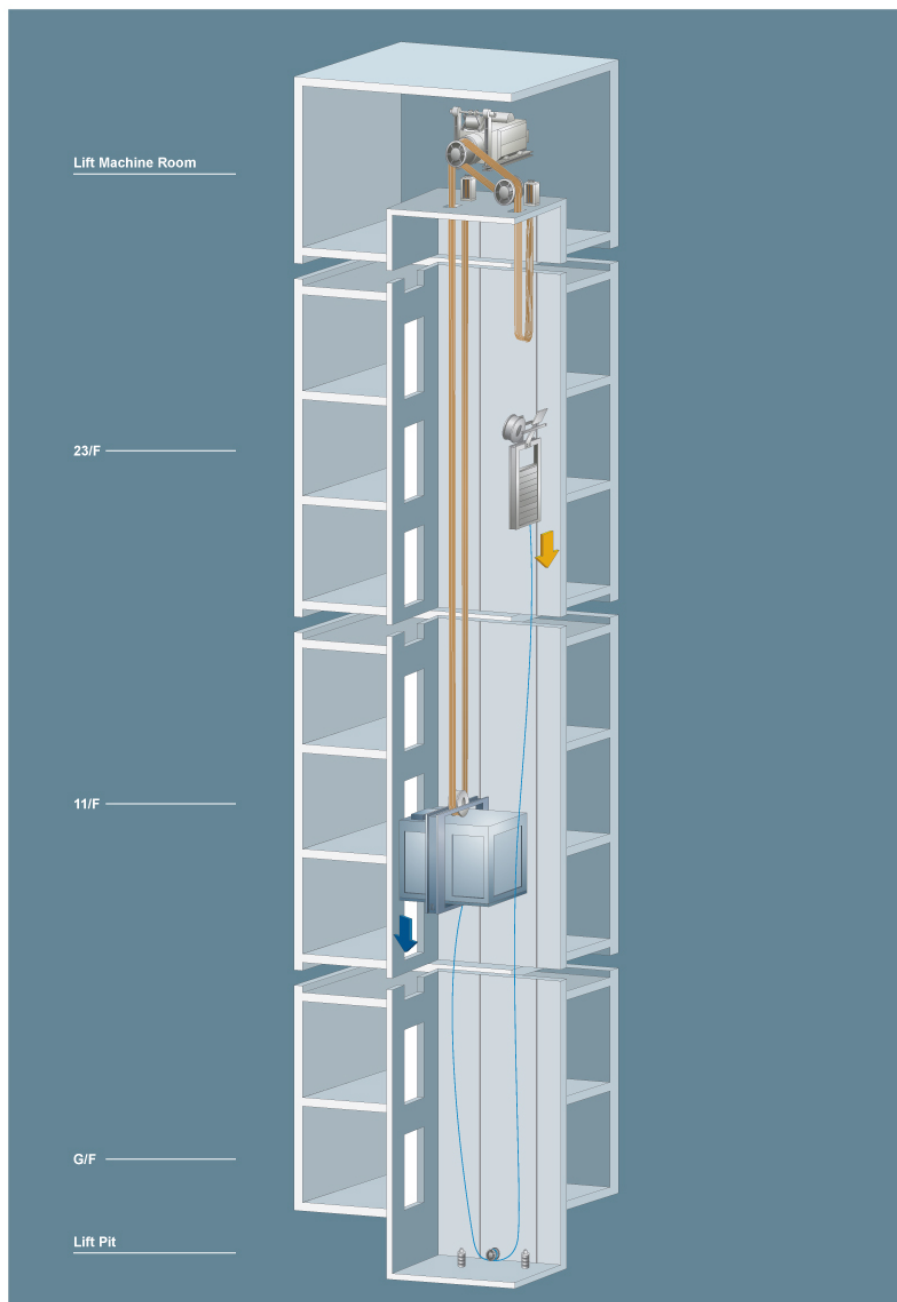
12.2 As shown in Sketch 2, due to the dislodgement of the suspension ropes, the counterweight was set free and slid down under gravity along the counterweight guide rails towards the bottom of the lift shaft. The counterweight pulley also detached from the bracket and fell under gravity. Without the counterweight, the lift car started descending and gaining momentum.

Sketch 2 – Lift Car and Counterweight slid under gravity.

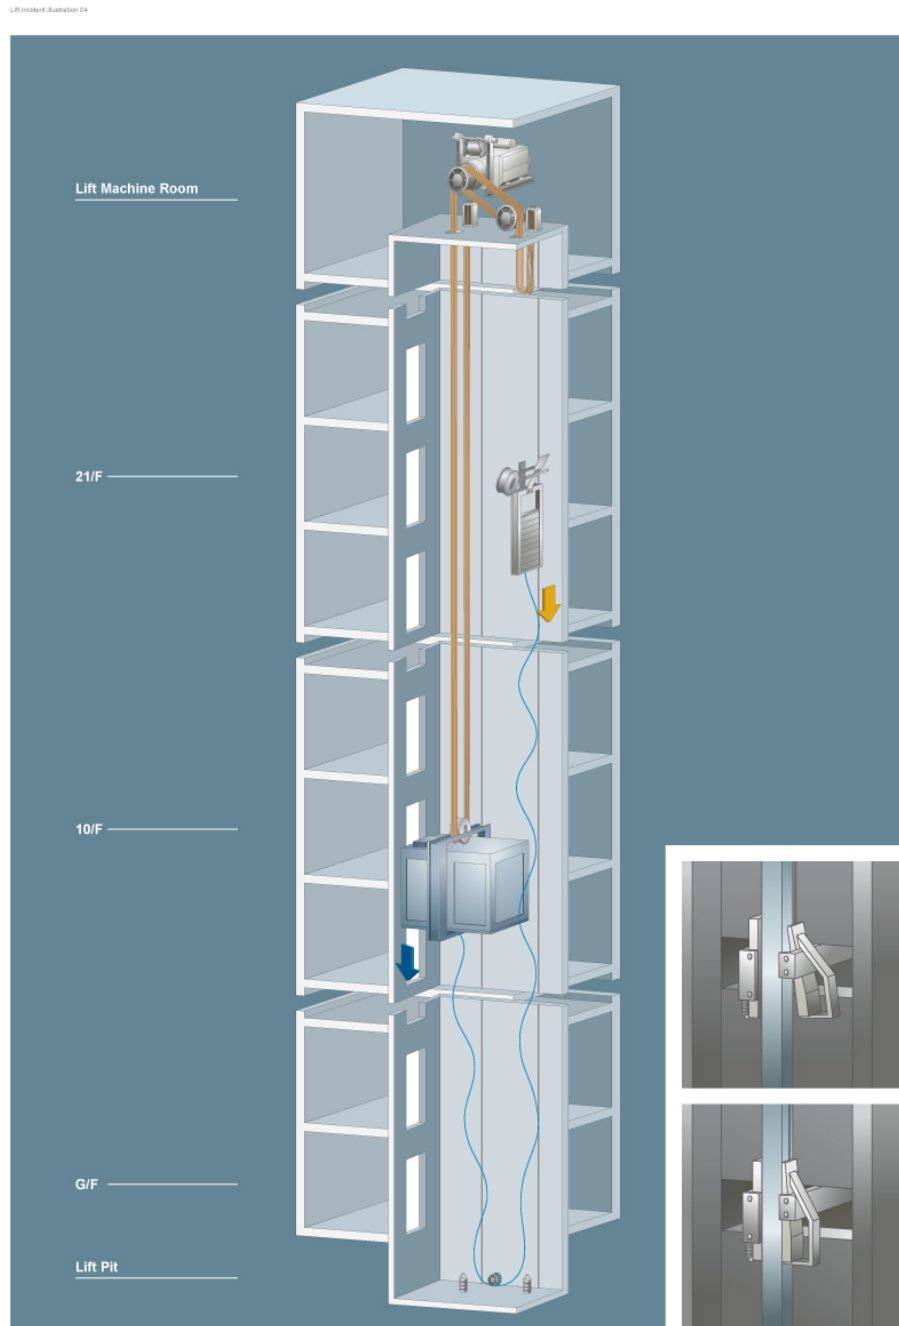
12.3 Accelerating above the rated speed, the overspeed governor activated its electrical switch stopping the lift motor operation and applying the motor brake. Because the suspension ropes were not in tight contact with the motor pulleys, there was not sufficient friction and the motor brake was not effective to stop the descending of the lift car. As shown in Sketch 3, the lift car continued to accelerate,

the overspeed governor activated the safety gear of the lift at around the 10th floor, and slowed down the lift car. The safety gear, however, did not bring the lift car to a stationary position.

Sketch 3 – Lift car safety gear activated and slowed the lift car.

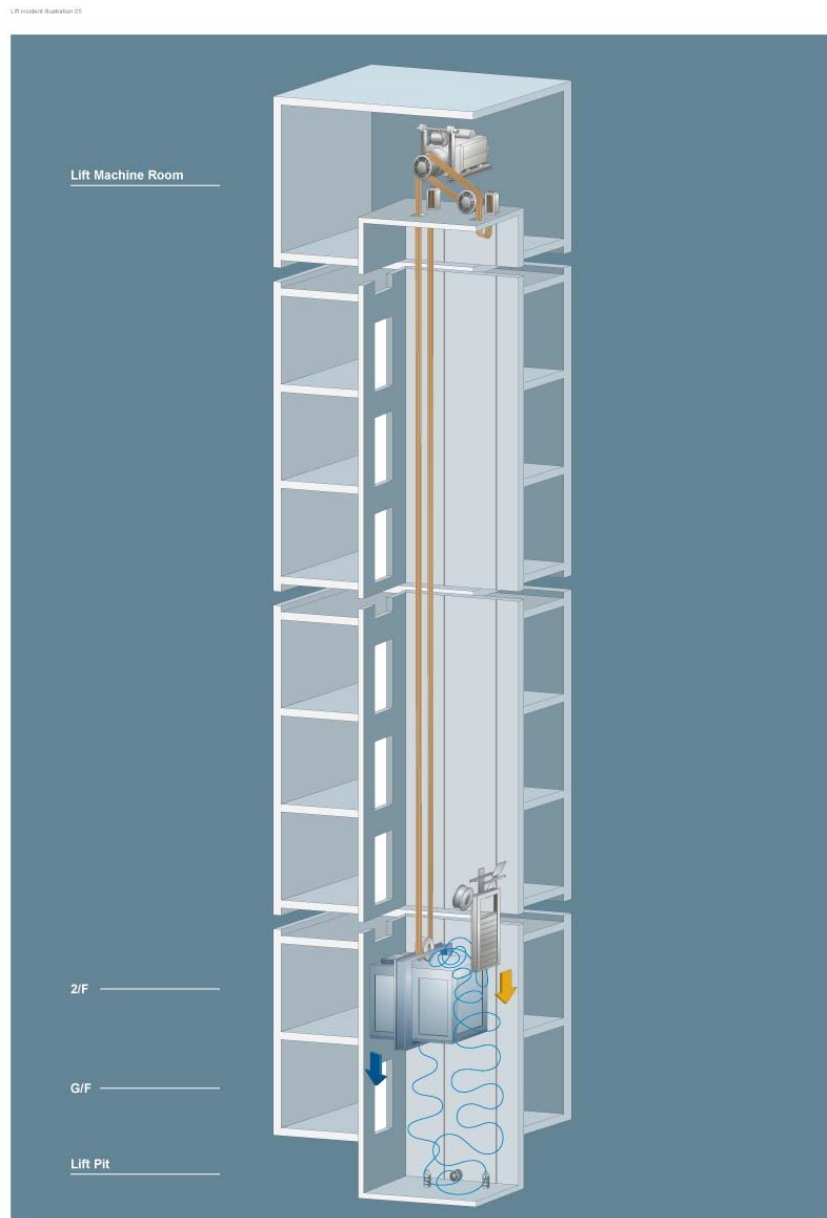
12.4 In the meantime, the counterweight also slid down along the guide rails. Because of the limited space between the lift car and counterweight, (a horizontal clearance of about 65mm only), it is suspected that the compensating ropes (5 in number and each of 16 mm diameter) connected to the bottom of the counterweight became tangled on the top and the side of the lift car. As the counterweight was accelerating under gravity, the counterweight and the tangled

Sketch 4 – Counterweight and the tangled compensating ropes forced the lift car into the lift pit.

compensating ropes exert extra loading on the lift car. The load imposed by the descending counterweight and the tangled compensating ropes forced the lift car to travel further downwards overshooting the ground floor level into the lift pit, see Sketch 4.

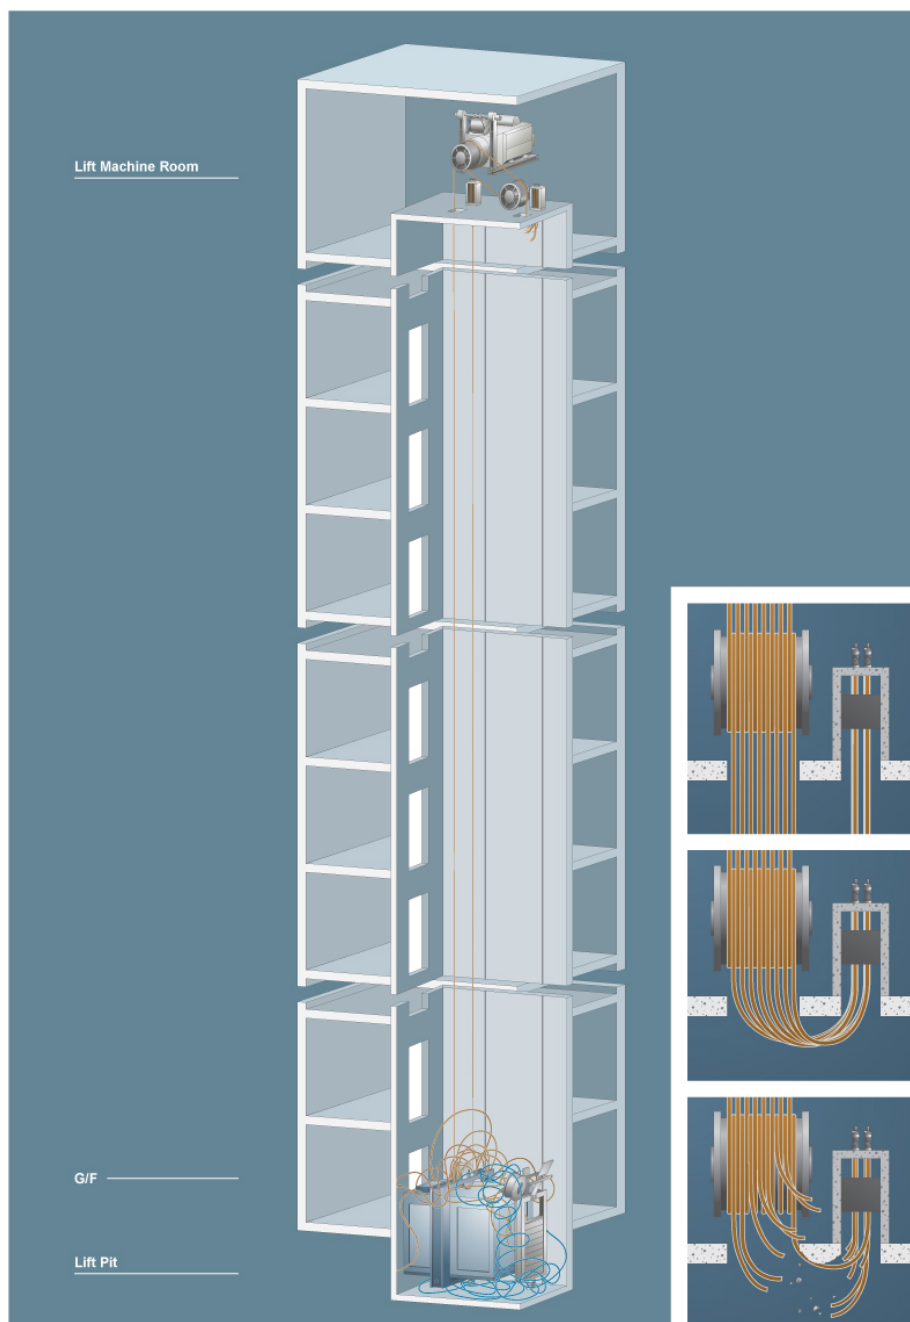
12.5 When the lift car overshot the ground floor level into the lift pit, seven out of the eight suspension ropes became taut, while one rope came out of the diverter pulley and was not tight. Five suspension ropes were pulled against the concrete floor slab of the lift motor room whilst two suspension ropes were pulled against the counterweight rail bracket at the top of the lift shaft. The resultant force due to the fall of the counterweight and the lift car exceeded the tensile strength of the ropes, and broke these seven ropes, see Sketch 5. The remaining one rope which was loose was not broken.

Sketch 5 – The resultant force due to the fall of the counterweight and the lift car broke the suspension ropes.

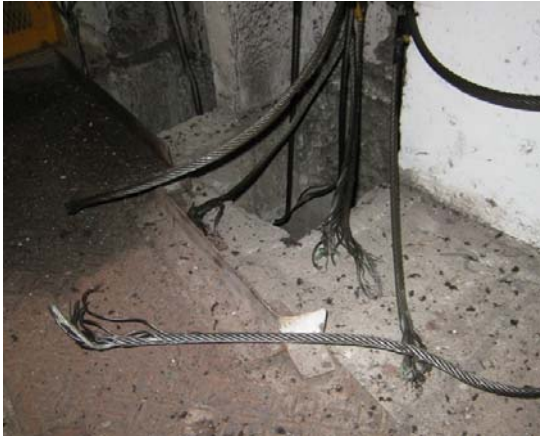
8.1 Seven out of eight suspension ropes were found broken. Five ropes were found broken at position around 1.1 to 1.2 metres from the anchored points on the counterweight side. The other 2 ropes were broken at around 2 to 2.5 metres from the anchored points (see Figure 3 in Appendix A.)

10. The 7 sets of broken suspension ropes were examined by City University of Hong Kong (CityU). The examination revealed that the fracture surfaces generally had the characteristics of overstressing tensile failure.

Figure 3 - Broken suspension ropes found in Lift Motor Room.

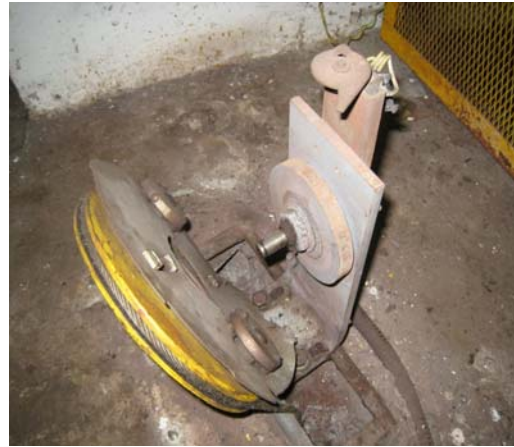
Figure 4 – Damaged lift overspeed governor.

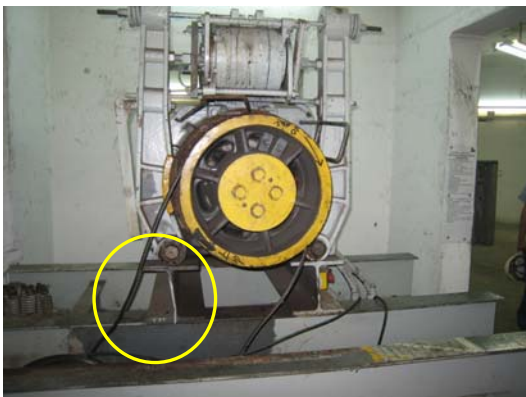
8.2 The overspeed governor in the machine room was damaged. (see Figure 4 in Appendix A) The 2 'I-beams' supporting the lift motor inside the machine room were deformed. (see Figure 5A and 5B in Appendix A.) The bracket of the counterweight pulley was found with grease marks and scratches resulting from contact with moving ropes and the pulley. (see Figure 6A and 6B in Appendix A.)

Figure 5A – I-beams of lift motor were deformed.

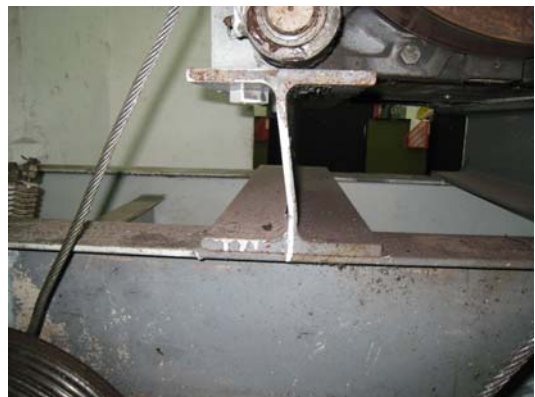
Figure 5B – Close-up view of the deformed I-beam.

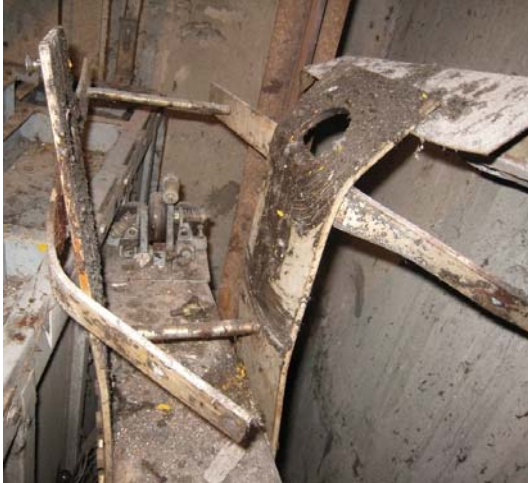
Figure 6A – Rope markings on counterweight pulley bracket.

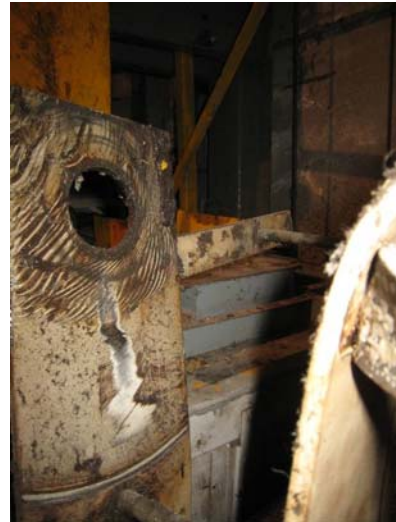
Figure 6B – Close-up view of the rope marks and pulley scratch mark on counterweight pulley bracket.

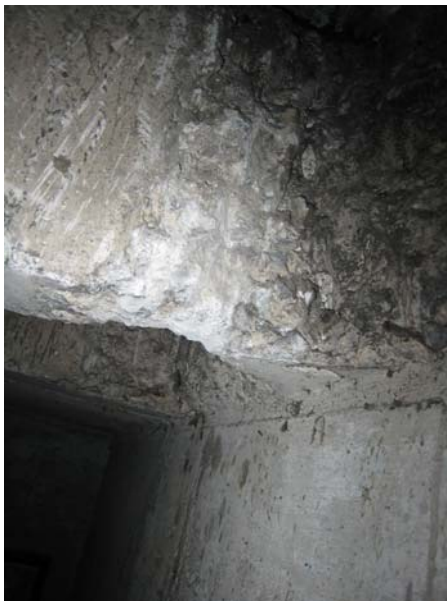
8.3 The suspension ropes passed through the floor of the machine room to the lift shaft through openings in the concrete slab. There were new abrasion marks on the side of the concrete slab. (see Figure 7 in Appendix A.)

Figure 7 – Concrete slab with new abrasion marks.

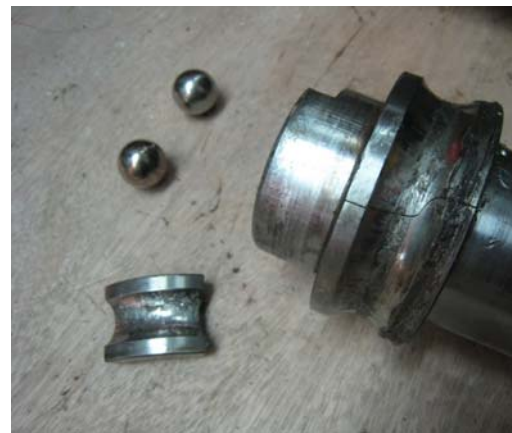
8.4 The counterweight pulley was found lying on the top of the counterweight and the bearing of the counterweight pulley was found broken lying on the floor of the lift pit. (Figure 8 in Appendix A shows the damaged bearing.)

11. The pulley shaft and bearing of the counterweight were also examined by CityU. Corrosion was found at the inner surfaces, bearing balls and contact surface between the bearing and the shaft.

Figure 8 – Damaged counterweight pulley bearing.

- a) all drums, sheaves, pulleys and bearings;
- b) overspeed governor, safety gear, guide rail and guide shoe of the lift car and counterweight; and
- c) suspension ropes, compensating ropes/chains and their anchorages.

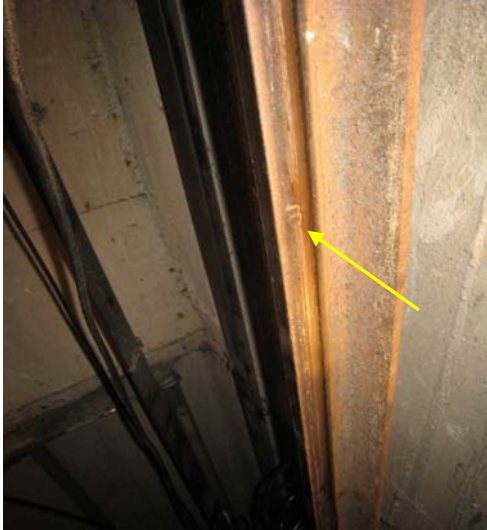
8.5 The two guide rails were found to have scratch marks starting from 10th floor down to the ground floor. (see Figure 9 in Appendix A.)

Figure 9 – Intermittent scratch marks on guide rail.

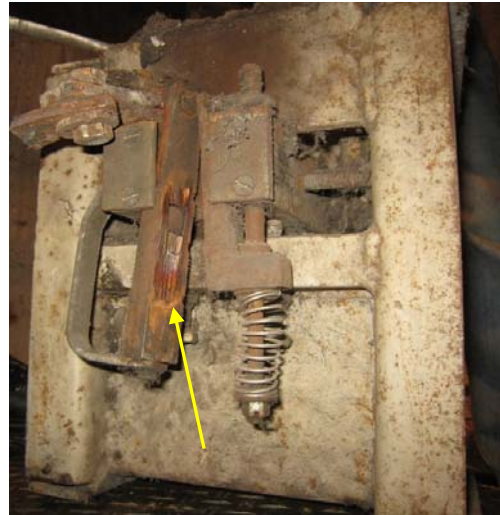
8.6 The safety gear was found having scratch marks on both surfaces, see Figure 10 in Appendix A.

Figure 10 – Fresh scratch marks on the safety gear.

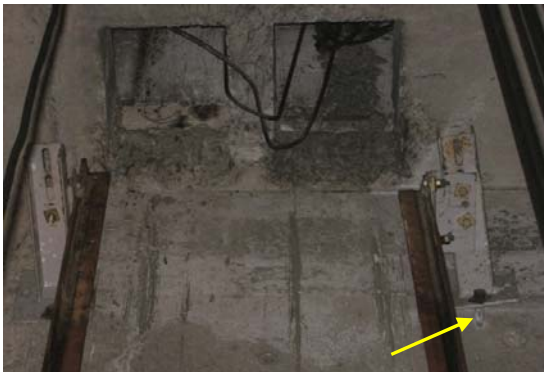
8.7 The top counterweight rail bracket was found deformed. (see Figure 11 in Appendix A.)

Figure 11 – Deformation of counterweight rail bracket (on the right hand side when looking into the lift shaft from 35/F landing)
