**Technical Investigation Report on
Escalator Incident at Langham Place,
Mong Kok, Kowloon**

Date of Incident: 25 March 2017
事故日期：2017年3月25日

Issued Date: 9 June 2017
出版日期：2017年6月9日

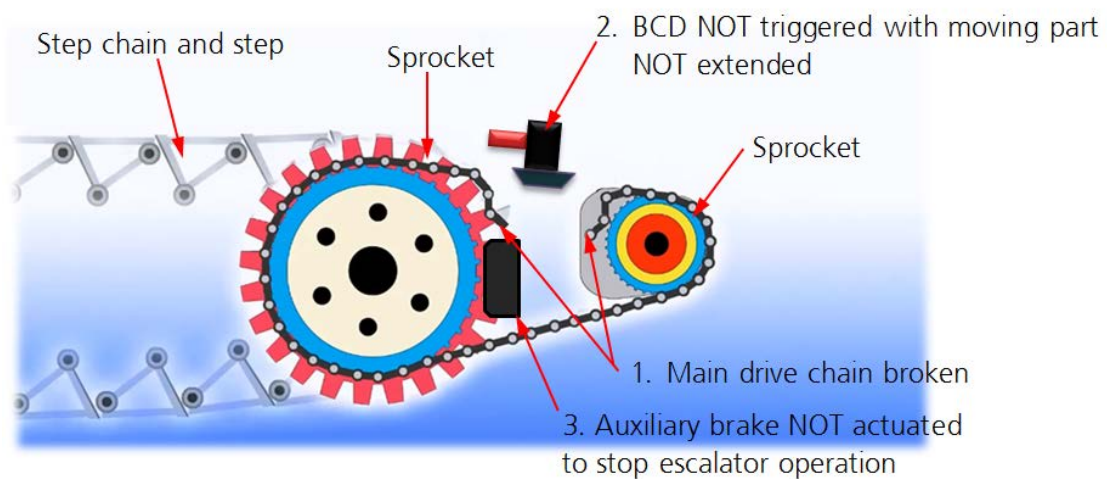
Figure 2b: Double failure of the main drive chain and BCD in the incident

5.2 Under normal circumstance, the breakage and/or excessive elongation of the main drive chain are continuously monitored by the broken chain safety device (BCD, Figures 1 and 3 refer). In case of breakage or excessive elongation of the main drive chain, the BCD will be triggered and will send a signal to activate the auxiliary brake to stop the moving escalator (Figure 2a refers). In this incident, upon breakage of the main drive chain, the BCD failed to detect the chain breakage and the auxiliary brake was not activated to stop the moving escalator (Figure 2b refers).

5.3 The incident was caused by the double failure of both the main drive chain and BCD. Such double failure is very rare. According to the EMSD's records, there was no similar failure occurred in Hong Kong previously.

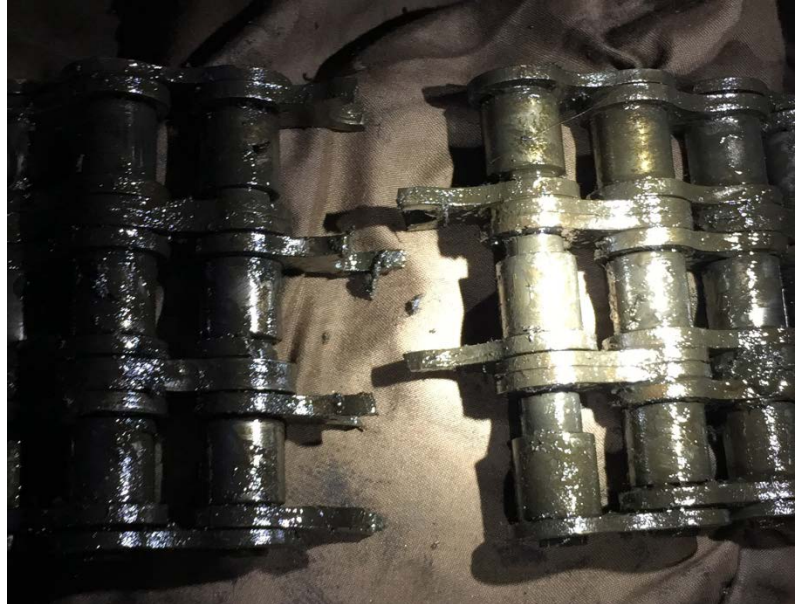
Figure 4: Photo showing the breakage position of main drive chain

6.2.3 After the incident, the main drive chain was found broken. According to the numbering system, the breakage occurred between pin Nos. 1 and 104. Figure 4 shows the breakage position of the main drive chain right after the incident.

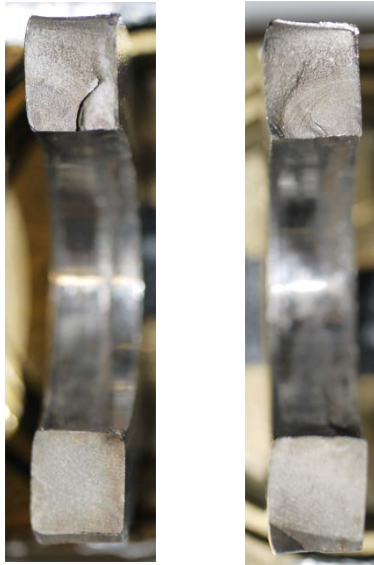
Figure 6: Fracture surfaces

6.2.4 The breakage of the main drive chain was further analysed by material experts at laboratory by stereo micrography and scanning electron micrography. All fracture surfaces contain beach marks, which are characteristics of metal fatigue. (Figures 5 and 6)

7.2 The breakage of the main drive chain was due to metal fatigue. The malfunction of BCD was due to sticky grease on the sliding surface of the moving part of the BCD and improper setting of the compression springs. The sticky grease and the reduced spring force had hindered the operation of the moving part so that no signal was sent to the auxiliary brake to stop the escalator when the main drive chain was broken.

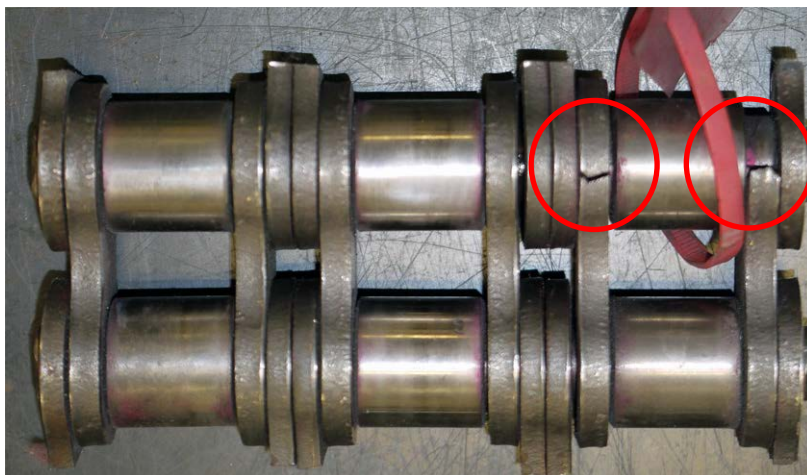
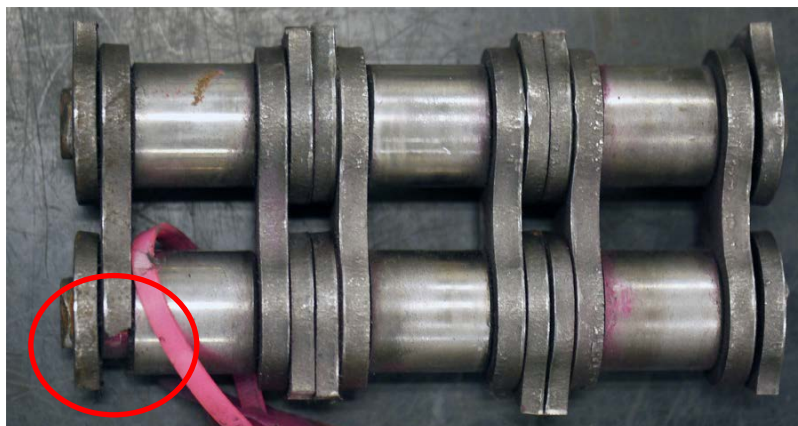
Figure 7: Other broken/cracked roller link plates

6.2.5 Other than the chain breakage position in between pin Nos. 1 and 104, link plates were also found broken/cracked at other pins (Figure 7).

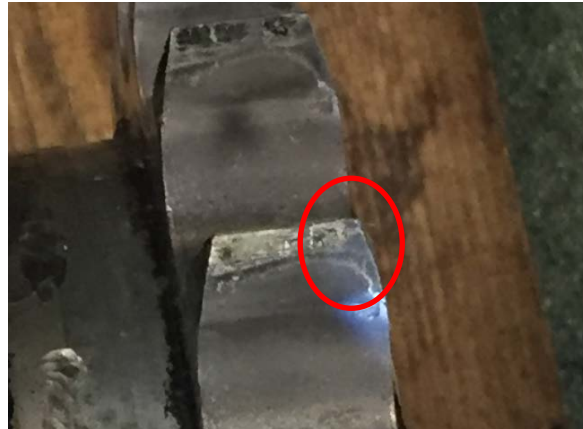
Figure 8: Photo of wear surface on the teeth of motor sprocket

6.2.6 Apart from the abnormal damage to the main drive chain, abnormal wear and scratch were also found at the teeth of the motor sprocket and the step chain sprocket. Figure 8 shows the wear surface on the teeth of motor sprocket.

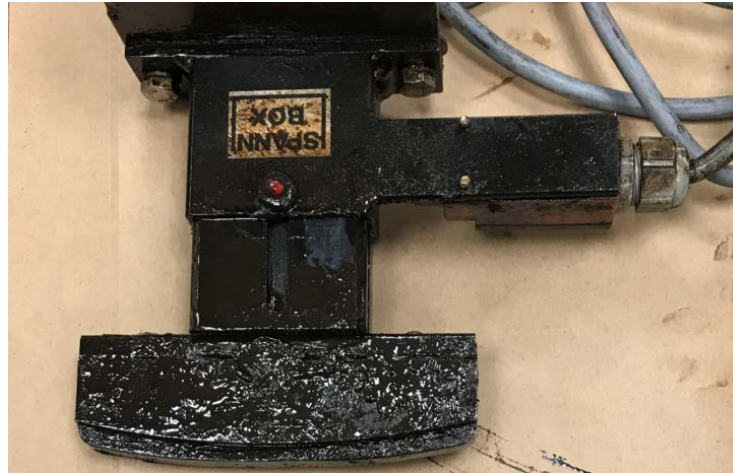
6.3.3 After the incident, the BCD as shown in Figure 9 was seized for laboratory investigation. Having disassembled the BCD, sticky grease was found between the fixed metal housing and the sliding surface of the moving part. The sticky grease was formed from the mixture of oil used for lubricating the main drive chain and dust from the environment.

Figure 9: Photo of the BCD moving part and the shoe. Mixture of lubrication oil and dust formed the sticky grease, which was found on the surface.

6.3.5 The increased friction between the moving part and the fixed metal housing arisen from the sticky grease and the reduced spring force due to an ineffective spring had resulted to the non-operation of the BCD, so that the moving part and the shoe were not extended downwards to activate the micro-switch when the main drive chain was broken. The auxiliary brake was therefore not activated to stop the escalator.

8.5 The EMSD issued a reminder circular No. 3/2017 on 7 April 2017 to remind all registered escalator contractors and registered escalator engineers that the BCD should be properly maintained to ensure the free operation of its entire activation mechanism and to be fully tested to check the full integrated operation of its electrical and mechanical components. Also, the main drive chain should be closely inspected to confirm that it is free from cracks, breakage and excessive elongation, all in accordance with the relevant clauses in the Code of Practice for Lift Works and Escalator Works.

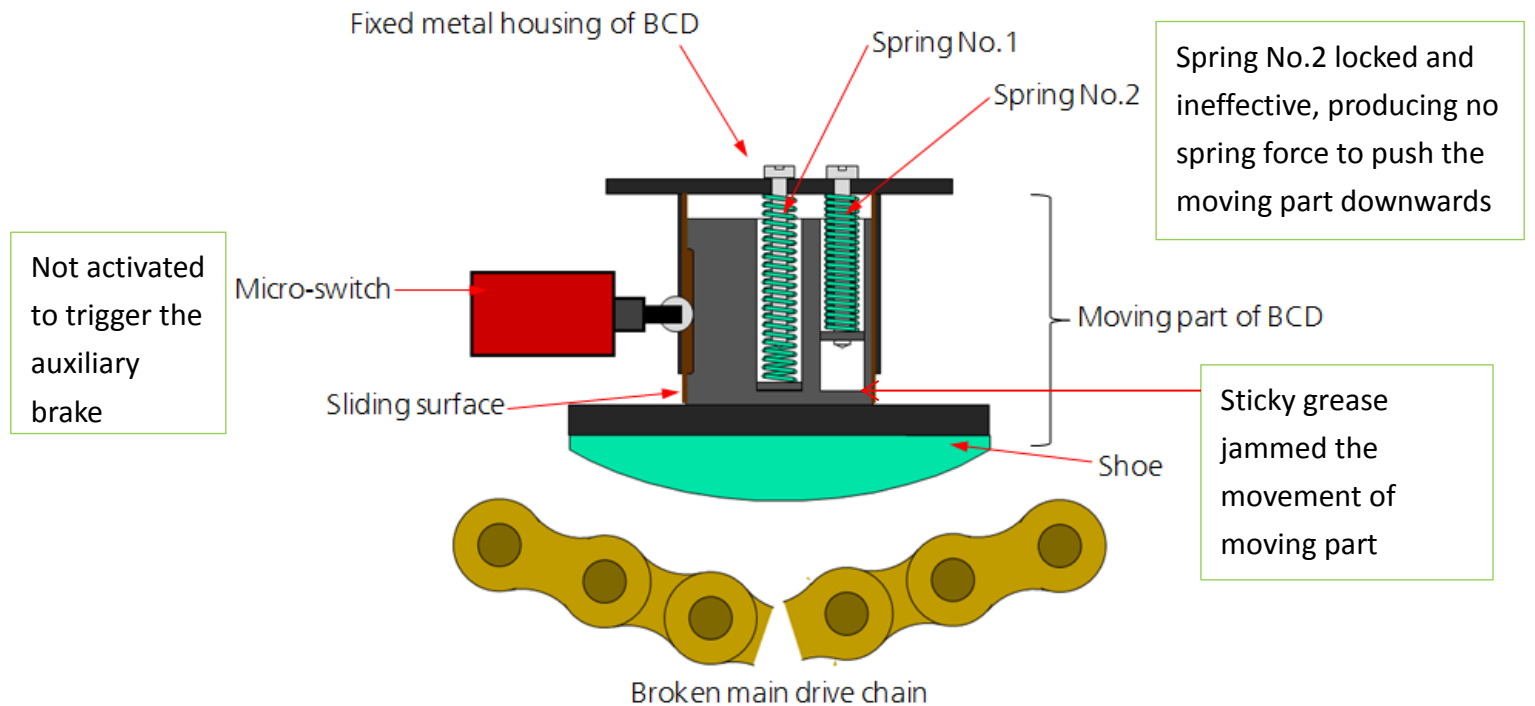
Figure 10: Illustration of BCD with spring No. 2 locked and made ineffective

6.3.4 Furthermore, it was found that one of the two compression springs had been locked and made ineffective (i.e. not providing spring force to the BCD moving part), thereby causing reduced spring force to push the moving part downwards. Please refer to Figure 10 for illustration.
