## **Technical Report on Lift Incident on 11 January 2009**

### **at Heng Shan House, Heng On Estate, Ma On Shan**

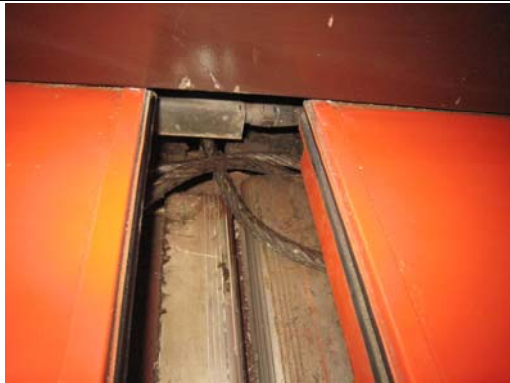
4. Inspection by EMSD confirmed that one of the four suspension ropes had broken. One end of the broken rope was found entangled at the car door top on 24/F

6. As part of the investigation, an independent expert was engaged to conduct laboratory examinations and tests on the broken rope to ascertain whether the tensile strength of the rope was in compliance with the manufacturer's technical specification. The test results showed that the rope met the manufacturer's technical specification of 66.6kN in tensile strength. The failure was due to lack of effective lubrication at the inner part of the ropes, resulting in damage to the wire rope strands through rubbing action between the strands. This damage led to deterioration of the strength of the rope which eventually resulted in tensile overstressing failure of the rope.

Photo 1 – Broken rope hanging on the lift car door at 24/F.

7. All the suspension ropes of Lift No. 7 were replaced by Otis and the lift was put back in operation after the examination and certification by a RLE of Otis on 9 February 2009.

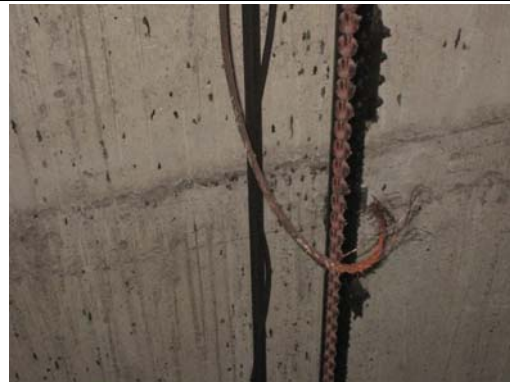
(see Figure 1 in Appendix A). Another end of the broken rope was found hanging inside the lift shaft (see Figure 2 in Appendix A). No other damage of the lift component was observed. (see Figures 3 and 4 in Appendix A).

Photo 2 – Broken rope hanging inside the lift shaft.

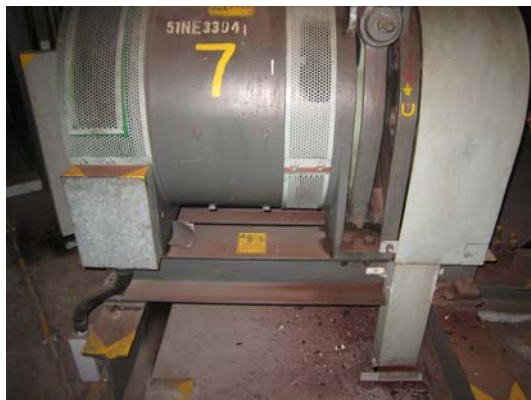
Photo 3 – No damage found on the main drive.

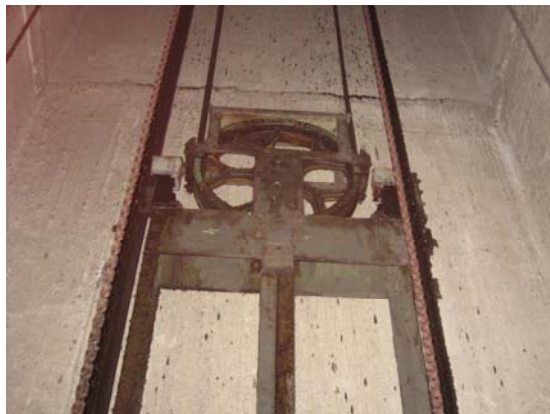
Photo 4 – No damage found from the counterweight.
