**Technical Report on Lift Incident on 12 March 2009**  
**at Westlands Centre, 20 Westland Road, Quarry Bay, Hong Kong**

Electrical & Mechanical Services Department

14 April 2009

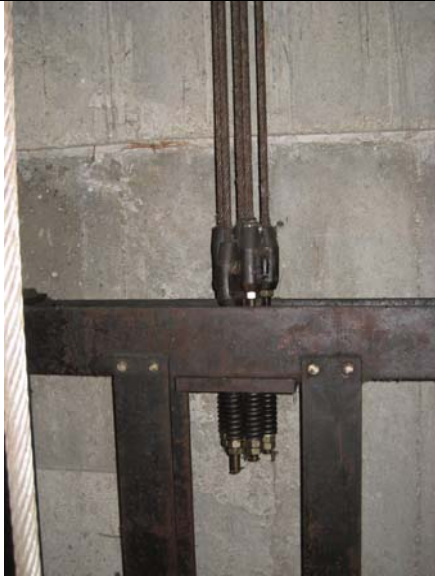
4. Inspection by EMSD found that one of the six suspension ropes of L2 was broken at the termination point of the counterweight side. The other 5 ropes were found intact and fixed to the counterweight (see Photo 1 in Appendix A). The broken suspension rope was shown in Photo 2 in Appendix A. Whereas in the Lift Machine Room for L2, the groove of the traction sheave for the broken rope was found to be severely worn (see Photo 3 in Appendix A). No other damage of the lift component was observed (see Photo 4 in Appendix A).

Photo 1 – Five ropes were still fixed to the lift counterweight.

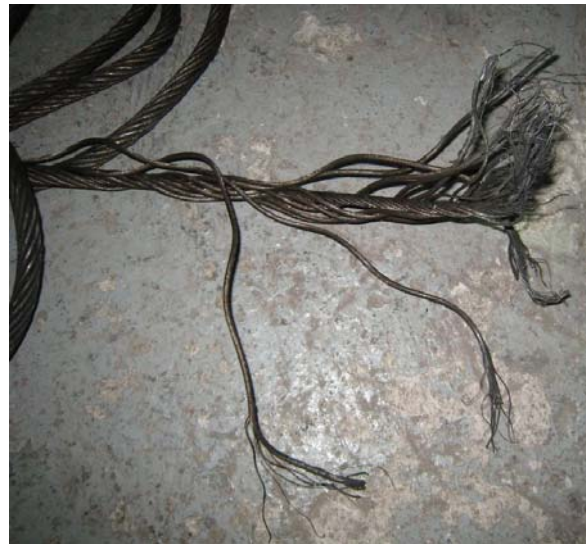
6. As part of the investigation, an independent expert was engaged to conduct laboratory examinations and tests on the broken rope to ascertain whether the tensile strength of the rope was in compliance with the manufacturer's technical specification. The test results showed that the rope met the manufacturer's technical specification of 158kN in tensile strength.

7. From the severe wear found only on one of the grooves of the traction sheath, it was concluded that the rope failure was due to unbalanced loading condition of the suspension ropes with the failed rope carrying a high proportion of the total load. The loading overstressed this suspension rope and broke the rope wires at the termination point of the counterweight side.

Photo 2 – Broken suspension rope.

8. The traction sheaves of L2 together with all the suspension ropes with their terminations were replaced by Schindler. The lift L2 was put back in operation after the examination and certification by a RLE of Schindler on 31 March 2009.

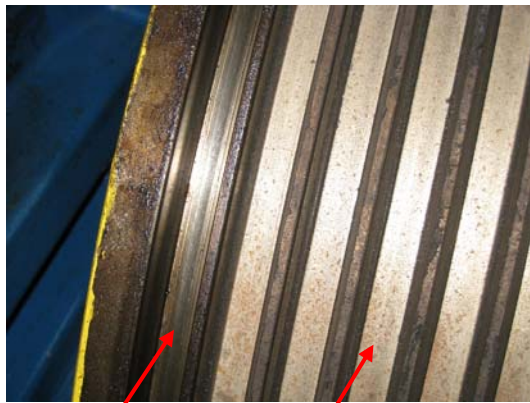
Photo 3 – Traction sheave of Lift No.2.

Worn groove Normal groove

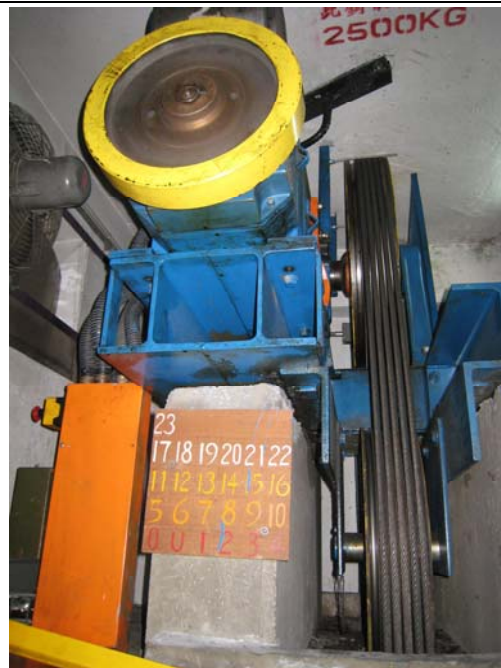
Photo 4 – No damage was found in L2 main drive unit.
