# **Technical Investigation Report on Escalator Incident**

## **at the Hong Kong Design Institute, Tseung Kwan O**

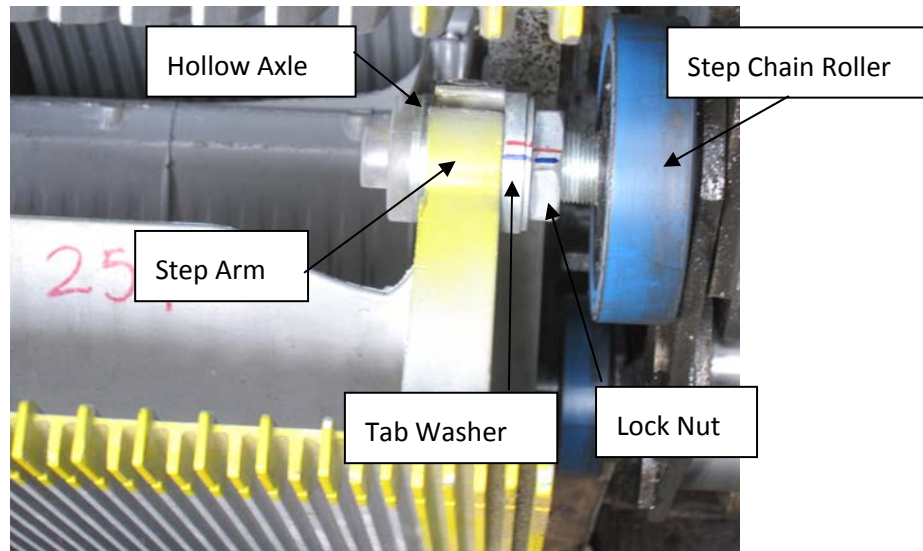
4. In this escalator, each step is attached to two rollers on each side. One roller, known as the step chain roller, is connected to the step chain by means of a step bolt. The step arm is engaged on a hollow axle and secured in position by fastening the lock nut with a tab washer (see Photo No. 1 in Appendix A). The other roller is known as an idle roller resting on the guide rail of the escalator.
5. Inspection by EMSD found that 10 escalator steps were jammed in the upper landing return station of escalator no. E4. The first jammed step, namely step no. 24, was under the comb plate at the upper landing (see Photo No. 2 in Appendix A)

Photo 1 – Step Assembly

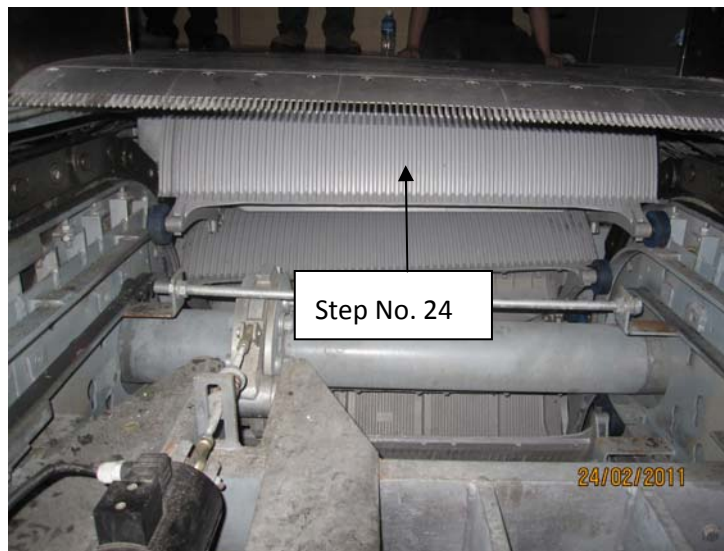
10. It was concluded that the incident occurred when the step no. 24 became jammed in the upper return station. The jamming of the step no. 24 was caused by disengagement of the step arm from the hollow axle where the lock nut and tab washer were not properly secured in their originally designed position.

Photo 2 – First jammed step (step no. 24) below the comb plate at upper landing.

12. All the damaged steps of Escalator No. E4 were replaced by TKE. Full load brake test was completed for Escalators on 21 April 2011. TKE had checked all step assemblies for the escalators in Hong Kong Design Institute. The escalators will resume operation after thorough examination and certification by registered escalator engineer.

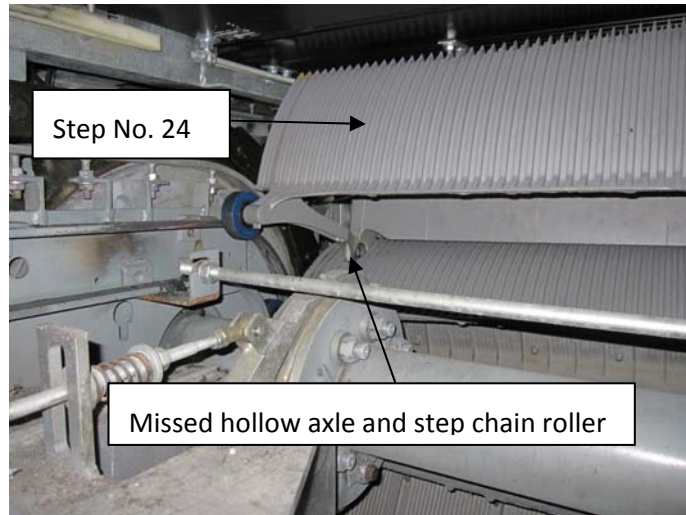
and the step bolt was found broken. No hollow axle with the step roller was attached on the step arm on both sides of the step no. 24 (see Photo Nos. 3 and 4 in Appendix A).

9. To evaluate the possibility on loosened connection of the lock nut and tab washer on both sides of the step, a simulation test was conducted by ThyssenKrupp Fahrtreppen (TKF), Hamburg in Germany. The test indicated that step would drop at the upper return station when the lock nut and tab washer of the hollow axle on both sides of the step were loosened completely. This also explained why the hollow axle on both sides of the step no. 24 was not engaged on the step arm after the incident.

Photo 3 – The hollow axle and step chain roller were found missing  
from the left hand step arm

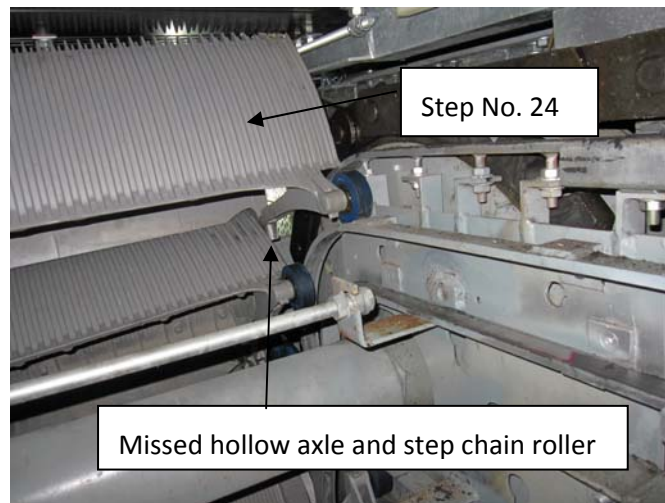
Photo 4 – The hollow axle and step chain roller were found missing  
at the right hand step arm
