## **Report on Lift Incident on 9 November 2008**

### **at Lift No. 4, Wan Lam House, Wan Tau Tong Estate, Tai Po**

Electrical & Mechanical Services Department

17 December 2008

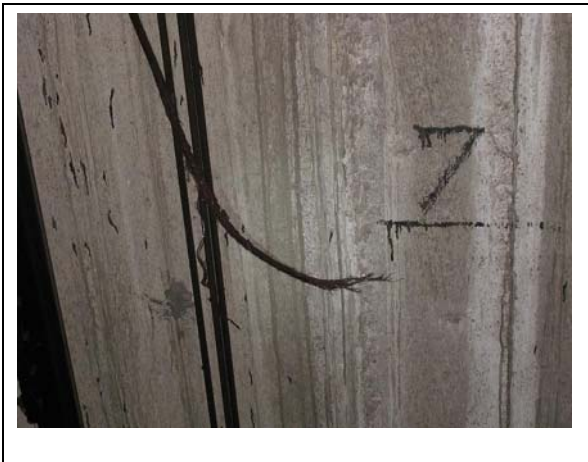
4. On 10 November 2008, inspection by EMSD found that one of the four suspension ropes had broken inside the lift shaft at 31/F, a position around 16 metres below the anchored point at the lift machine room. (see Figure 1 in Appendix A.) The other three suspension ropes were found in safe condition. No physical damage of other lift components was observed. (see Figures 2 and 3 in Appendix A.)

8. The fracture ends of the broken rope were then examined under microscope at the University of Hong Kong. Most of the wires of the broken rope exhibited signs of overload and some wires ends had signs of corrosion. The corroded wires caused deterioration in the tensile strength in that portion of the broken rope.

<p>Photo 1 – Broken rope inside the lift shaft at about 31/F.</p>	<p>Photo 2 – No damage of the lift machine inside the lift machine room.</p>

9. Fujitec was required to replace all the suspension ropes of Lift No.4. After the rope replacement, the lift was thoroughly tested and examined by a RLE of Fujitec

under the monitoring of EMSD on 21 November 2008. The lift was certified by the RLE in a safe working condition.

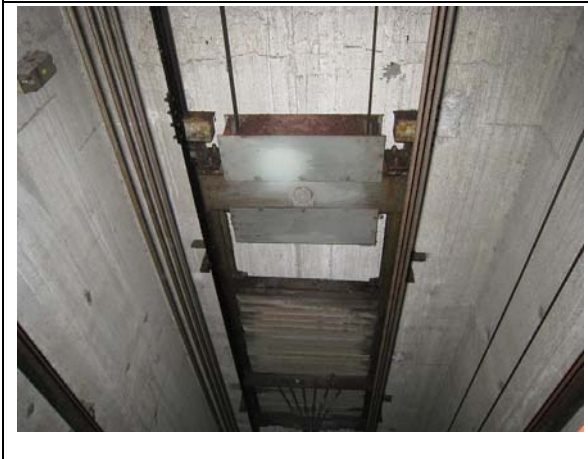
<p>Photo 3 – No damage found from the counterweight.</p>
