**Technical Investigation Report on Lift Incident  
at Selwyn Factory Building, 404 Kwun Tong Road, Kwun Tong, Kowloon**

**Electrical and Mechanical Services Department**

**April 2015**

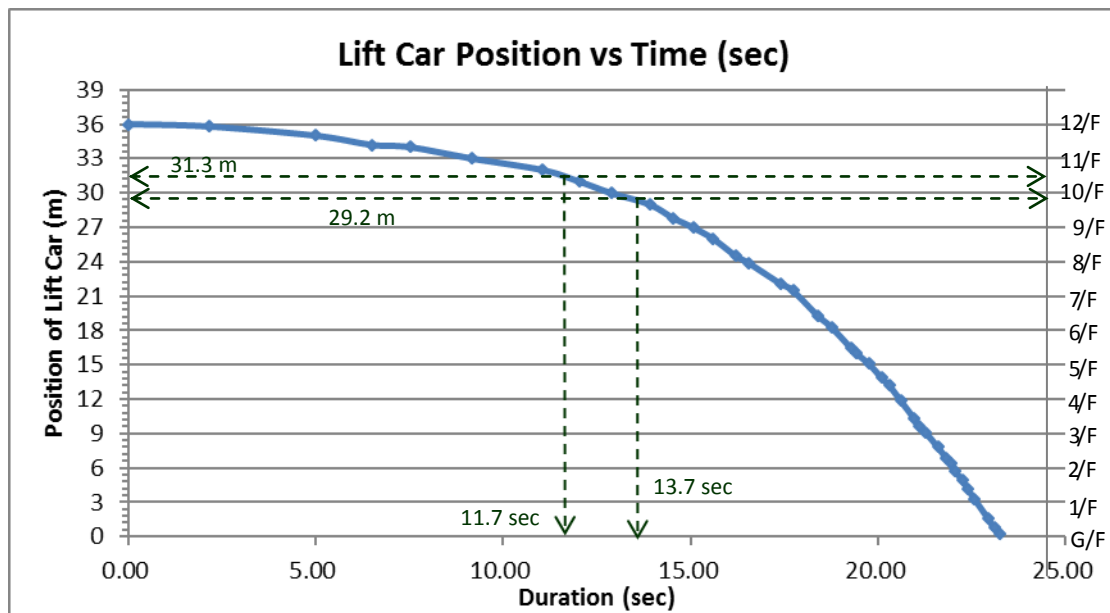
Figure 1 Lift Car Position against Time

5.5 The position of the lift car against time during the course of the incident was estimated based on the CCTV footage.

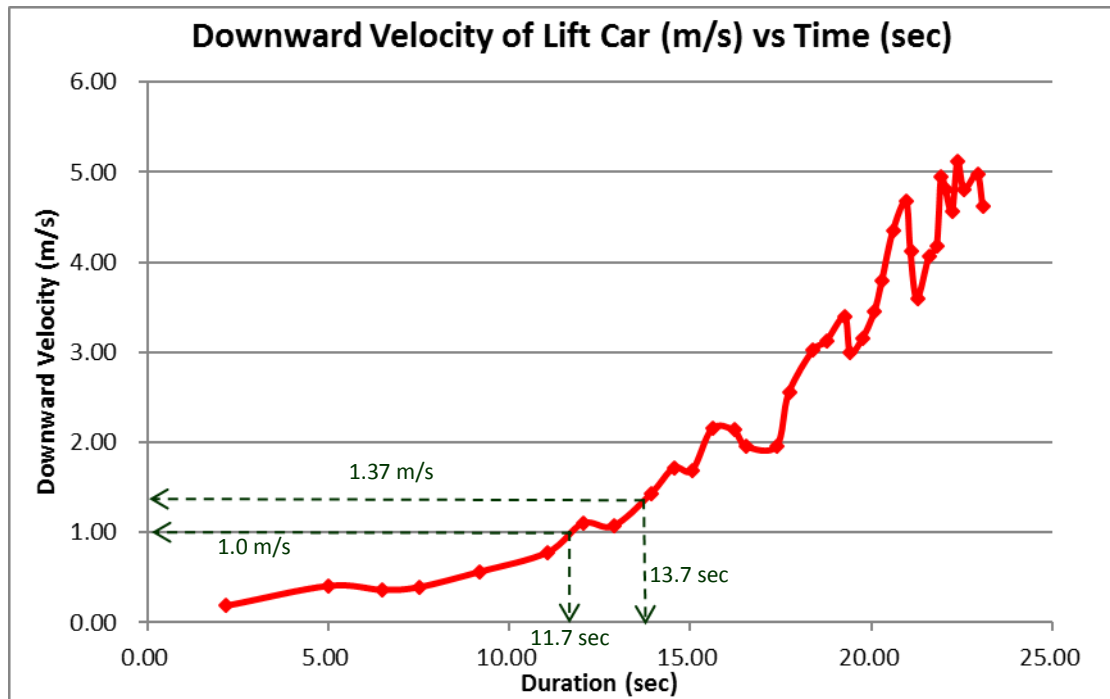
Figure 2 Velocity Profile of Lift No. 1

5.6 The velocity profile (Figure 2) of the lift against time during the course of the incident was estimated based on the CCTV footage.

5.7 The velocity of the lift car in the first 5 seconds was found increasing gradually. The lift car continued to accelerate and attained its rated speed (i.e. 1.0 m/s) at around 11.7 seconds after it began to slip downward at 12/F. The lift car further attained the tripping speed of the governor system (i.e. 1.37 m/s, see para. 5.19) at around 13.7 seconds. The velocity of the lift car continued to increase and the maximum velocity attained was 5.1 m/s at the time before it hit the buffer at the bottom of the lift pit. Some signs of momentary reduction in the lift car velocity were noted at approximately 16 seconds, 20 seconds and 22 seconds after the initial downward movement.

5.8 The velocity profile indicated that both the lift brake system and the safety gears were exerting braking forces to stop the lift movement but were unable to stop the downward movement of the overloaded lift.
