**Technical Investigation Report on  
Lift Incident at Paris Court,  
Sheung Shui Town Centre, New Territories**

Date of Incident: 11 May 2018  
事故日期：2018年5月11日

Date of Issue: 20 August 2018  
出版日期：2018年8月20日

**Technical Investigation Report on  
Lift Incident at Paris Court, Sheung Shui Town Centre, New Territories on  
11 May 2018**

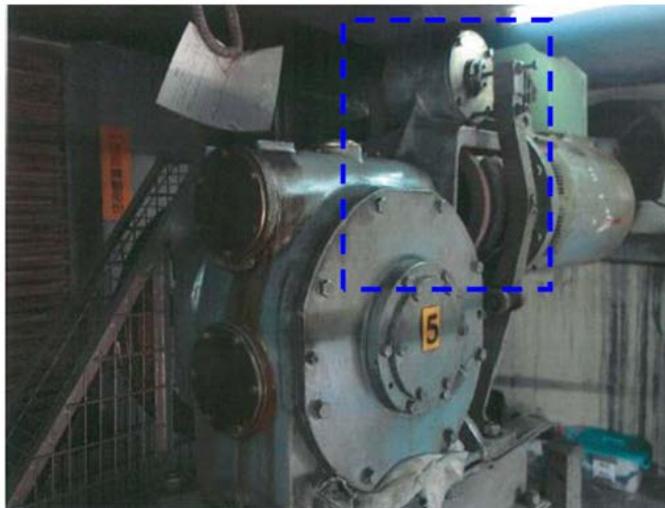
Figure 1: Photo of lift traction machine  
(Electromechanical brake system highlighted by blue dotted lines)

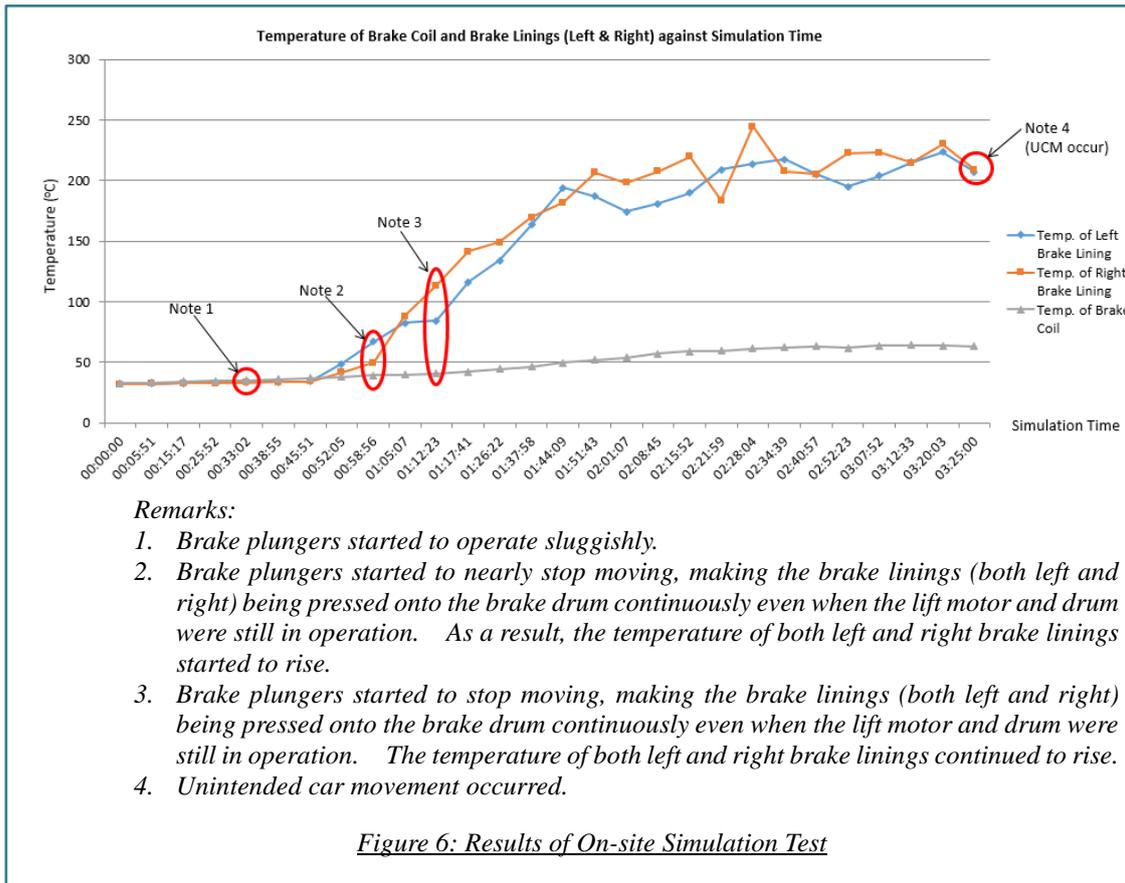
- d) The travel pattern of the lift before the time of the incident was recorded in order to simulate the complete sequence of event. A thermal imager (Figure 5) was used to record the temperature of the brake coil and the brake linings. The simulation results are shown in Figure 6. The simulation test was started at 00:00:00 (hh:mm:ss). With the lift operated as per the pattern before the incident, it was found that at the simulation time of 00:33:02, the left and right brake plungers started to operate asynchronously and sluggishly (with around 1 second delay between their movements). The simulation test continued and it was found that the brake plungers started to stop moving, causing the brake arms and associated brake linings unable to open at simulation time 01:12:23. With the brake plungers failed to move, the brake linings (both left and right) were being applied onto the brake drum continuously even when the lift motor and drum were running. As a result, the temperature of both left and right brake linings started to rise continuously to about 220°C. Finally, at simulation time 03:25:00, the lift car was found moving while the landing door was still at open position, and an unintended car movement occurred.

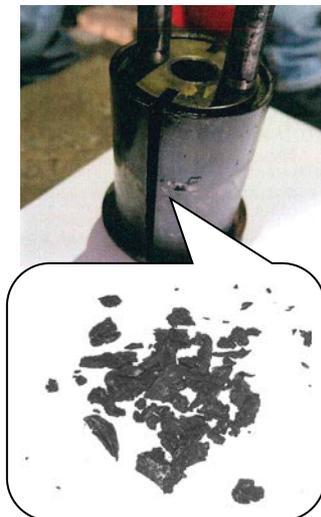
- e) When the braking system was dismantled for investigation, the brake coil housing and brake plungers were found not lubricated for a long time so that dark dried lubricant was found on their surfaces. Figures 7, 8 and 9 show the inner part of the brake coil housing, and the conditions of the left brake plunger and that of the right brake plunger respectively, revealing the lack of lubrication between the surfaces of the brake coil housing and the plungers, and the frictional forces so generated obstructed the normal smooth operation of the brake plungers occasionally.

*Figure 8: Condition of left  
brake plunger(Dark dried  
lubricant was found)*

6.2 Lift expert found that the brake plungers did not move smoothly and their movement was finally jammed during on-site simulation tests. Dark dried lubricant was found on the surfaces of the brake coil housing and the brake plungers, so that there was insufficient lubrication between the sliding surfaces of the brake plungers and the brake coil housing and the movement of the plungers would be occasionally jammed when the frictional force at the sliding surfaces was too high. This would lead to incomplete opening of the brake arms when the Incident Lift was in operation, making the brake linings remain in contact with and rubbing against the brake drum surface, thus resulting in overheating

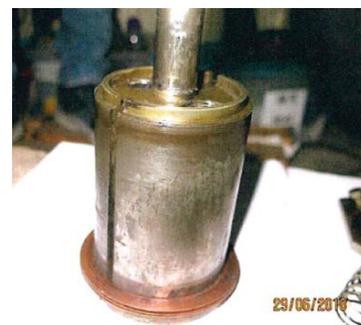
*Figure 9: Condition of right brake  
plunger (No lubricant was found)*

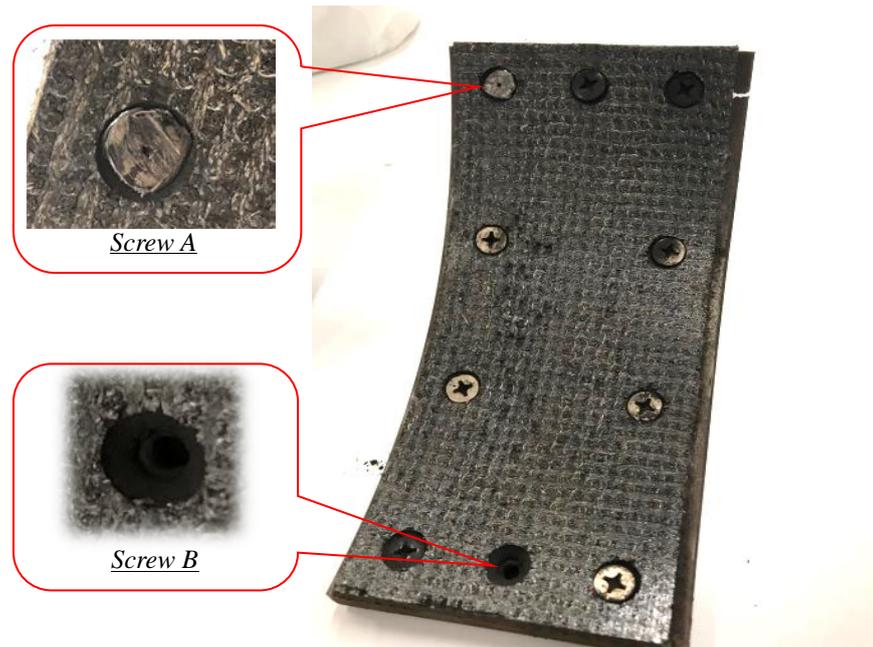
- a) On the left brake lining of the Incident Lift, there should be ten stainless steel screws for fixing the lining to the brake pad, with the head of one screw being seriously worn out (Screw A), and one screw was lost (Screw B) (Figure 10). However, on the right brake lining, all the ten stainless steel screws mounting the brake lining on the brake pad were intact (Figure 11). It was observed from the cross section of a non worn-out screw in the left brake pad (Figure 12) that the head of worn-out Screw A as shown in Figure 10 should have been worn out by around 3 mm.

*Figure 10: Left brake lining - Head of Screw A was seriously worn out while Screw B was lost*

6.3 The rubbing of brake lining against the brake drum and the vibration so generated at the left brake pad loosened the fixing screws of the brake linings, thereby leading to the loss of one of the fixing screws (i.e. Screw B), while the other one (i.e. Screw A) was protruded out of the lining and scratched with the brake drum surface. The protruded screw reduced the contact surface area between the brake lining and brake drum, thereby further reducing the braking force of the brake to stop the lift (Figure 21). As a result, there was insufficient braking force to hold the lift system when the lift

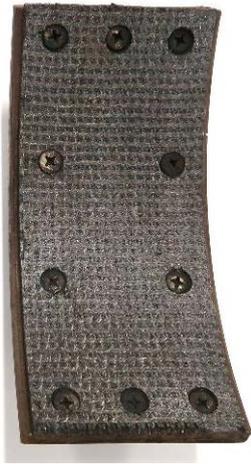
Figure 11: Right brake lining with all 10 mounting screws

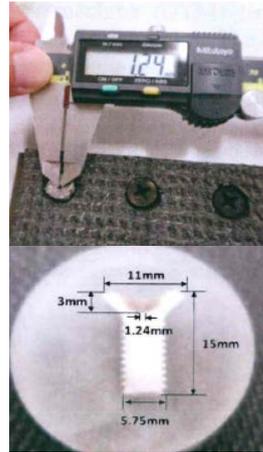
Figure 12: Cross section of a non-worn out screw

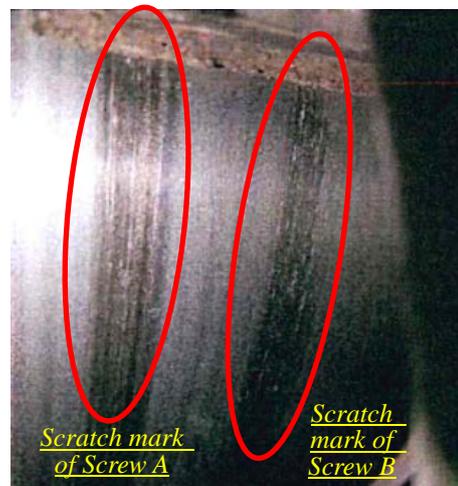
- b) Two different scratch marks were observed at the brake drum (Figure 13). The scratch marks match well with the installation positions of Screw A and Screw B at the left brake lining as mentioned in paragraph 5.2(a) above. It was believed that screw head A had been scratched with the brake drum for certain time so that it had been severely worn out. The scratch marks on the drum matching with Screw B also showed that such scratching had happened between Screw B and the drum.

Figure 13: Scratch marks observed at the corresponding locations of Screw A and Screw B on the brake drum

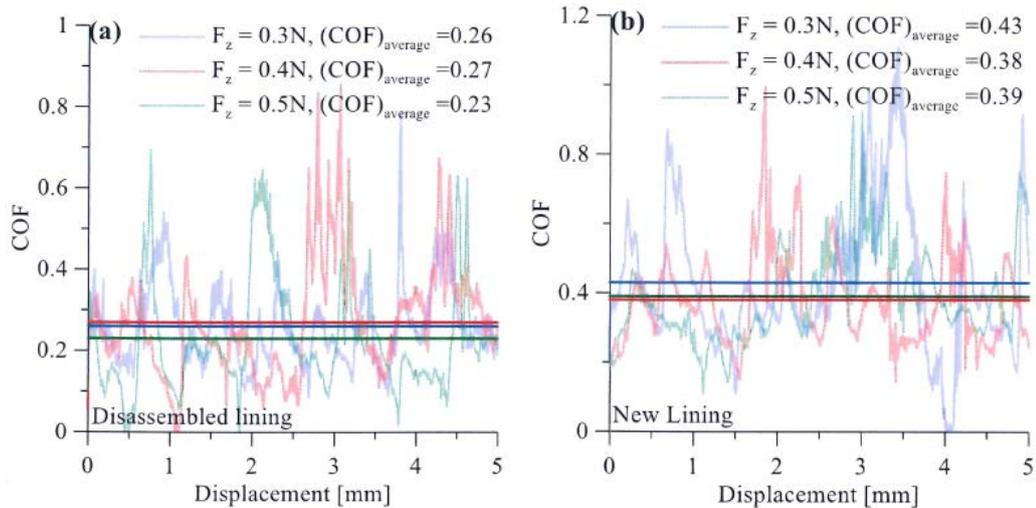
- c) A tribological test on the brake linings of the Incident Lift and new brake linings made of the same materials as those of the Incident Lift was performed. It was found that the coefficient of friction (COF) of the incident brake lining was lower than that of the new one. Figure 14 shows the results of the experiments.

*Figure 14: Results of the experiments for the incident brake lining (left) and the new brake lining (right)*

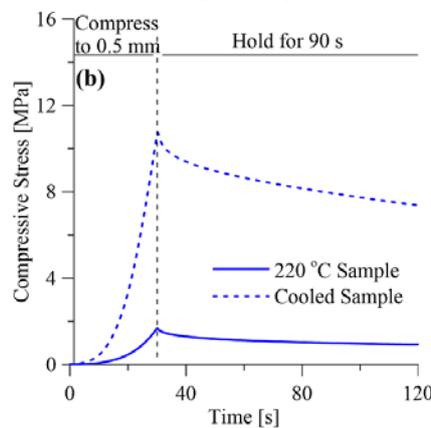
- d) A compression test on the new brake lining made of the same materials as the brake linings of the Incident Lift was performed. It was revealed that the vertical force applied to the brake lining surfaces to maintain a constant compression (0.5mm) dropped significantly under high brake lining temperature (around 220°C) compared with normal room temperature (Figure 15). It implies that the braking force of the brake linings would be reduced significantly under high temperature (around 220°C).

*Figure 15: Compression test results for new brake lining under 220°C brake lining temperature and being cooled down to room temperature condition.*

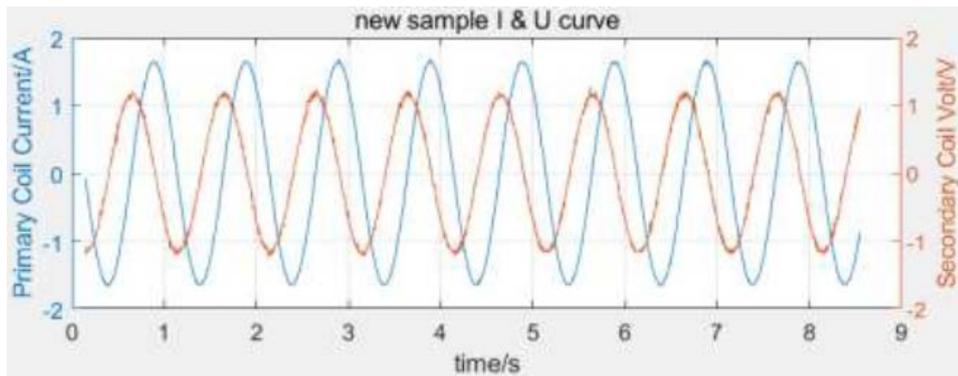
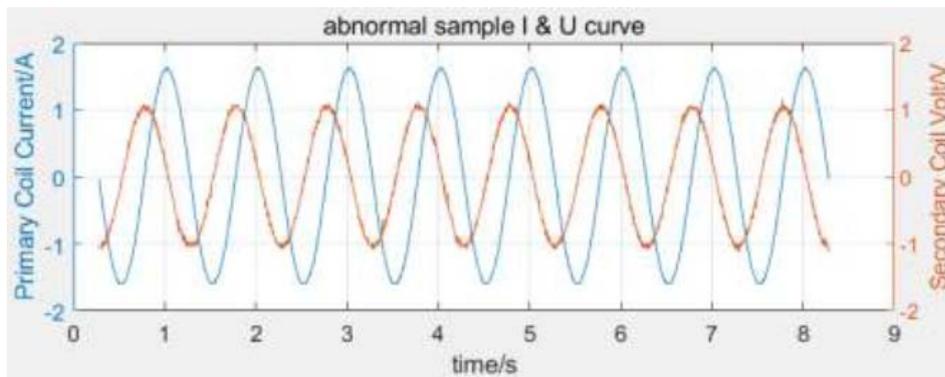
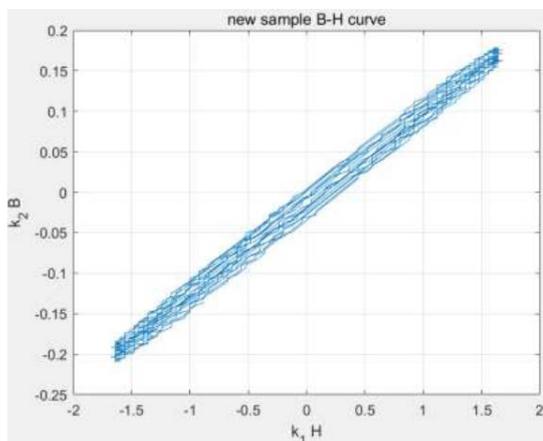
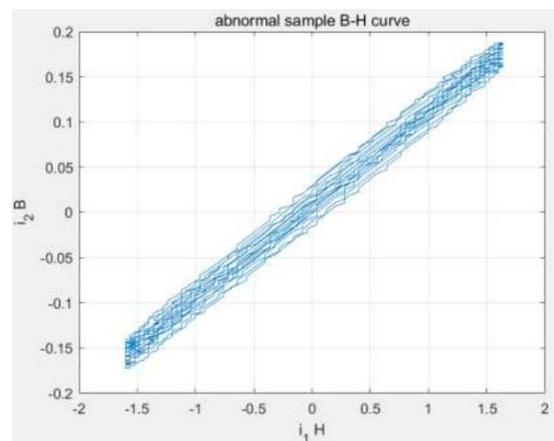
- a) A hysteresis loop test on the brake plungers was performed to check if there was any magnetic saturation problem which could lead to abnormal operation of the plungers. The test was conducted on both new brake coil and plunger, as well as the brake coil and plunger of the Incident Lift. Results of the experiments showed that no magnetic saturation was observed for the brake plunger of the Incident Lift.

Figure 16: Relationship between primary coil current and secondary coil voltage with 90 degree phase difference for new brake coil and plunger

Figure 17: Relationship between primary coil current and secondary coil voltage with 90 degree phase difference for brake coil and plunger of the Incident Lift

Figure 18: B-H curve for new brake coil and plunger

Figure 19: B-H curve for brake coil and plunger of the Incident Lift

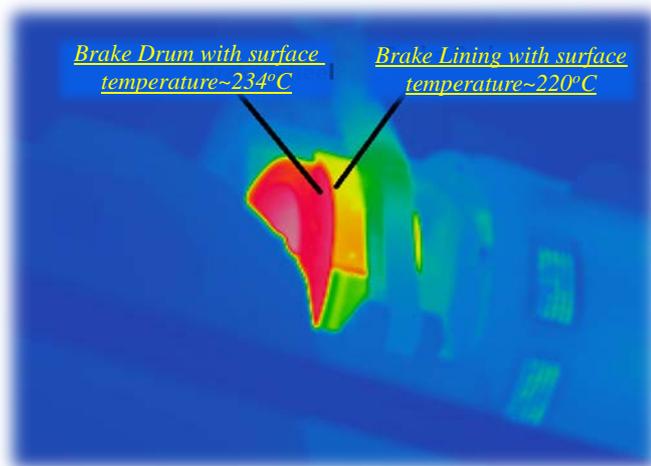
*Figure 20: Overheating of Brake Pad*

of the brake linings (Figure 20). When the brake linings were overheated, their braking force would be significantly reduced according to the above laboratory tests carried out by the mechanical engineering expert.

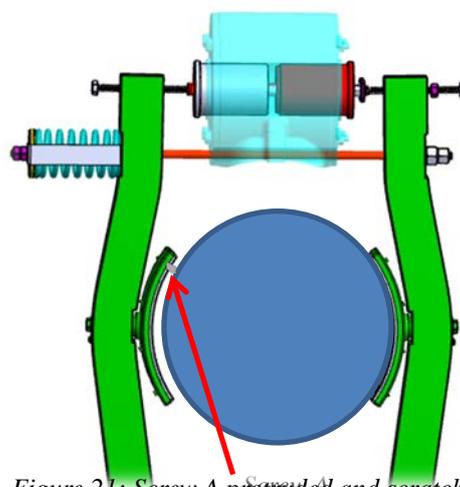
*Figure 21: Screw A protruded and scratched with the brake drum surface. The reduced contact surface between the brake lining and brake drum further reduced the braking force.*

6.4 Four unintended car movements of the Incident Lift were observed from the CCTV footage prior to the incident, during which the loosened and protruded screw head had been ground and scratched with the rotating brake drum during these occasions as well. During the incident, the loosened and protruded screw head became flushed with the brake lining after continuous grinding with the brake drum, so that eventually the left brake pad was able to press on the brake drum to stop the lift.
