Technical Investigation Report of Lift Incident
in Tsui Lai Garden, Sheung Shui on 11 September

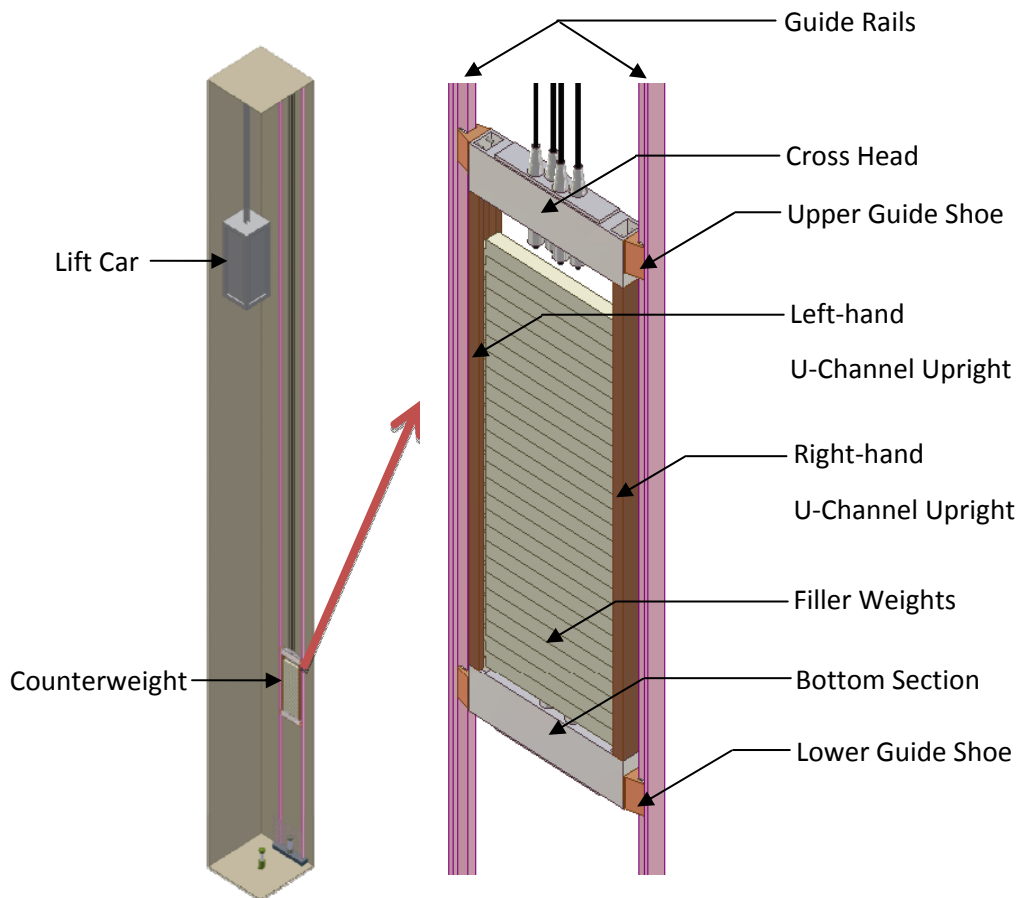
Figure 1 – The layout of the Counterweight

4. The incident was caused by detachment of the lift counterweight components of lift no. 11, resulting in one passenger being trapped inside the lift car.
5. The lift and its counterweight were driven by an electric motor in a 1:1 ratio roping system with 4 suspension ropes. The counterweight frame was constructed with structural steel members including a cross head, 2 U-channel uprights and a bottom section. The steel members were joined by welding. Filler weights were mounted inside the frame. The counterweight frame was

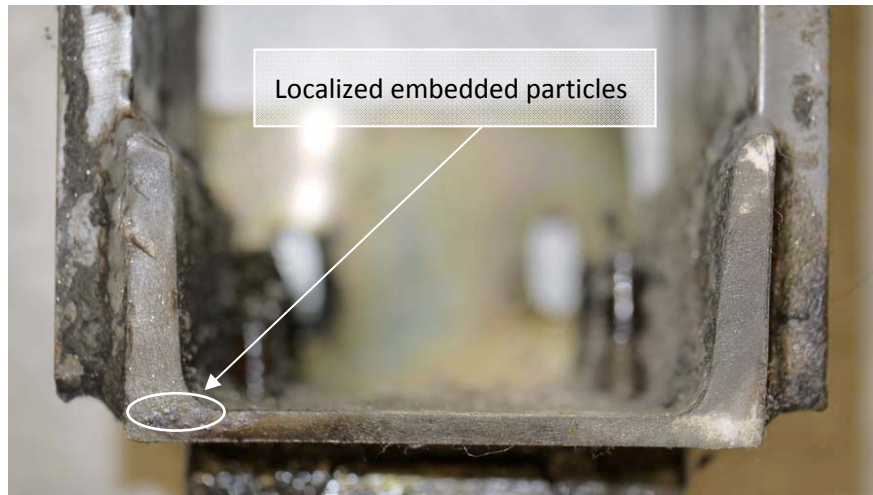
9. The examination and test results revealed that the material specifications and mechanical properties of the counterweight frame were in compliance with manufacturer's technical specifications, i.e. the material specifications of steel SB41A and ultimate tensile stress of 510 MPa. However, localised embedded particles of Manganese (Mn) and Silicon (Si), which were formed during manufacturing, were found in the left-hand U-channel upright's fracture surface. This latent defect led to material strength reduction in some local spots which caused the fatigue failure in the left-hand U-channel upright of the counterweight frame. The fracture surface of the left-hand U-channel upright was shown in Figure 2.

Figure 2 – Fracture surface of the left-hand U-channel upright

10. Mn and Si were normally present in the production of structural steel for certain purposes. Mn could enhance the strength of the steel and Si was one of the principal deoxidizers. There are stringent quality control measures including third party certification in steel production and localized concentrations of particles containing Mn and Si are rarely present in structural steel. No such failure in counterweight steel frame has been reported before in Hong Kong or overseas. The incident in Tsui Lai Garden was an extremely rare one.

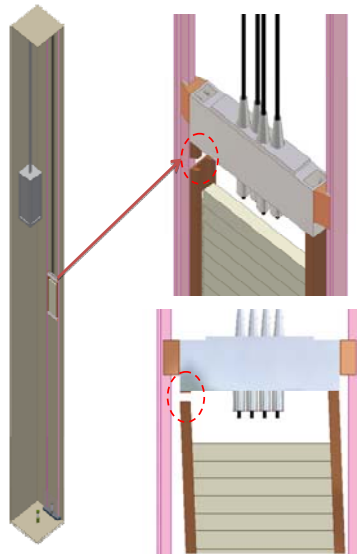
12. Based on the findings of the investigation, it was likely that the left-hand U-channel upright of the counterweight frame fractured first due to latent defect in the material. This fracture reduced the rigidity of the frame and subsequently the lower part of the frame started to tilt downwards and sideways (See Figure 3). The bottom of the counterweight frame then started to derail from its guide rails.

Figure 3 – Left-hand U-channel upright with latent defect fractured first

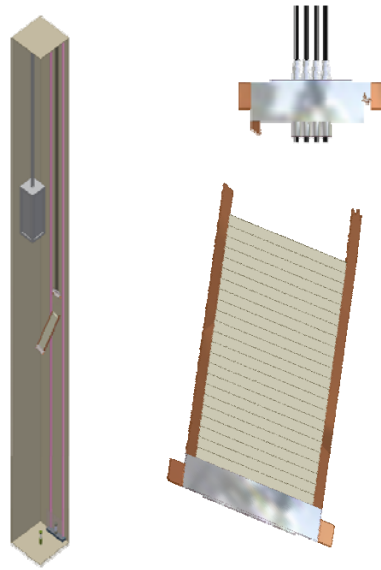
13. The top right-hand U-channel upright derailed and shifted towards the back of the lift shaft when the counterweight frame reached at 12th floor level. The bottom right side of the counterweight frame then pulled the right side guide rail and a supporting bracket of the guide rail away from the wall. This caused a section of the right side counterweight guide rail deformed outward and one supporting bracket of the guide rail was pulled out. As a result, the right-hand U-channel upright of the counterweight fractured under excessive load. The counterweight frame uprights with its bottom section and the filler weights were then detached from the cross head of the frame and fell down to the lift pit (see Figure 4).

Figure 4 – Right-hand U-channel upright then fractured due to excessive load

14. Sigma confirmed that there was a total of 23 lifts in Hong Kong, which were manufactured from the same batch of materials as those in the counterweight frame at Lift No. 11 in Tsui Lai Garden. Non-destructive tests to reveal surface and internal material imperfections including magnetic particle inspection and ultrasonic test were conducted on all these 23 lifts' counterweight frames. No similar defect was found in all these counterweight frames.
15. Sigma agreed to replace the counterweight frames of the 23 lifts by the end of December this year to enhance user's confidence in their lifts. EMSD will closely monitor the counterweight replacement work.
16. EMSD has reviewed and agreed with the trade to implement new measures during regular inspection of the counterweight frame with a view to enhancing safe operation of the counterweight.
