Technical Investigation Report on
Lift Incident at Waterside Plaza,
Tsuen Wan, New Territories

Date of Incident: 8 April 2018

Date of Issue: 14 July 2018

Technical Investigation Report on Lift Incident at Block 2, Waterside Plaza, Tsuen Wan, New Territories on 8 April 2018

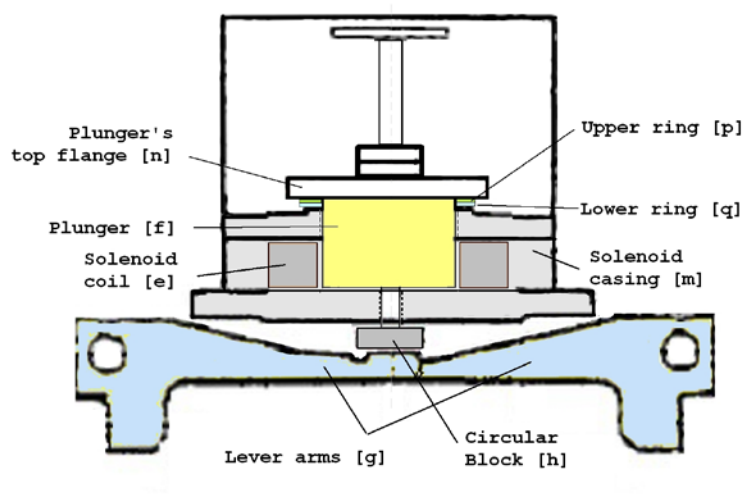
Figure 4 – Detailed view of Brake Solenoid [a]

5.2 Two spacer rings [p and q] (See Figures 4 - 6) between the plunger's top flange [n] and the brake solenoid casing [m] were found broken and heavily deformed.

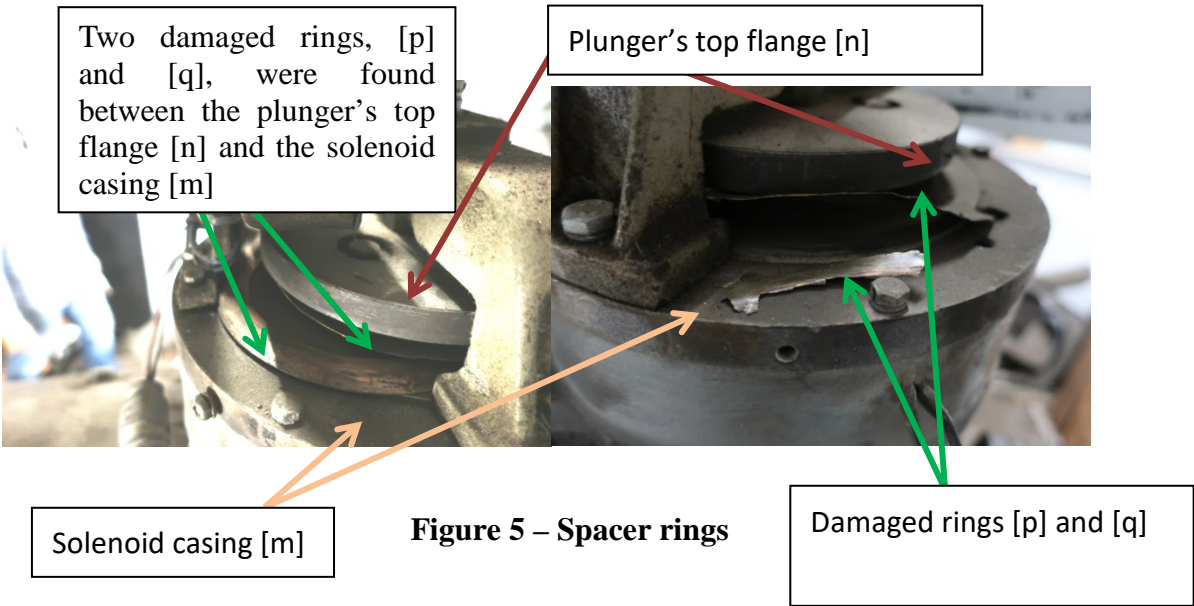
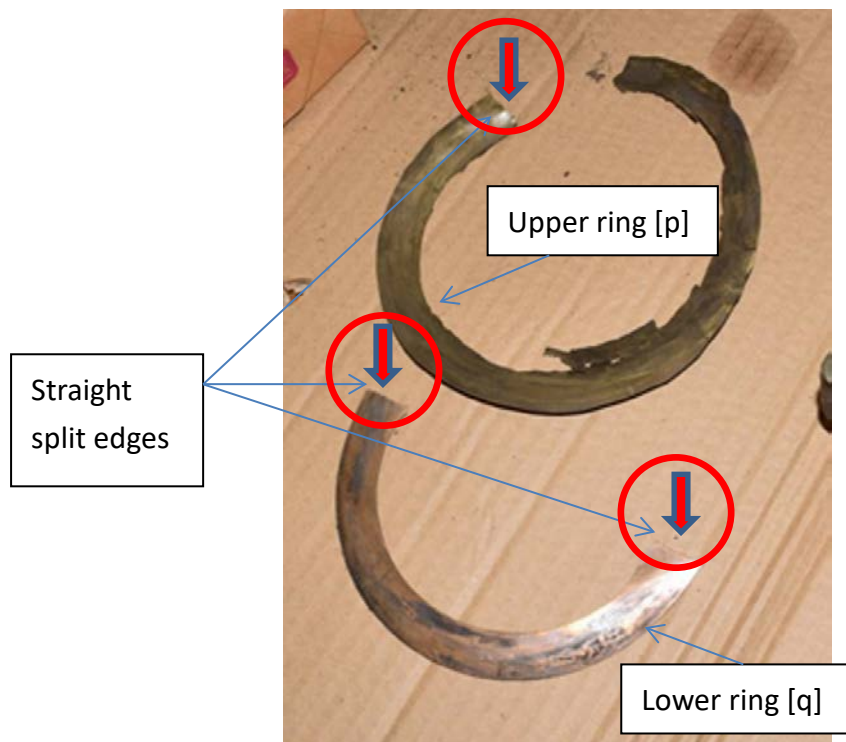
Figure 5 – Spacer rings

5.5 The spacer rings [p and q] between the plunger [f] and the solenoid casing [m] were found damaged. In the laboratory analysis, the upper ring [p], which sustained more severe hammering/stamping damage due to the plunger's top flange [n] hitting the ring [p] and the plunger [f] dragging the edges, suffered thinning and some of its edges were cut into strips. The ring was also split open at one position.

5.6 The lower ring [q] was split open and only half was found remaining between the plunger [f] and the solenoid casing [m]. This ring sustained less severe stamping damage.

6.3 The upper spacer ring [p] was damaged by repeated hammering/stamping, which generated metal strips and debris that jammed the brake plunger[f] at the time of the incident.

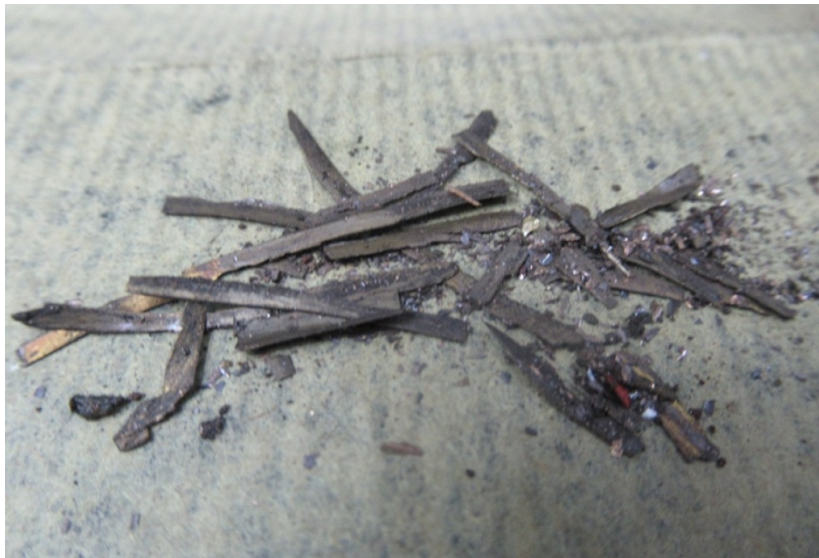
Figure 7 - Metal debris

5.7 Upon removal of the plunger [f], metal debris was found trapped inside the solenoid casing [m] (Figure 7). The debris was of similar composition as the upper spacer ring [p].

6.2 The cause of malfunction of the brake system was the trapping of metal debris from the damaged upper spacer ring [p] that eventually jammed the movement of the plunger[f], preventing the mechanical brake from engaging at the time of the incident.

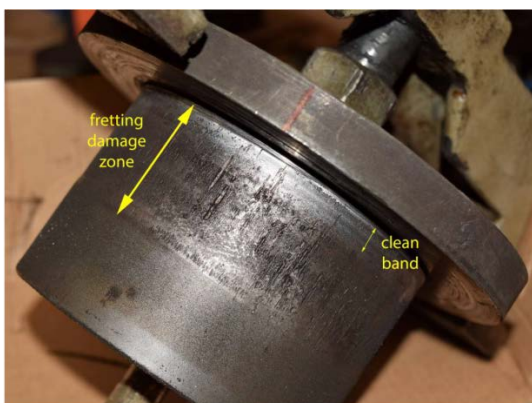
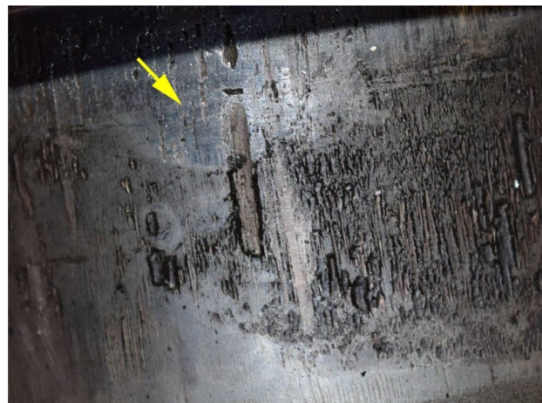
Figure 8 - Plunger surface

5.8 Damage and scratches were found on the plunger [f] surface (Figures 8 and 9). There were also scratches on the plunger's [f] axle rod (Figure 10) and the bush was worn down unevenly (Figure 11). The damages and wearing are believed to be caused by the metal debris being jammed in the solenoid casing [m] along the travel of the plunger [f].

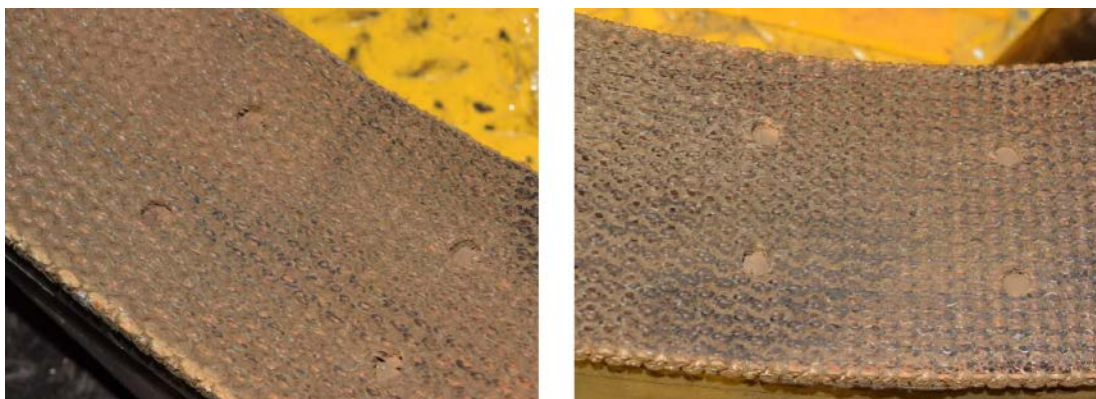
Figure 12 – Lining surface of the brake pads

5.9 The brake pads [d] were in good condition and had no signs of overheating. No obvious scratch marks or abnormal wear patterns were found on the lining surfaces (Figure 12).
