A Greener Future – Safe, Reliable and Clean Electricity Generation

Natural Gas Facilities in Lamma Power Station

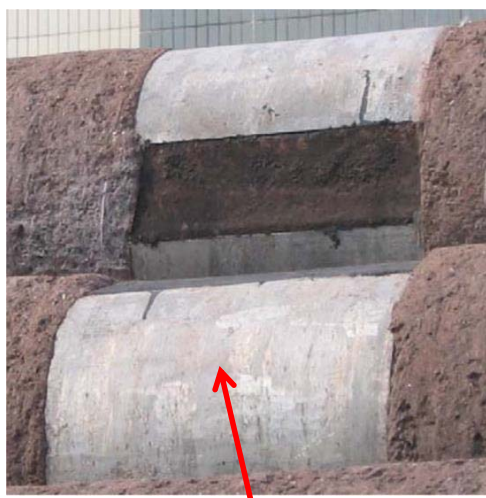
Aluminium Bracelet Anode

● Application of Anodic Protection on Pipeline

- Total number: 1,534
- Installed at every 5 pipe joint length (around 61 m) interval

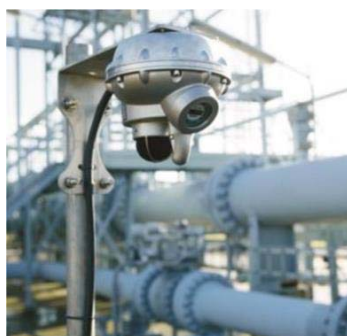
Open-Path Gas Detector

- Modifications

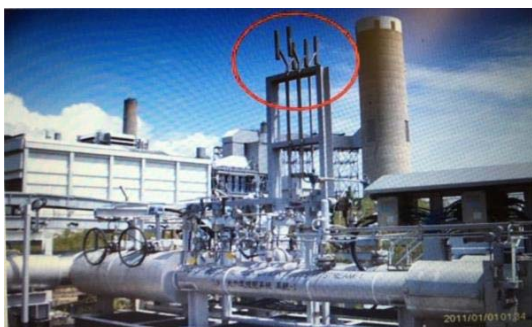
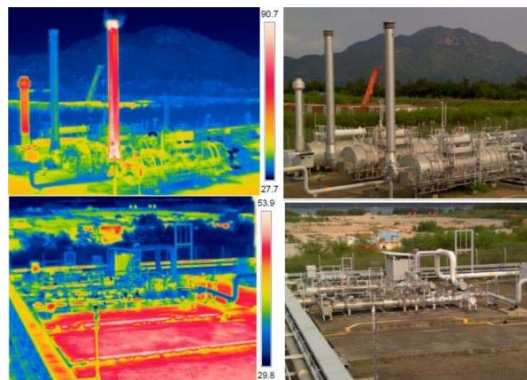
Vent pipe for pilot valve

- Modifications

Infra-red imaging

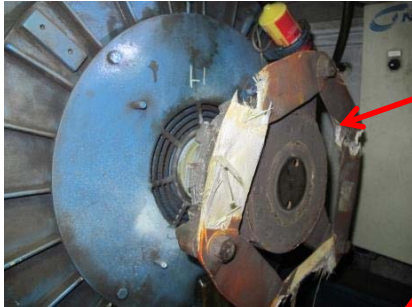
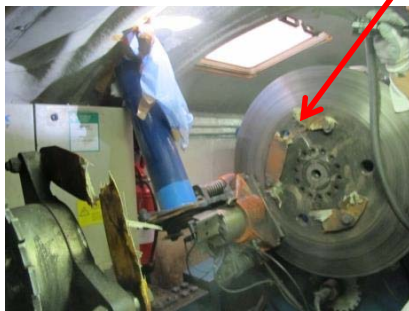
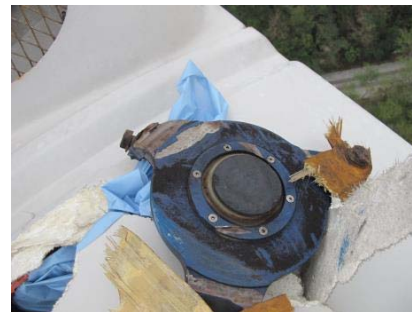
Broken Coupling Discs

- Damage and Detachment of Coupling Discs and Associated Connecting Shaft

Detached Coupling Shaft

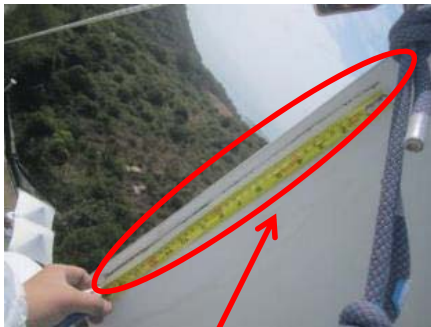
Cracks on blades

- Cracks and wear found at blade tips

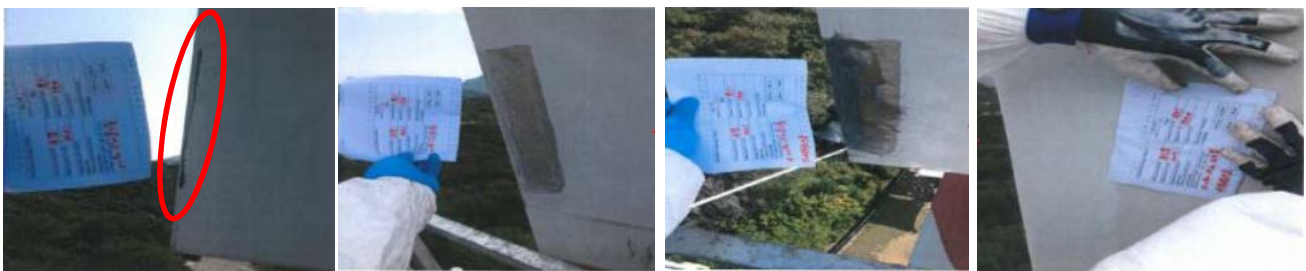
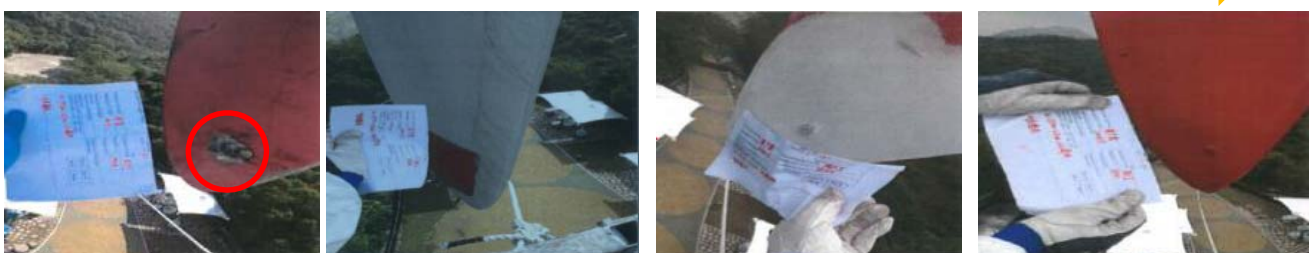
Blade Refurbishment

- Refurbishment of Blade Cracks and Blade Tips

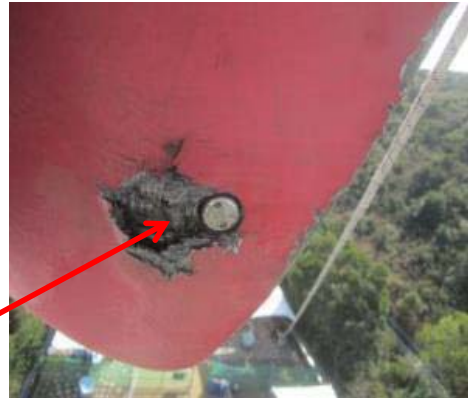
*Damage of Blade tips
around Lightning Receptor*

- Damage of Blade tips around Lightning Receptor due to severe Lightning Strike

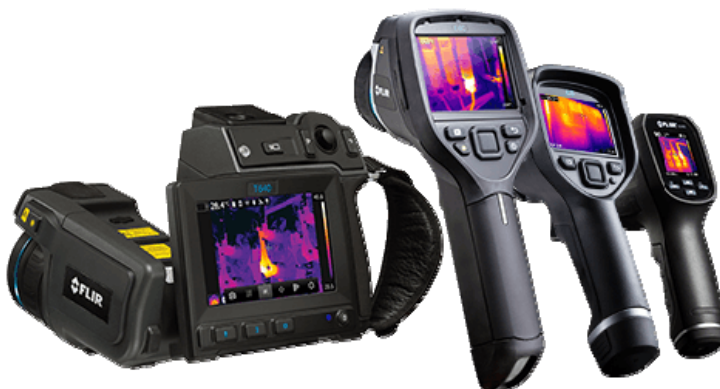
- Thermal-Image Scanning
 - Using infrared (IR) camera
 - Able to find out abnormal hot spots

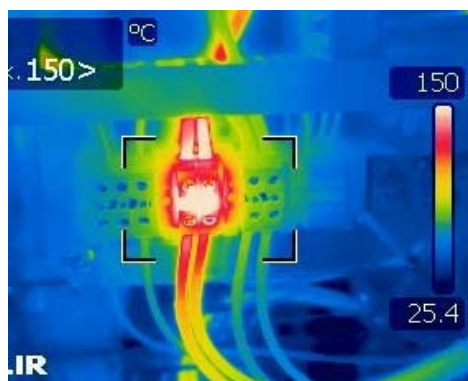
- Usage of Infrared Camera
 - Hot Spot at Terminals of PV Combiner Box

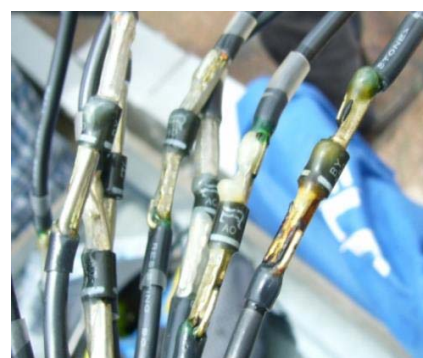
- Usage of Infrared Camera
 - Hot Spot on Blocking Diodes in Combiner Boxes

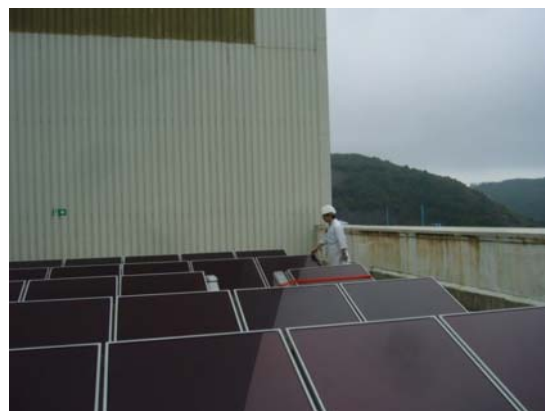
- Loosened screw due to vibration under strong wind
- Frame of module detached under strong wind

- Replaced damaged modules
- Applied reinforced installation method

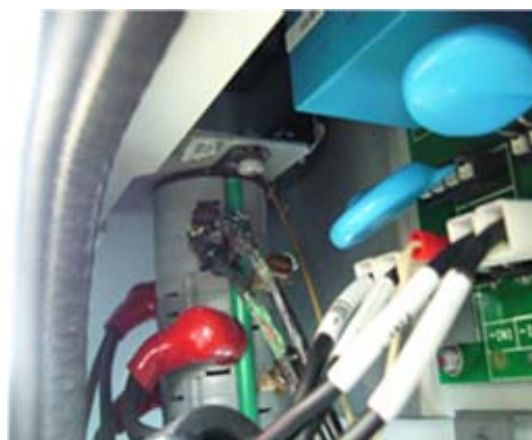
- Inverter Switch fault
- Bad contact at switch terminal

- Inverter replaced
- Screws at switch terminal tightened and checked

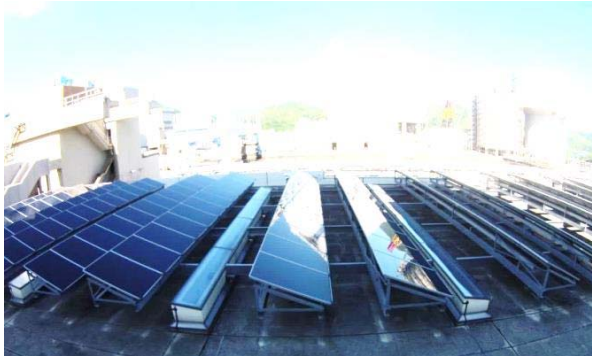
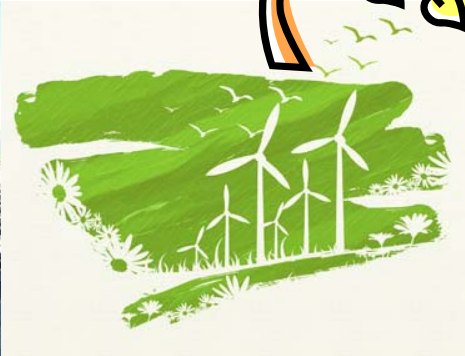
All panels are set to face south and are inclined at 22 degrees

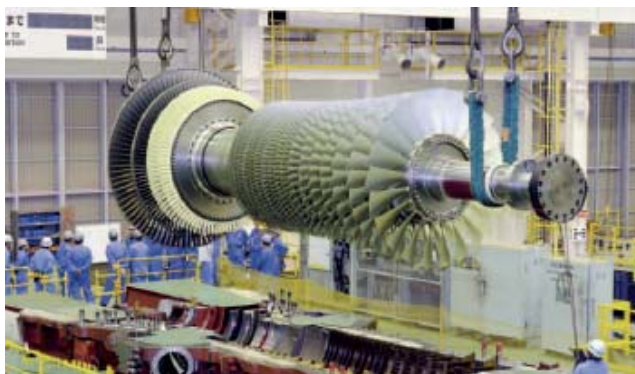
- Meet stringent new emission limits
- Equipped with
 - Selective Catalytic Reduction (SCR) system
 - Dry Low NOx combustion system
