Installation of a gear box onto the anemometer mast of the water buoy has enhanced safety for maintenance staff and air traffic.

## 提升員工和飛機乘客 **安全** Safety for Staff and Air Passengers

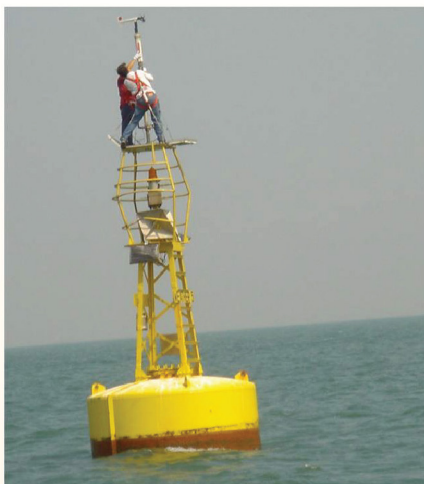
(安裝前) 在風速計支柱安裝齒輪箱前，高空作業為維修工作帶來潛在危險。

(Before installation) Maintenance work before installing the gear box on the anemometer mast posed potential hazards of working at height.

然而，攀爬維修籠至浮標頂部進行維修工作，容易對高空作業的工作人員帶來人體下墮的潛在危險。我們得到天文台和客戶部門海事處的准許，主動重新審視風速計支柱的設計，安裝一組密封式金屬齒輪箱，這樣，豎立在浮標頂部的風向及風速監察裝置便可輕易降下，工作人員便不需攀爬維修籠進行維修工作。新的設計既提升了工作安全，又不影響浮標的堅固性和穩定性。

However, climbing over the maintenance cage of the weather buoy and up to the anemometer mast to carry out

maintenance work for the wind sensor poses potential hazards of working at height for staff. With consent from HKO, the client department, and owner of the buoy, the Marine Department (MD), we took the initiative to re-design the anemometer mast by installing a gear box onto it so that the mast of anemometer erected on top of weather buoy could be lowered down and our staff were no longer required to climb up the cage for maintenance work. The new design has enhanced work safety without compromising the robustness and stability of the buoys.

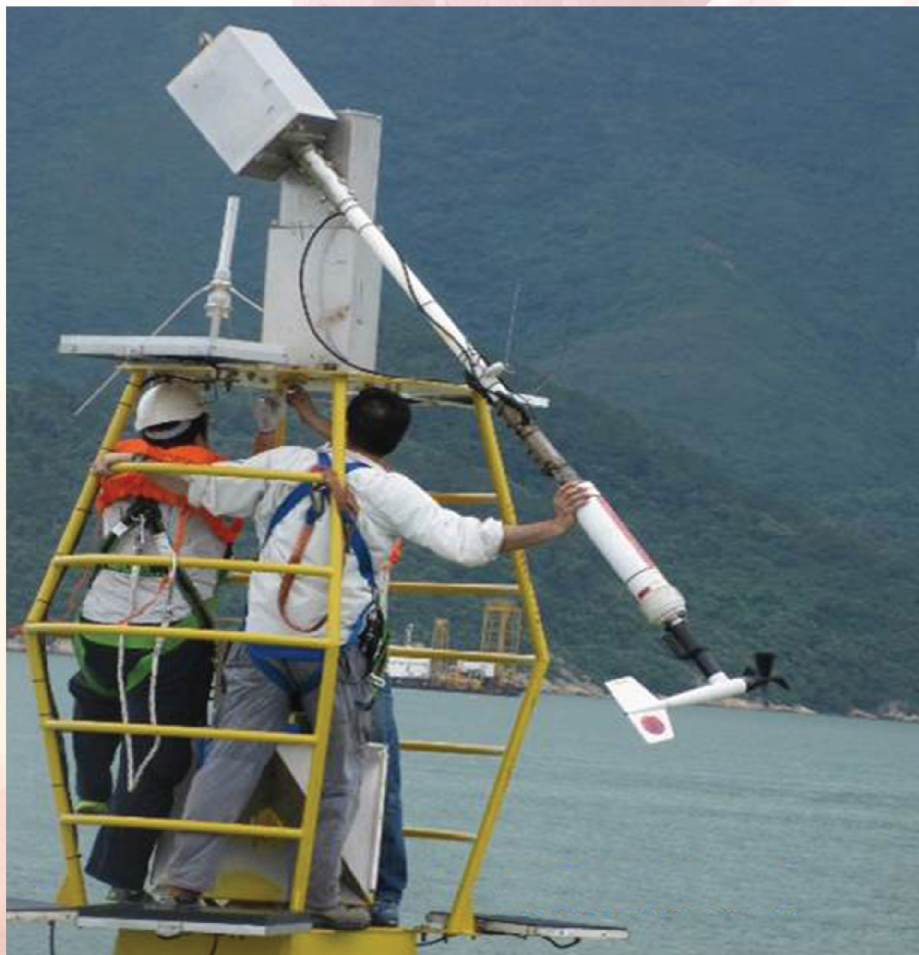
(安裝後) 改善風速計支柱設計後，維修工作更安全。

(After installation) Maintenance work after fixing the anemometer mast in the cage is much safer.
