新科技去除油煙

New Technology to Remove Oily Fumes and Grease

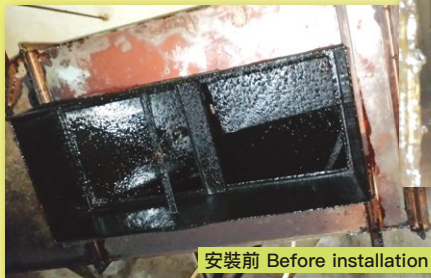
安裝前 Before installation

由於熟食中心長時間運作，使用水濺機或靜電除油煙器的傳統方法未能全面防止油脂在排氣管道內迅速積聚。我們為客戶安裝的排煙系統，乃科技的一大突破，通過應用紫外光(短波UV-C)結合臭氧的技術，再配合排氣管道的特別設計，能有效地將油煙內的油分子快速分解。同時，紫外光與臭氧能將油分子化成水、氧氣、二氧化碳和聚合油脂，這些非黏性物質能有效防止油脂積聚在管道內壁上。

Due to the long operating hours of cooked food centres, the conventional method of using water scrubbers or electrostatic precipitators to treat oily fumes can no longer prevent the rapid build-up of grease inside the exhaust ductwork. The new exhaust system we installed for the client is a technology breakthrough, which combines the technologies of UV light (short wave UV-C) and ozone. Coupled with the special design of the exhaust ductwork, the grease molecules of oily fumes can be effectively decomposed. Moreover, the UV light and ozone can further break down the grease molecules into water, oxygen, carbon dioxide and polymerised grease. These non-sticky substances can effectively prevent accumulation of grease on the inner walls of the exhaust ductwork.

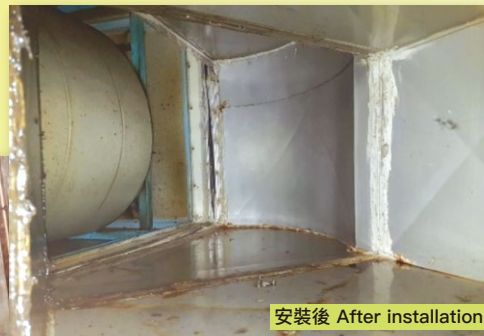
安裝後 After installation

安裝配備紫外光C及臭氧除油煙設備的排煙系統六個月後，排氣管道內壁沒有明顯的油脂積聚，效果顯著。Six months after installation of the exhaust system equipped with UV-C and ozone technologies, there was no obvious grease accumulation on the inner walls of the exhaust ductwork, showing a remarkable effect.
