Technical Investigation Report on Lift Incident
at 478-480 King's Road, North Point, Hong Kong

Electrical and Mechanical Services Department
July 2013

**Technical Investigation Report on Lift Incident
at 478-480 King's Road, North Point, Hong Kong on 2 March 2013**

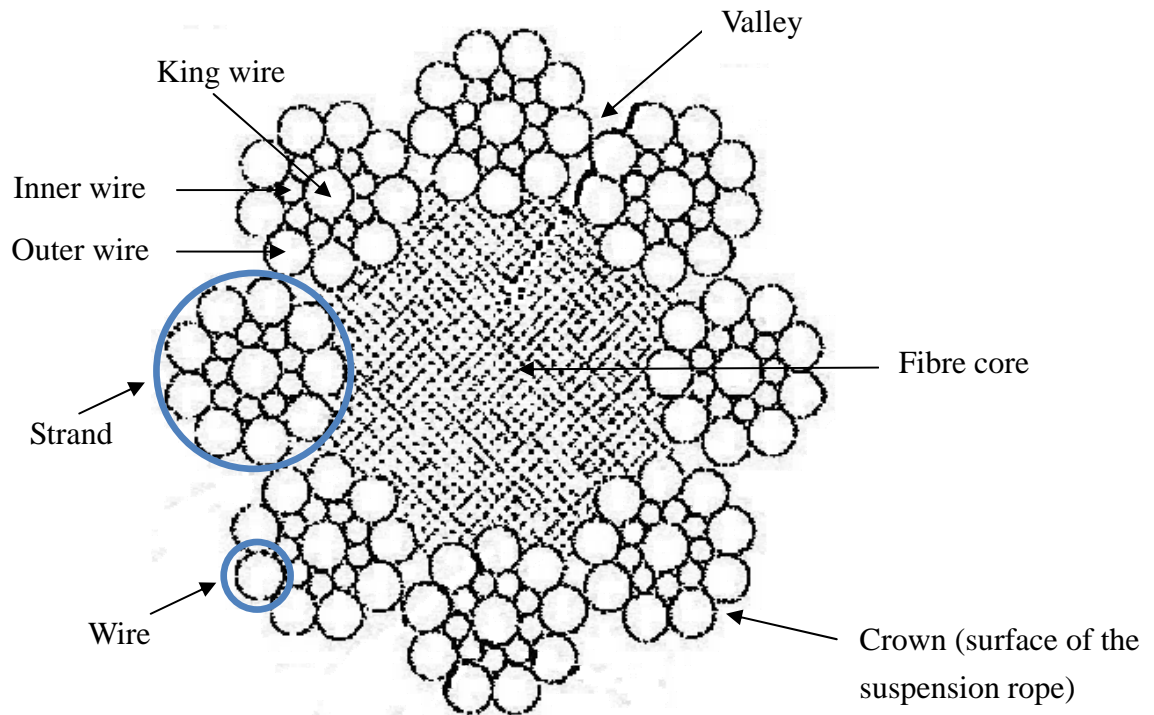
Figure 3 : Sectional view of a wire rope

6.9 The four suspension ropes were found broken at about the same position (i.e. near to the diverting pulleys). Visible wear and red iron oxide particles (also known as rouge) could be observed from the suspension ropes, in particular at sections close to the breakage points. Figure 3 shows the sectional view of a typical suspension rope of a lift.

6.10 At the very ends of failed strands in all ropes, only king wires and inner wires were found. The fibre cores and the outer wires were completely missing (refer to Figure 3a). Adjacent to the failed ends, the strands of the ropes opened up after failure. Detailed examination revealed that the fibre cores of the ropes could not be found in the suspension ropes until at some distance from the failed ends. It was suspected that movement of the wires had already cut the fibre cores into small pieces, which had escaped from the ropes when they broke (refer to Figure 3b). Besides, notches formed on the outer wires of the strands were observed and these indicated that abrasion had occurred between strands of the ropes (refer to Figure 3c).

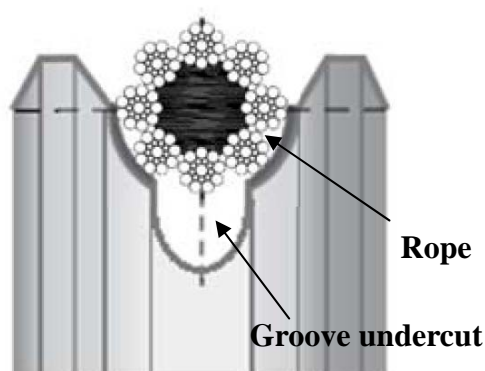
Figure 5 : Undercut of sheave groove

6.12 The grooves of the traction sheave were examined. According to the design, an undercut is made to each groove so that the pressure between the suspension rope and the groove would be increased (see Figure 5). This feature helps to increase the friction between the ropes and the sheave to provide the traction required for effective operation of the lift.

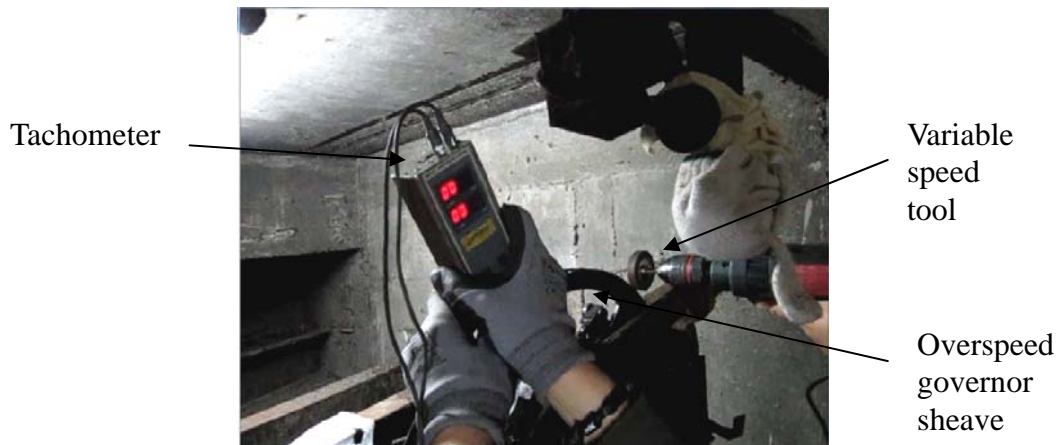
6.23 Another test was conducted to verify if the activation speed of the overspeed governor was correctly set. The test was conducted by driving the overspeed governor sheave with a variable speed tool when the governor rope was detached from the governor sheave. (see also Figure 9) Test results showed that the activation speeds (1.3 m/s for activating the electrical switch and 1.4 m/s for activating the safety gears) were in line with the speeds shown on the data plate of the overspeed governor and were in compliance with the requirements specified in the Code of Practice on the Design and Construction of Lifts and Escalators issued by the Electrical and Mechanical Services Department.

Figure 9 : Governor activation speed test arrangement – governor sheave being driven by a variable speed tool

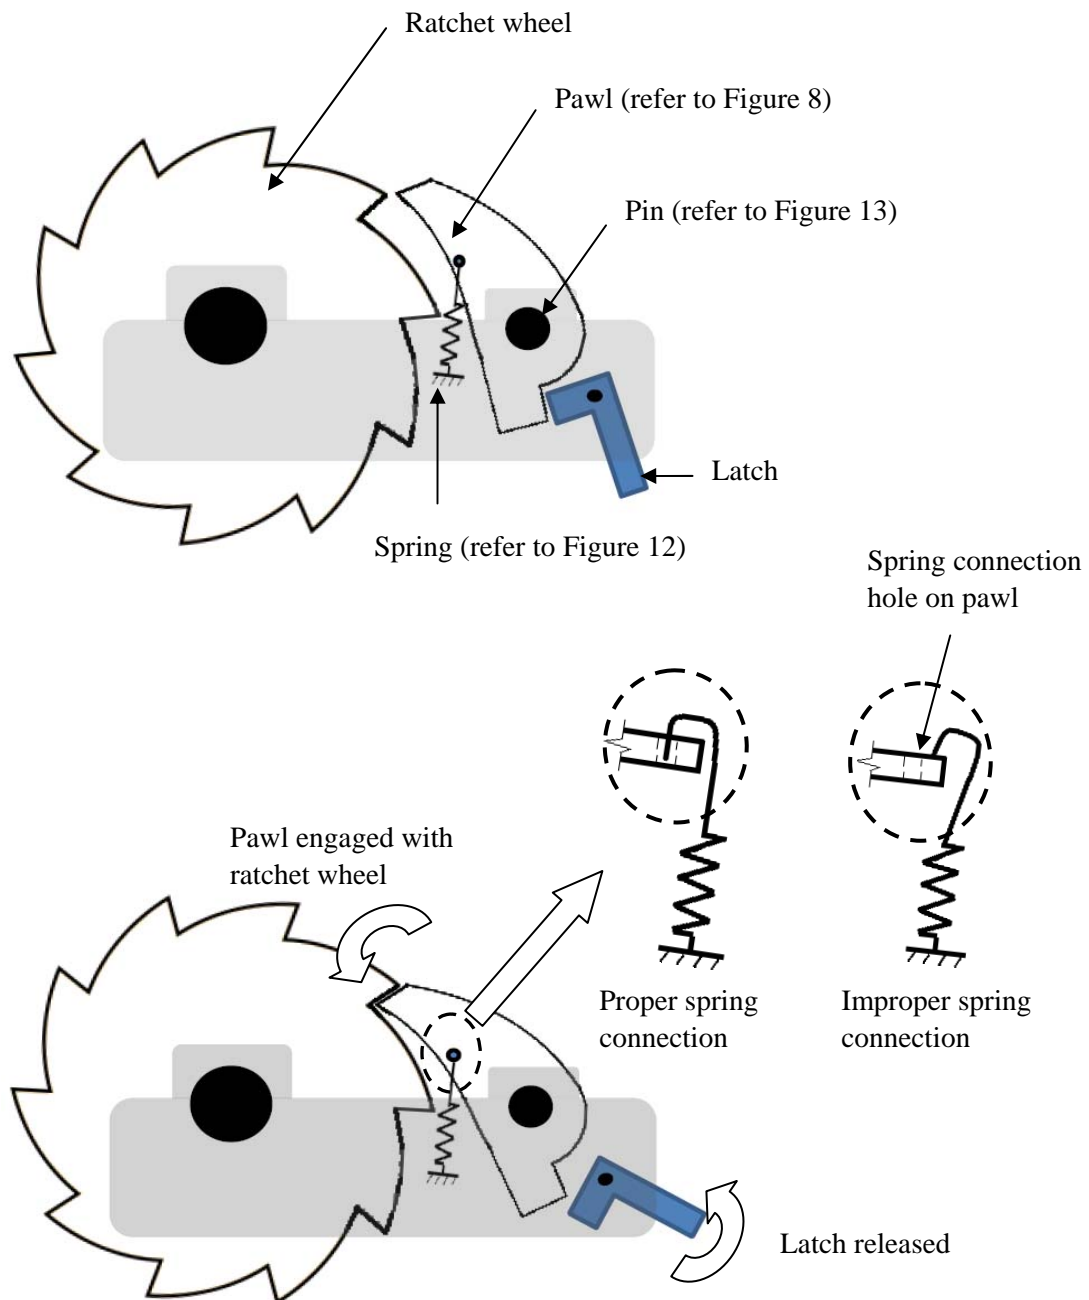
6.26 The pawl of the overspeed governor was spring-loaded to ensure its engagement with the ratchet wheel when the latch was released. The operation of the pawl and ratchet wheel is shown in Figure 11. It was found that the tension spring of the pawl was not properly connected to the pawl and the connection end of the spring was deformed (see Figure 12).

Figure 11 : Diagrams showing the operation of the pawl and ratchet wheel of the overspeed governor. The lower diagram shows the latch released and the pawl engaged with the ratchet wheel.
