2007 年 6 月 11 日

昂坪纜車
車廂墜下事故

專家委員會報告

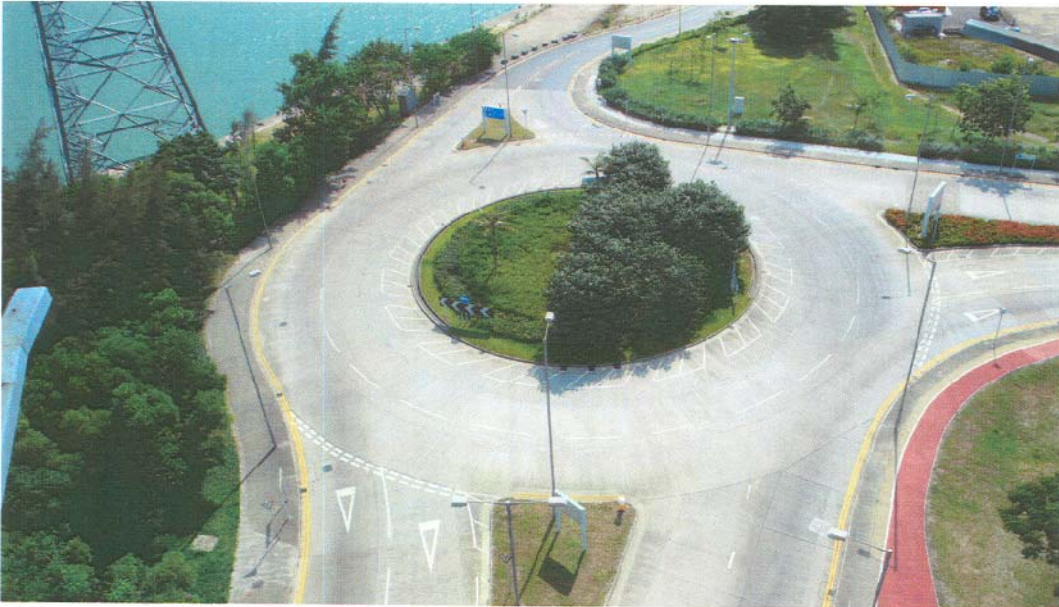
圖 2－ 2B 號塔範圍環境

2. 當時車廂內並無乘客，墜落地點為 2B 號塔旁的草叢。事故並無導致人命傷亡及財產損失。

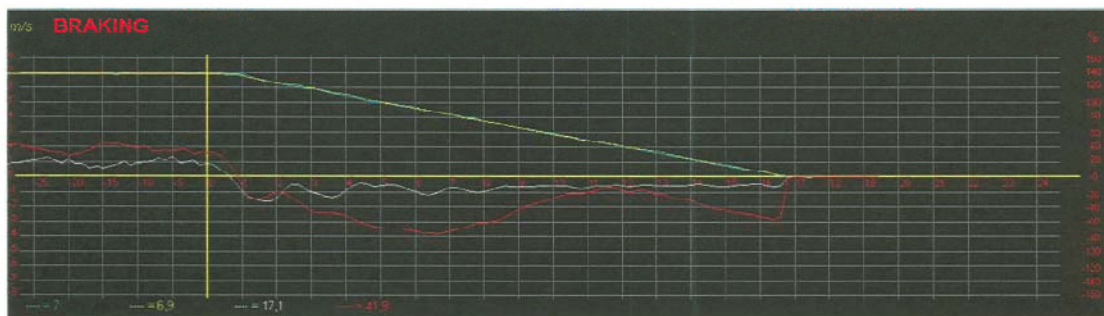
- The first three tests of 11. 6. 07 – brake test No. 1 (7:21 pm), brake test No. 2 (7:25 pm) and brake test No. 3 (7:29 pm) – (diagrams 1, 2 and 3) produced almost identical results as the equivalent tests of 16. 5. 06.

Diagram 1: Electrical braking by motor with "Stop" (brake test No. 1, 11. 6. 07)

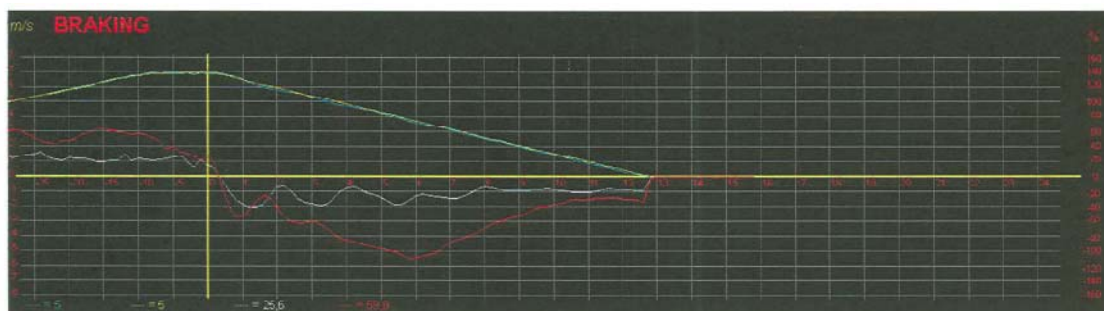
Diagram 2: Electrical braking by motor with "Fast Stop" (brake test No. 2, 11. 6. 07)

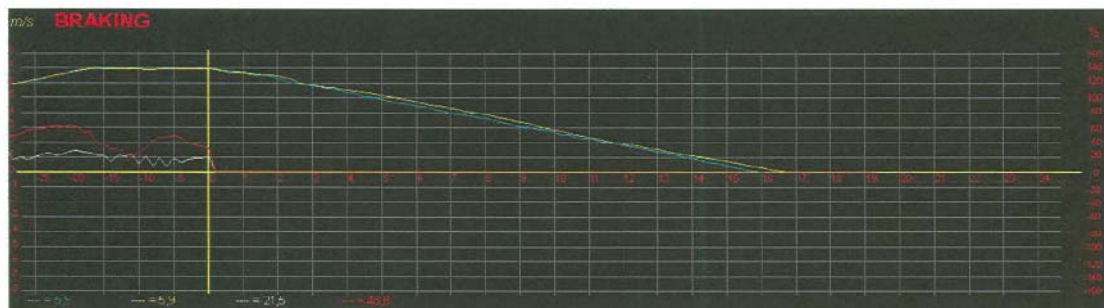
Diagram 3: Mechanical braking by service brake, controlled, normal deceleration (brake test No. 3, 11. 6. 07)

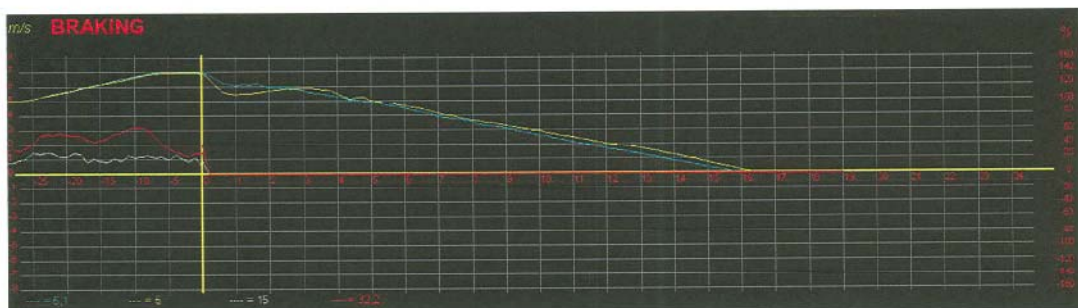
- In O+M Manual only service brake test No. 3 (7:29 pm) is required for the annual brake tests.
- Brake test No. 4 of commissioning on 16. 5. 06 was not performed on 11. 6. 07.
- At 7:36 pm an attempt was made to perform an uncontrolled service brake stop according to brake test No. 5 of commissioning (mechanical braking with service brake, uncontrolled, normal deceleration). The maintenance technician pressed four pushbuttons on the test console (Fig. 1) for an uncontrolled stop of all service brakes, but only for approximately 0.5 s – the switching cubicle had to be opened for that purpose. Therefore the initial uncontrolled braking with approximately 2.5 m/s^2 was followed by a controlled stop with linear deceleration as in brake test No. 3 (7:29 pm), with an average of approximately $a = 0.4 \text{ m/s}^2$ (see No. 5B.1 in Table 1, diagram 4).

Diagram 4: Mechanical braking by service brake, uncontrolled (four pushbuttons) for approximately 0.5 s, afterwards controlled, normal deceleration (brake test No. 5B.1)

- Because of the low deceleration rate ($0,45 \text{ m/s}^2$) of brake test No. 5B.1 (7:36 pm) this test was judged as invalid. Obviously nobody took care of the difference between the braking diagrams of brake test No. 3 (7:29 pm) and brake test No. 5B.1 (7:36 pm) with its high deceleration rate of approximately 2.5 m/s^2 at the beginning of the braking (see diagram 4).
- At 7:39 pm brake test No. 5B.1 was repeated but with pressing the four pushbuttons pressed during the whole braking time. This resulted in the sharpest possible braking with a braking time of approximately 5 s. The initial deceleration was 2.5 m/s^2 , at the end of braking it was still 1.0 m/s^2 and on average approximately 1.5 m/s^2 (see Nr. 5B.2 in Table 1, diagram 5).

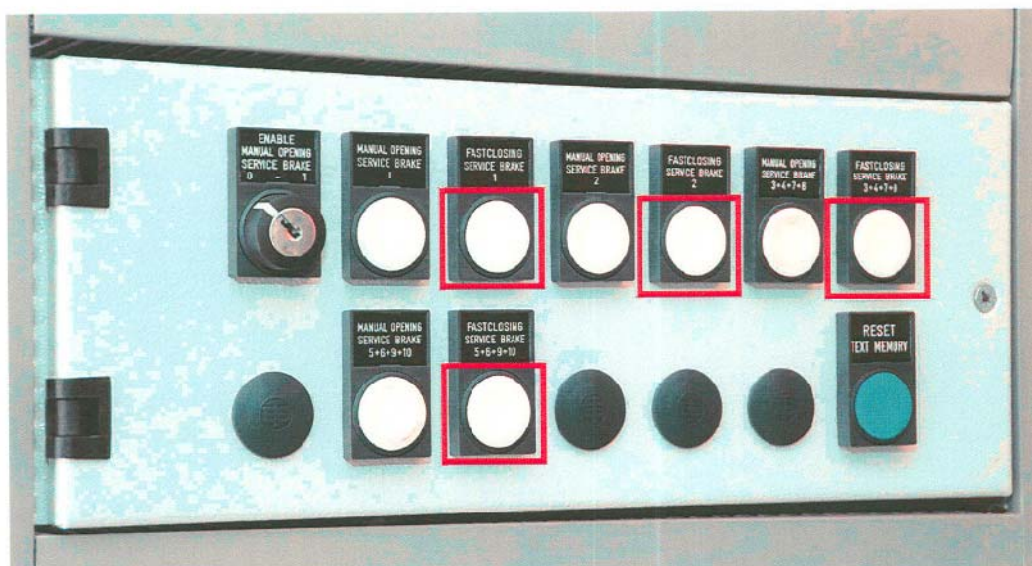
Fig. 1: Test console for service brakes inside the switching cubicle. The four buttons marked red are characterized as “FAST CLOSING SERVICE BRAKE 1”, “FAST CLOSING SERVICE BRAKE 2”, “FAST CLOSING SERVICE BRAKE 3+4+7+8” and “FAST CLOSING SERVICE BRAKE 5+6+9+10”. The function of the pushbuttons when pressed is to close the relevant service brakes immediately without any modulation.

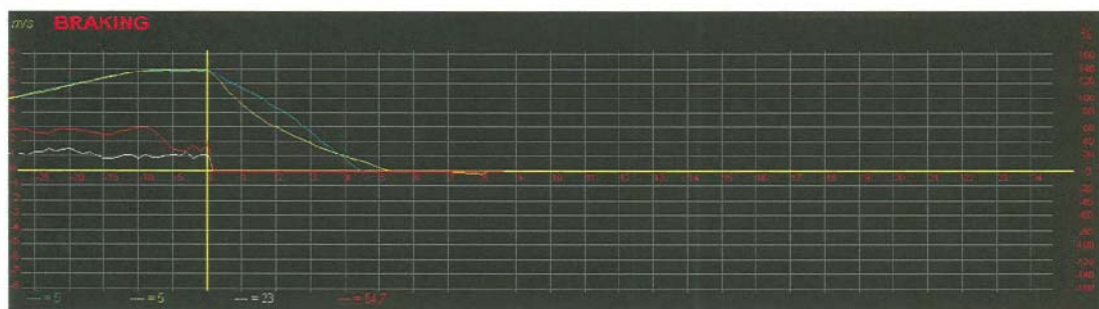
Diagram 5: Mechanical braking by service brake, uncontrolled (four pushbuttons)

The sharp braking of brake test 5 (diagram 5) caused a partial derailment of cabin 21 because of the dynamic effects emerging on both the hauling and carrying ropes. This was not observed by anybody. No grounding signal of hauling rope was observed.

The physical reason for the derailment of vehicle 21 was the brake test No. 5B.2 performed at 7:39 pm. The dynamic forces caused by the high deceleration of 2.5 m/s^2 led to lifting the carriage of cabin 21 off the carrying rope with the derailment following.

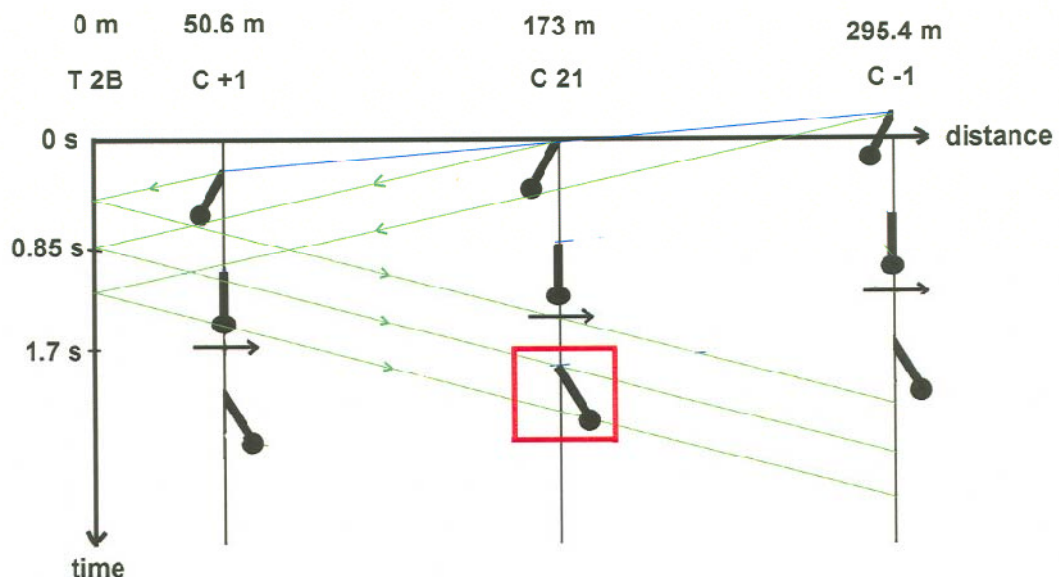
- 3.4.3 A further dynamic effect is to be considered. If a vehicle is decelerated by the hauling rope, the cabin swings off in the driving direction because of its inertia. The carriage applies a momentarily increased normal force on the carrying rope. In the carrying rope a transverse wave is produced, which starts to run in both directions. The wave reaches the next tower and is reflected there. In our case the longitudinal speed of the wave in the carrying rope was about 200 m/s. The distance between the car and tower 2B was 173 m, i.e. the reflected wave reached the vehicle after approximately 1.7 s. During this time the vehicle implemented a half oscillation. Thus the reflection wave of the carrying rope met the vehicle in a swinging-off-position in the uphill direction (Fig. 2).

Fig. 2: The green lines show the run of the transverse waves of the carrying rope caused by the braking as described in the preceding text. The shift times for the vehicles C +1 and C -1 (blue line) are not based on computations, they show the qualitative influence only. The coincidence of the oscillation period of vehicle 21 and the running time of the wave reflected by tower 2B that meets it coincide; the reflected wave meets the vehicle at the moment, when it is in its furthest swing-off-position in the opposite direction (marked red).

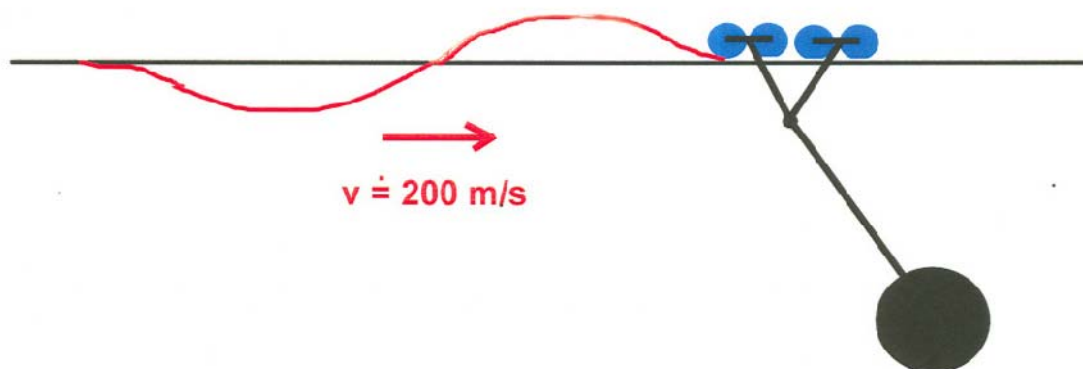
Oscillation tests show that the oscillation period of the empty cabin is about 3.4 s. Therefore the cabin of vehicle 21 is in swing-off-position to the rear when the reflected wave meets the carriage. The wave has the tendency to lift off the carriage (Fig. 3). This could be the cause of derailment of cabin 21 and not any other vehicle. The lifting off must happen by lifting all four rollers simultaneously because according to tests derailment is not possible if only one half of the carriage is lifted off alternately.

Fig. 3: If the transverse wave of the carrying rope running with approximately 200 m/s meets the carriage whilst the vehicle is in a swinging off position in the opposite direction it will tend to lift off the carriage (schematic sketch).

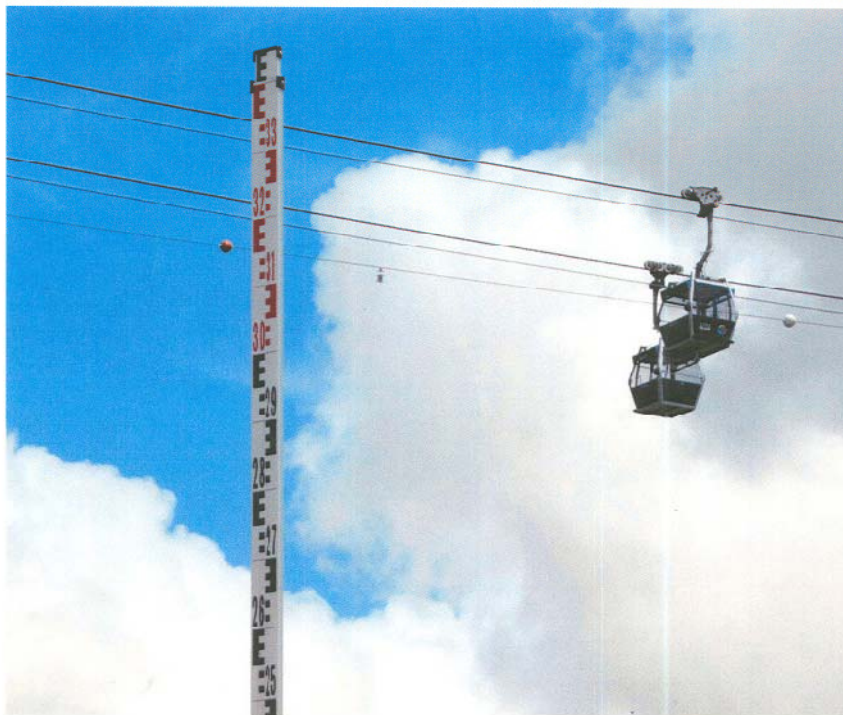
- 3.4.6 The initial assumption that rope waves caused by the acceleration phase have an influence on the waves of the following braking proved as groundless. This became apparent during the measurements of dynamic behaviour at about the point of derailment (Fig. 5).

Fig. 5: Measuring assembly for the observation of the peak-to-peak swings that the ropes perform during acceleration and deceleration phases (conducted on 26. 6. 07)
