Investigation Report on

Incident of the New Signalling System Testing on

MTR Tsuen Wan Line

Date of Incident: 18 March 2019

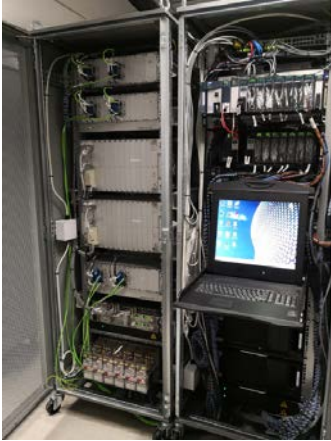
Figure 9: Simulator in Ho Man Tin Station

Simulation tests (Figures 9 and 10) were conducted at Ho Man Tin Station by using the ZCs and VOBCs of the incident trains with the same location and conditions of the incident, with a view to ascertaining whether the incident was caused by the incident ZCs and VOBCs. According to the results of the simulations, the same incident would happen by using the incident ZCs and VOBCs in the simulator.
