Ngong Ping 360 Ropeway
Incident occurred on 25 January 2012
Report of Investigation

Electrical and Mechanical Services Department
3 April 2012

Ngong Ping 360 Ropeway
Incident occurred on 25 January 2012
Executive Summary of the Report of Investigation

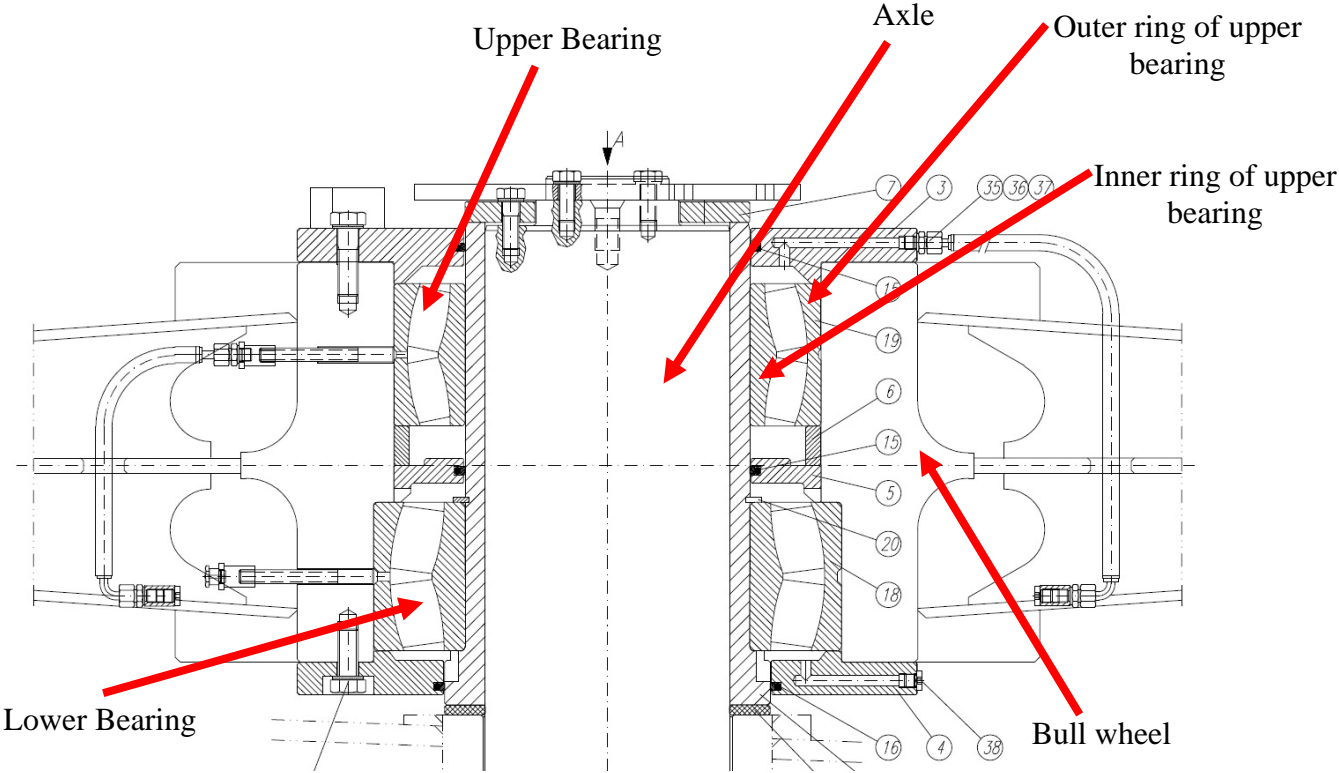
Figure 1 : Configuration of a typical bull wheel of the Ngong Ping 360 Ropeway

used to drive and guide the haul ropes in Section I and Section II. Two bearings (upper and lower) (see Figure 1) are used in each bull wheel to connect the bull wheel to its shaft. Among the numerous protective devices (more than 1,000) installed to ensure safe operation of the Ropeway, position sensor is installed adjacent to each bull wheel to stop the ropeway operation when there is any abnormal vibration in any of the bull wheels. A schematic diagram of the Ropeway is given in Figure 2 below.
