**Report of Incident Investigation on
Helium Balloon Ride at Ocean Park**

Electrical and Mechanical Services Department

30 August 2012

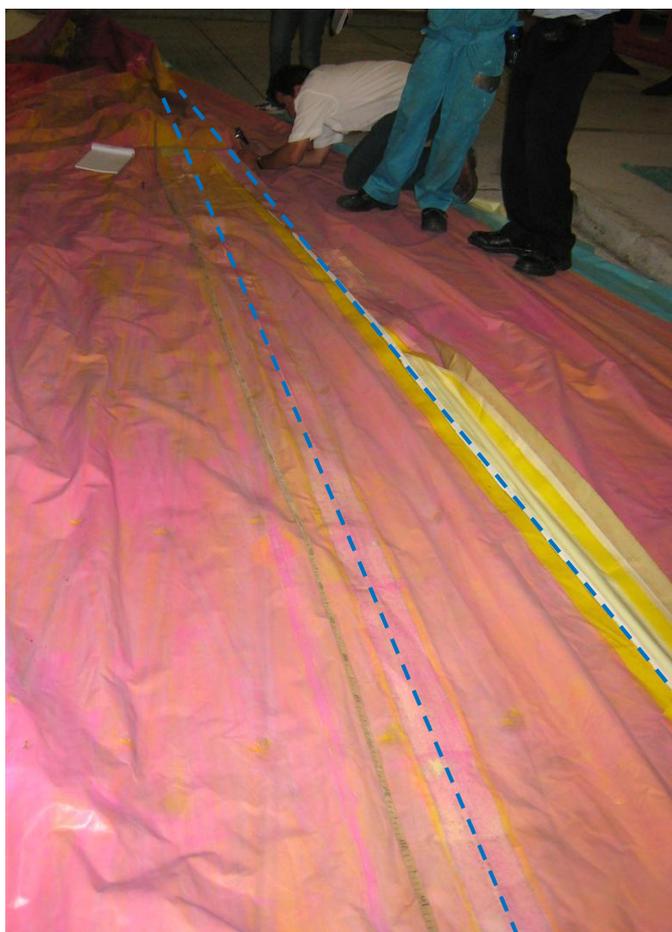
Figure A1 – Photo of the rip panel (rip panel joint indicated by dotted line)

A1. As the rip panel was found split during the inspection of the balloon envelope on site which appeared to be the cause of the opening of the rip panel joint, the description of it is presented in the following paragraphs (please refer to Figure A1).

A2. The rip panel is of triangular shape and serves for quick emptying of the balloon. It starts at a distance of approximately 4 m from the north pole of the balloon and runs with a panel over a length of approximately 7 m towards the equator.

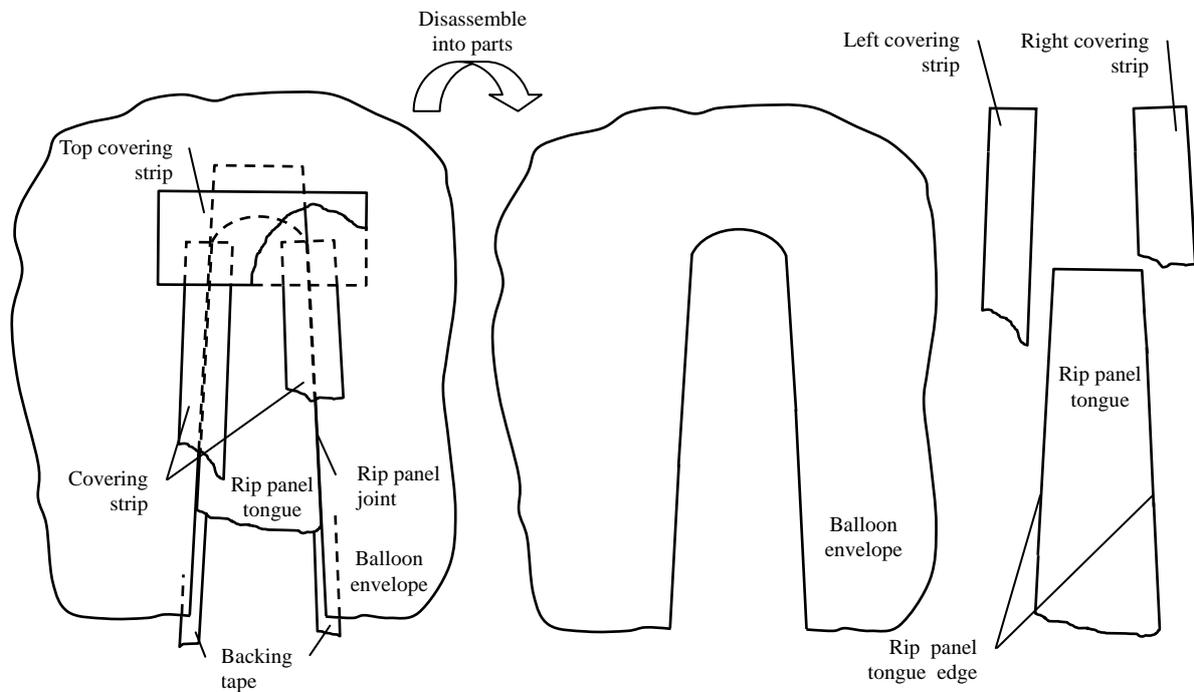
Figure A2 – Fabrication of the rip panel

A3. The detachable part of the rip panel is called the rip panel tongue. The rip panel tongue is sized to fit exactly into the rip panel. The rip panel joints are covered and bonded with specific cement by three 100 mm wide fabric covering strips (using the same fabric of the balloon envelope) on the sides and bottom as well as one 200 mm wide fabric covering strips on the top (please refer to Figure A2 and Figure A3a).

A4. According to the information provided by the manufacturer, the balloon envelop and the rip panel tongue were aligned and kept in place by three 40 mm wide adhesive backing tapes in order to facilitate the bonding of the covering strips by specific cement during fabrication (please refer to and Figure A2 and Figure A3b). The backing tapes are not designed to carry the load in the rip panel joints.
