**Technical Investigation Report on
Escalator Incident at Langham Place,
Mong Kok, Kowloon**

Date of Incident: 25 March 2017
事故日期：2017年3月25日

Issued Date: 9 June 2017
出版日期：2017年6月9日

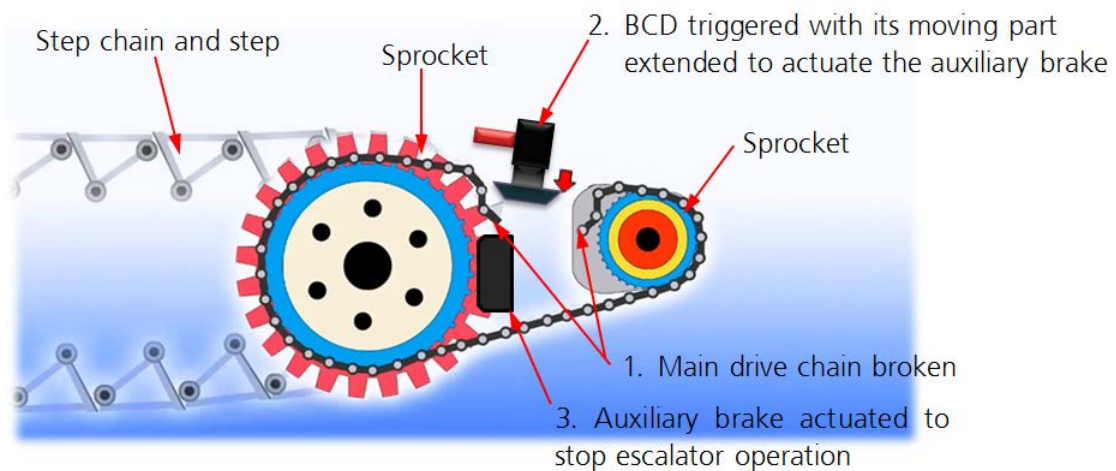
5.2 Under normal circumstance, the breakage and/or excessive elongation of the main drive chain are continuously monitored by the broken chain safety device (BCD, Figures 1 and 3 refer). In case of breakage or excessive elongation of the main drive chain, the BCD will be triggered and will send a signal to activate the auxiliary brake to stop the moving escalator (Figure 2a refers). In this incident, upon breakage of the main drive chain, the BCD failed to detect the chain breakage and the auxiliary brake was not activated to stop the moving escalator (Figure 2b refers).

Figure 2a: Design to protect against main drive chain failure
