**Technical Investigation Report on  
Lift Incident at Paris Court,  
Sheung Shui Town Centre, New Territories**

Date of Incident: 11 May 2018  
事故日期：2018年5月11日

Date of Issue: 20 August 2018  
出版日期：2018年8月20日

**Technical Investigation Report on  
Lift Incident at Paris Court, Sheung Shui Town Centre, New Territories on  
11 May 2018**

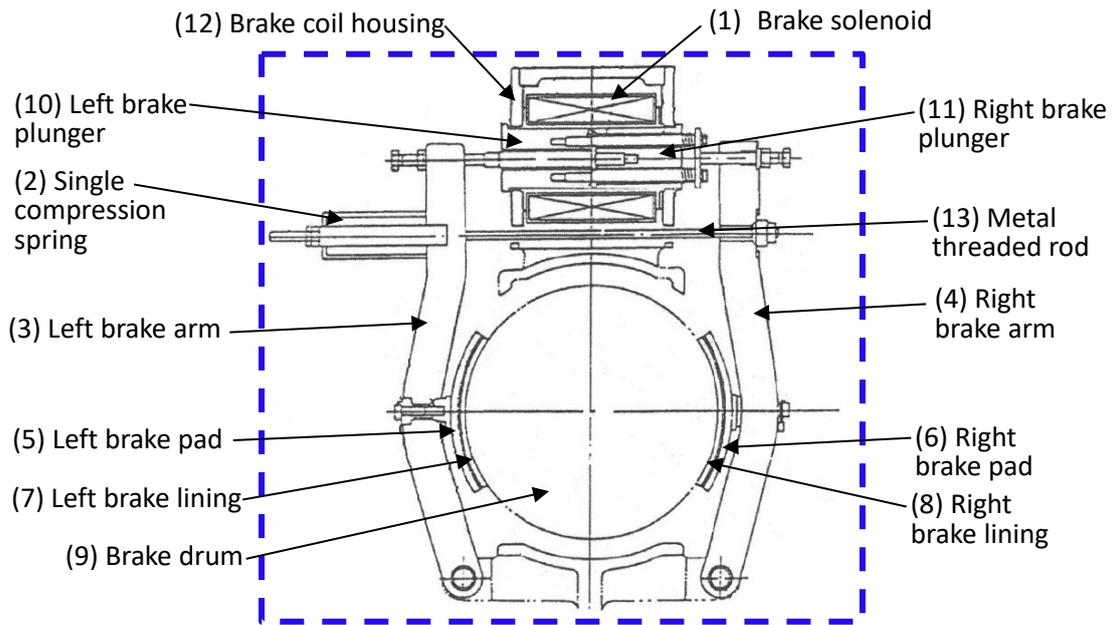
*Figure 2: Construction and operation of electromechanical brake*

To stop a lift, electricity supply to the brake solenoid (1) should be cut off and hence no magnetic field is generated. The single compression spring (2) will then push the left brake arm (3) to the right and pull the right brake arm (4) to the left through a metal threaded rod (13). The left and right brake pads (5 and 6) comprising left and right brake linings (7 and 8) respectively will press on the brake drum (9), which is a mechanical component axially connected to the lift motor, to stop the lift car movement (Figure 3).

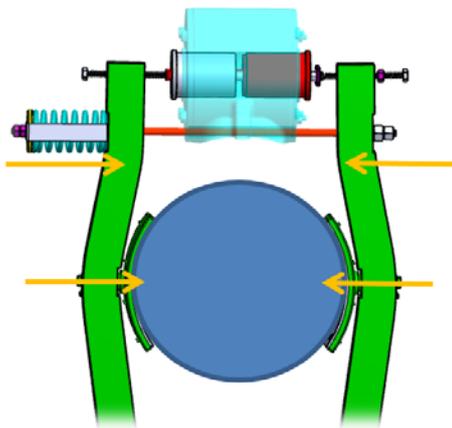
*Figure 3: Brake Closed*

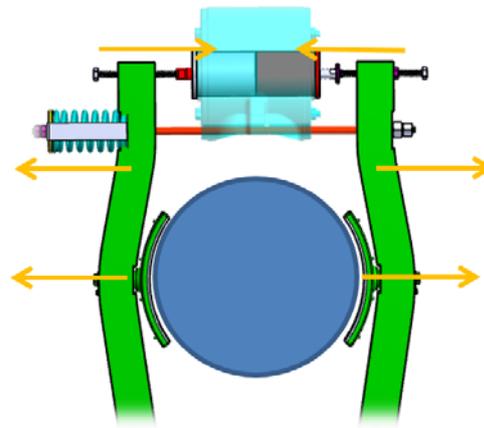
*Figure 4: Brake Opened*

When the lift is called to run, the lift control panel will energise the brake solenoid (1) electrically, thereby providing magnetic field inside the brake coil housing (12). The left and right brake plungers (10 and 11) inside the brake coil housing (12) will be magnetised and move towards each other. The brake arms (3 and 4) and the associated brake pads (5 and 6) attached to the brake arms will move away from the brake drum (9). The brake is disengaged and the lift motor can rotate freely. The lift motor will then be energised electrically by the lift control panel to move up or down according to the lift operation (Figure 4).

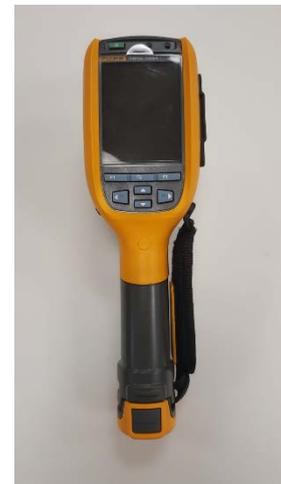
- d) The travel pattern of the lift before the time of the incident was recorded in order to simulate the complete sequence of event. A thermal imager (Figure 5) was used to record the temperature of the brake coil and the brake linings. The simulation results are shown in Figure 6. The simulation test was started at 00:00:00 (hh:mm:ss). With the lift operated as per the pattern before the incident, it was found that at the simulation time of 00:33:02, the left and right brake plungers started to operate asynchronously and sluggishly (with around 1 second delay between their movements). The simulation test continued and it was found that the brake plungers started to stop moving, causing the brake arms and associated brake linings unable to open at simulation time 01:12:23. With the brake plungers failed to move, the brake linings (both left and right) were being applied onto the brake drum continuously even when the lift motor and drum were running. As a result, the temperature of both left and right brake linings started to rise continuously to about 220°C. Finally, at simulation time 03:25:00, the lift car was found moving while the landing door was still at open position, and an unintended car movement occurred.

*Figure 5: Thermal Imager*
