Technical Investigation Report on
Lift Incident at Waterside Plaza,
Tsuen Wan, New Territories

Date of Incident: 8 April 2018

Date of Issue: 14 July 2018

Technical Investigation Report on Lift Incident at Block 2, Waterside Plaza, Tsuen Wan, New Territories on 8 April 2018

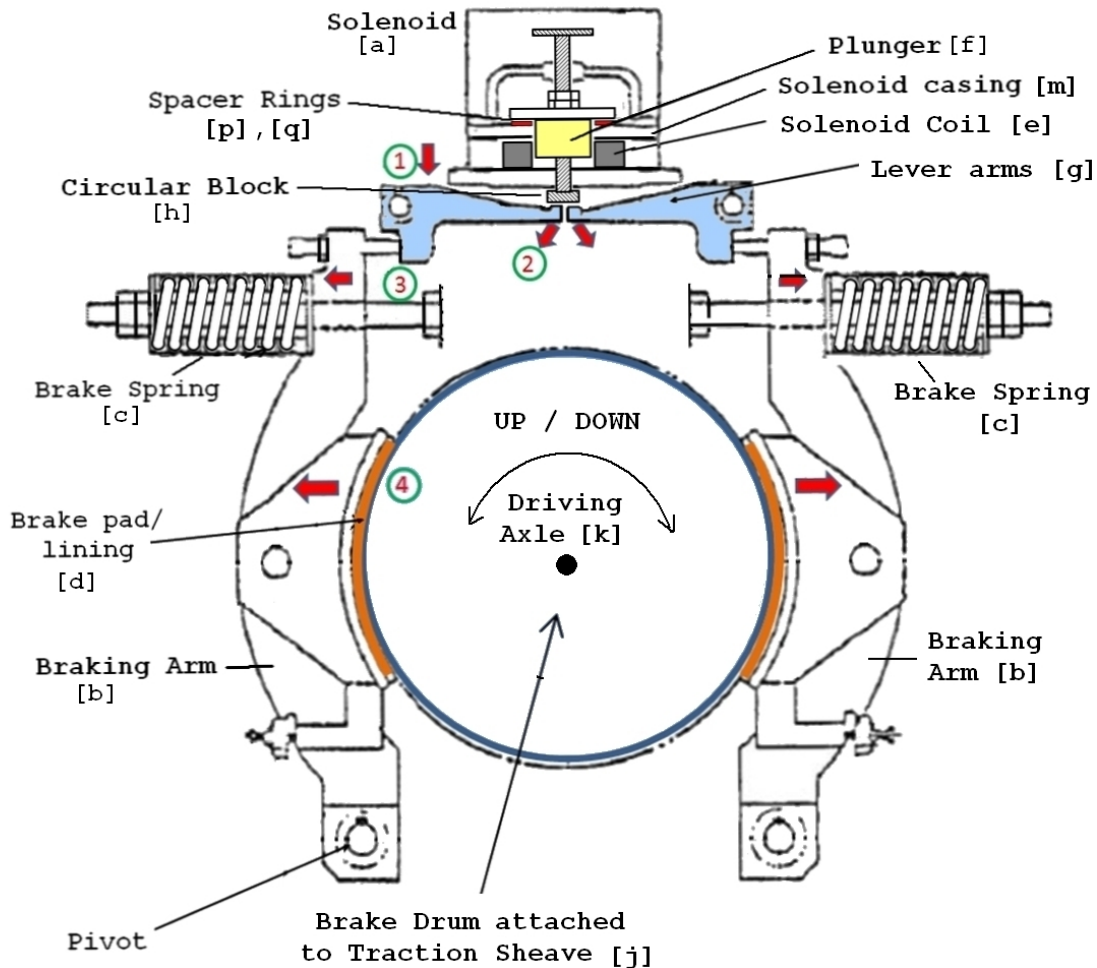
Figure 1 - Arrangement of lift brake system (released)

3.3 The traction machine was equipped with a brake system (Figure 1) in which a single brake solenoid [a] was installed in a vertical orientation. The brake was made up of two braking arms [b] with a brake spring [c] and brake pad [d] for each arm. To release the brake, power had to be supplied to the brake solenoid coil [e] to generate a magnetic force to push the plunger [f] in the downward direction. The downward moving plunger [f] ① pushed the lever arms [g] downward via a circular block [h] attached to the bottom end of the plunger [f]② (see Figure 2), which in turn compressed the brake spring [c]③ and drove the braking arm [b] with the brake pads [d] away from

the brake drum [j]④. Once the brake pads [d] were driven away from the brake drum [j], the traction sheave attached to the brake drum [j] could then rotate. The lift car attached to the suspension ropes would be driven to ascend or descend by the traction sheave.

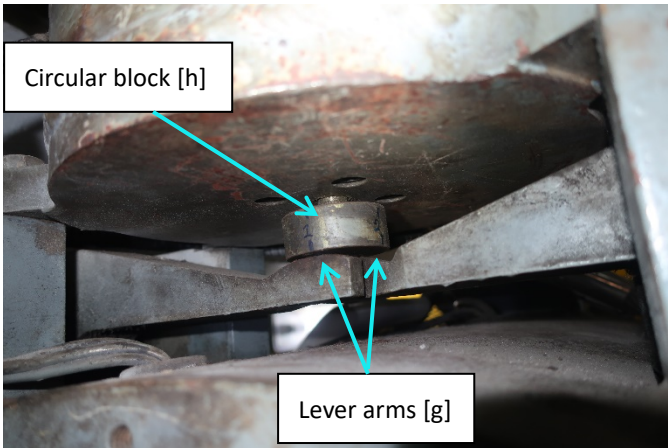
Figure 2 – Brake plunger

5.8 Damage and scratches were found on the plunger [f] surface (Figures 8 and 9). There were also scratches on the plunger's [f] axle rod (Figure 10) and the bush was worn down unevenly (Figure 11). The damages and wearing are believed to be caused by the metal debris being jammed in the solenoid casing [m] along the travel of the plunger [f].

6.2 The cause of malfunction of the brake system was the trapping of metal debris from the damaged upper spacer ring [p] that eventually jammed the movement of the plunger[f], preventing the mechanical brake from engaging at the time of the incident.

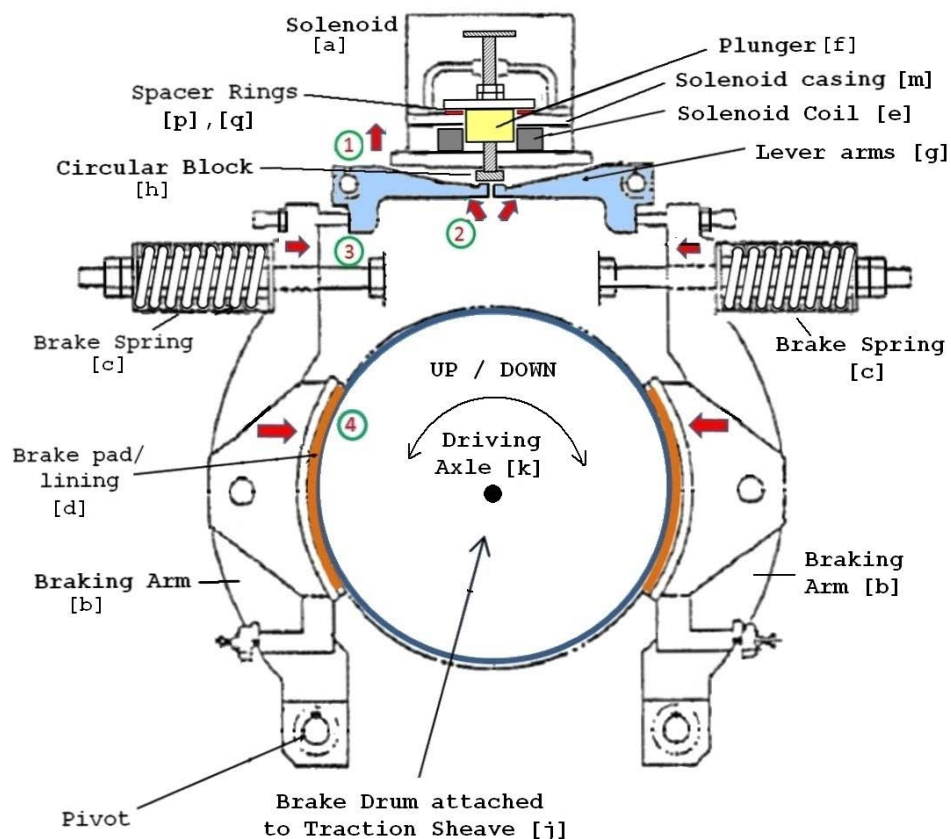
Figure 3 - Arrangement of lift brake system (engaged)

3.4 To apply the brake, power supply to the brake solenoid coil [e] (see Figure 3) was disconnected and the magnetic force generated by the solenoid coil for pushing down the plunger[f] was removed. The compressed brake springs [c] ③ would press the braking arms [b] and the brake pads [d] onto the brake drum [j] ④ in order to stop the movement of the lift car. The lever arm [g] ② and the plunger [f] ① would also be pushed upwards by the brake spring [c]. Eventually plunger [f] would fall under its own weight and the attached circular block [h] would rest in contact with the lever arms [g]. The plunger [f] should also be capable of being rotated smoothly within the solenoid casing [m].
