## **Ngong Ping 360**

### **Cause of Suspension of Service on 19 March 2008**

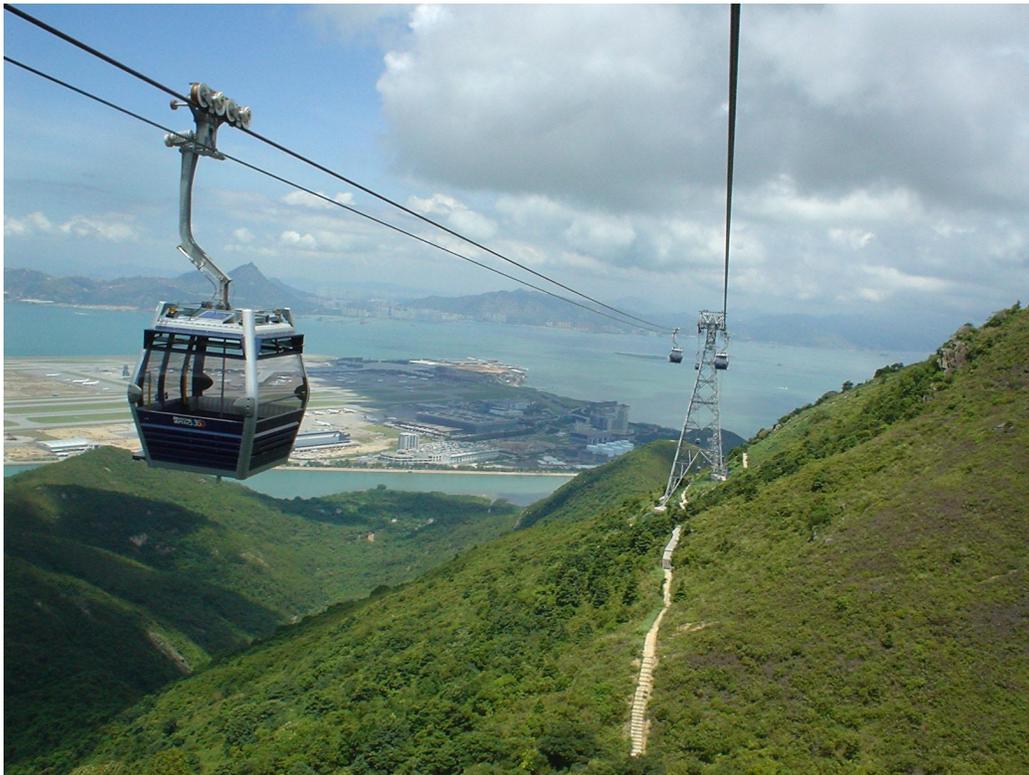
Ngong Ping 360 ropeway is a bi-cable type ropeway system. Figure A shows a typical cabin of Ngong Ping ropeway.

Figure A A cabin of the Ngong Ping ropeway
