Ngong Ping 360

Cause of Suspension of Service on 11 April 2008

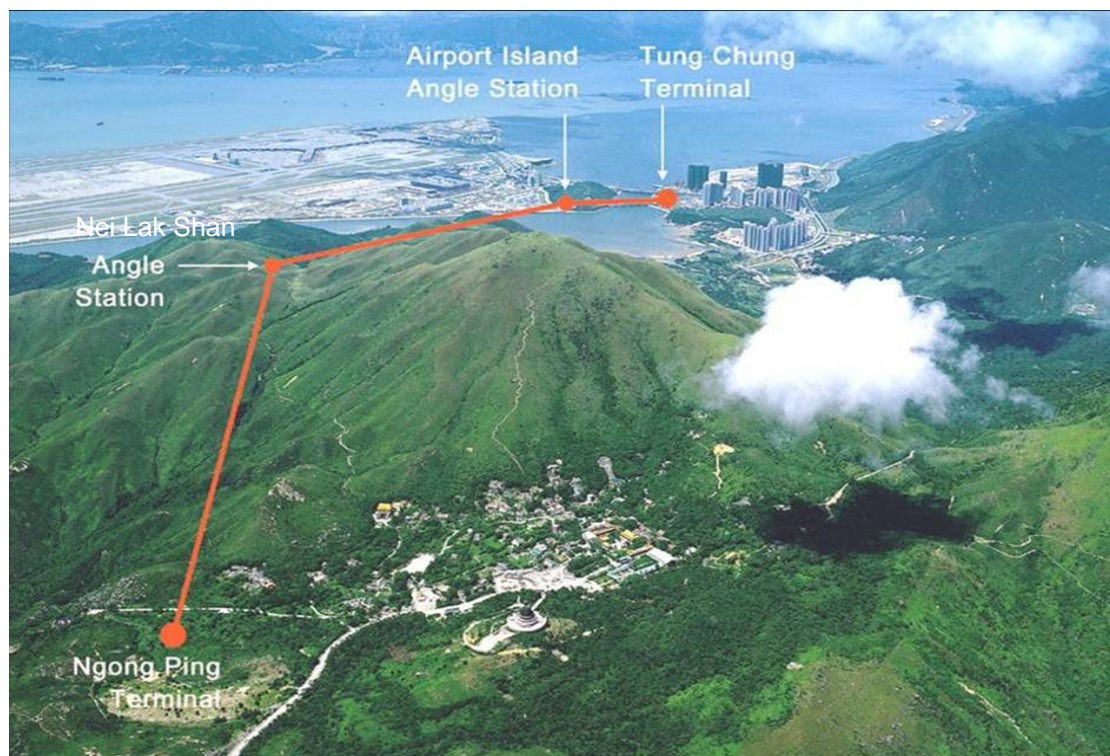
The route of the Ngong Ping 360 ropeway has two angle stations, namely Airport Island Angle Station, and Nei Lak Shan Angle Station. The route of the Ngong Ping 360 ropeway and the locations of the angle stations are given in Figure A.

Figure A Plan view of Ngong Ping ropeway
